WESTERBEKE

SERVICE BULLETIN 92

SUBJECT: Troubleshooting Water Temperature and Oil Pressure Gauges

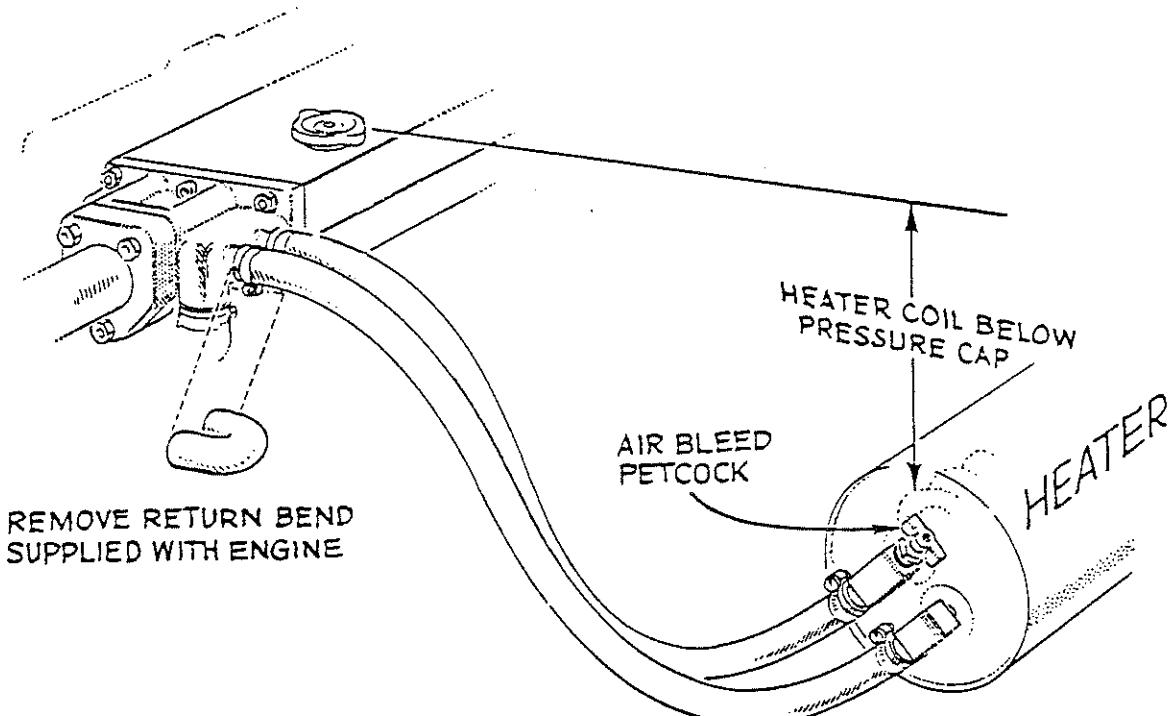
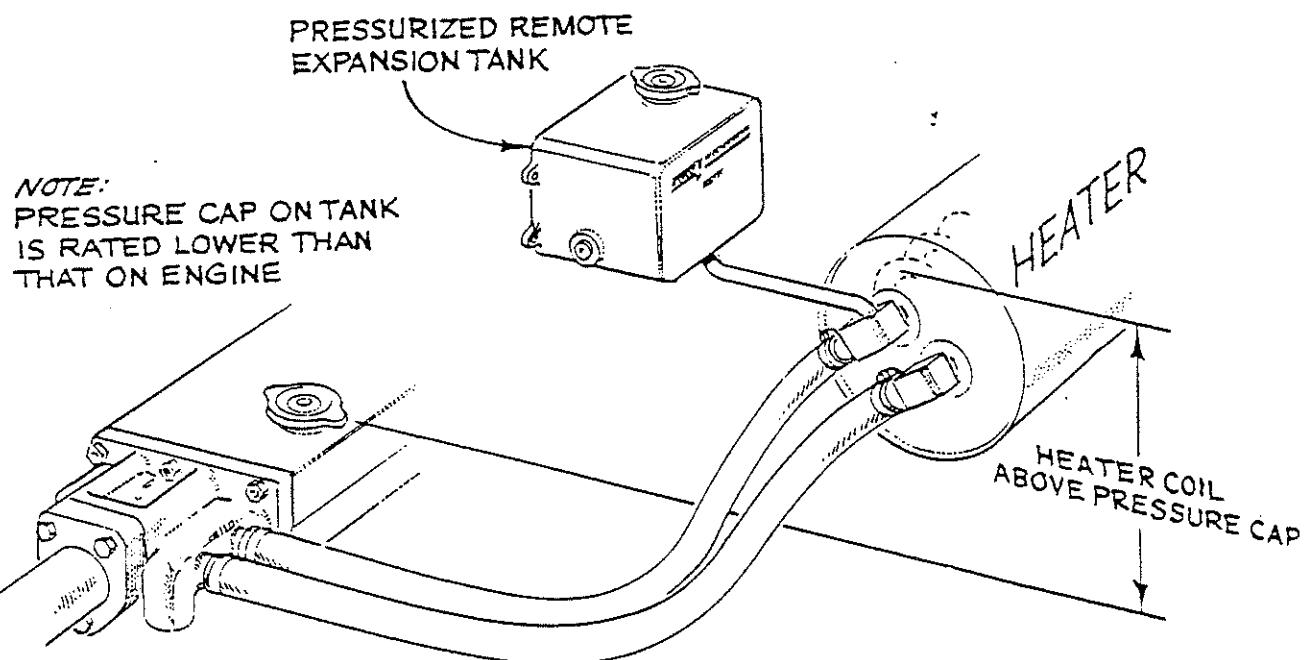
Hoses should rise continuously from their low point at the heater and to the engine so that trapped air will rise naturally from the heater to the engine. If trapped air can rise to the heater, then an air bleed petcock must be installed at the higher fitting at the heater for bleeding the air while filling the system. Avoid loops in hose runs which will trap air.

If any portion of the engine cooling water circuit to or from the heater rises above the engine's own pressure cap, then the pressurized remote expansion tank must be installed in the circuit to be the highest point. The tank kit Part Number is 24177. Install the remote expansion tank in a convenient location such as a sail locker for ease of checking fresh water coolant level.

The hose connection from the heater to the remote expansion tank should be routed and supported so as to rise continuously from the heater to the tank enabling any air in the system to rise.

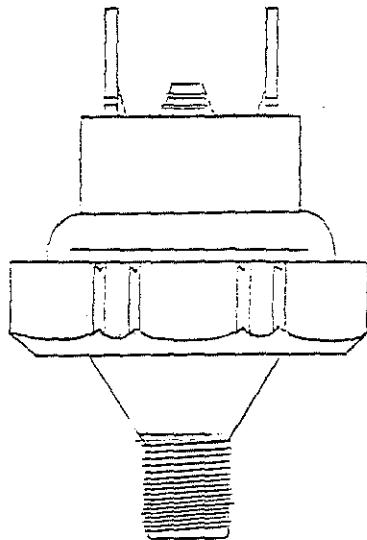
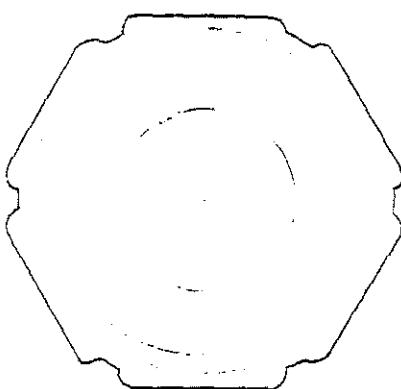
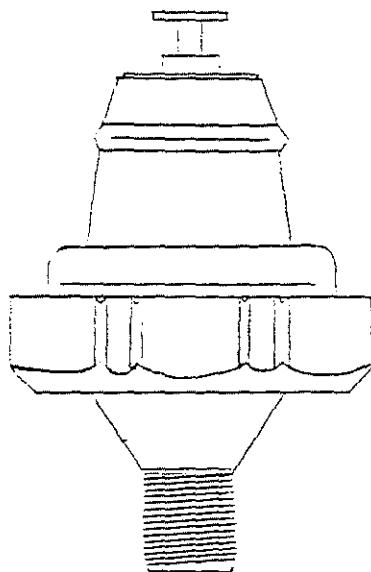
ILLUSTRATION

The correct socket can be acquired through well-known tool manufacturers such as Snap-On, New Britain, Cromwell, Proto and others. The use of channel lock pliers, vise-grips or pipe wrenches, is not advised, in that they may cause damage to the seal between the metal body and the plastic center insert, resulting in a leak and/or switch failure.

When removing and installing oil pressure switches of the type illustrated below, care should be taken to use the correct type socket specifically designed to correctly fit the metal circumference of these switches.

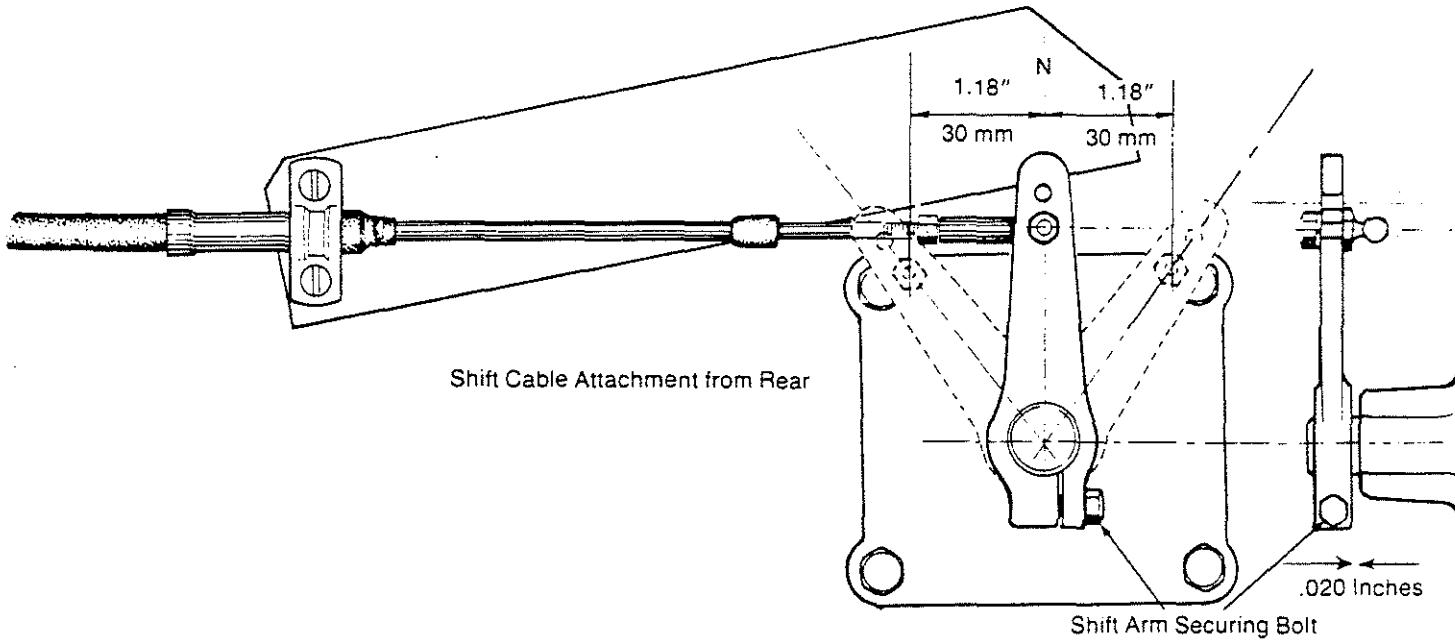
Minimum Travel (inner hole used)

The control cable, when attached to the transmission shift arm ball joint connector, should be attached so as to be at a 90° angle with the lever and transmission in the neutral position (Ref. Illustration).

The shift cable and pedestal control must allow the transmission shift arm to move from the neutral position into the forward or reverse engagement a MINIMUM of 1.37 inches (35mm) when the outermost ball joint attachment hole is used on the shift arm, or 1.18 inches (30mm) when the inner is used. Use of the inner attachment hole is preferred (Ref. Illustration).

Failure to properly adjust the shift arm and cable to produce the MINIMUM shift arm travel required for clutch engagement will result in clutch slip-page and eventual failure.

The transmission shift arm can be rotated on the transmission side cover shifting shaft by loosening the securing bolt (13mm) and rotating the shift arm to produce the 90° angle between the arm and the shift cable when the transmission is in neutral. Insure that there is at least .020 inch clearance between the shift arm and the shift cover before retightening the securing bolt.

Adjusting the shift arm and shift cable to produce shift lever movement greater than the minimum is recommended.

Movement at the shift arm preferably should be 1.5 to 2 inches of arm movement into the forward and reverse position. Cockpit controls must be of a design that will allow for this desired cable travel.

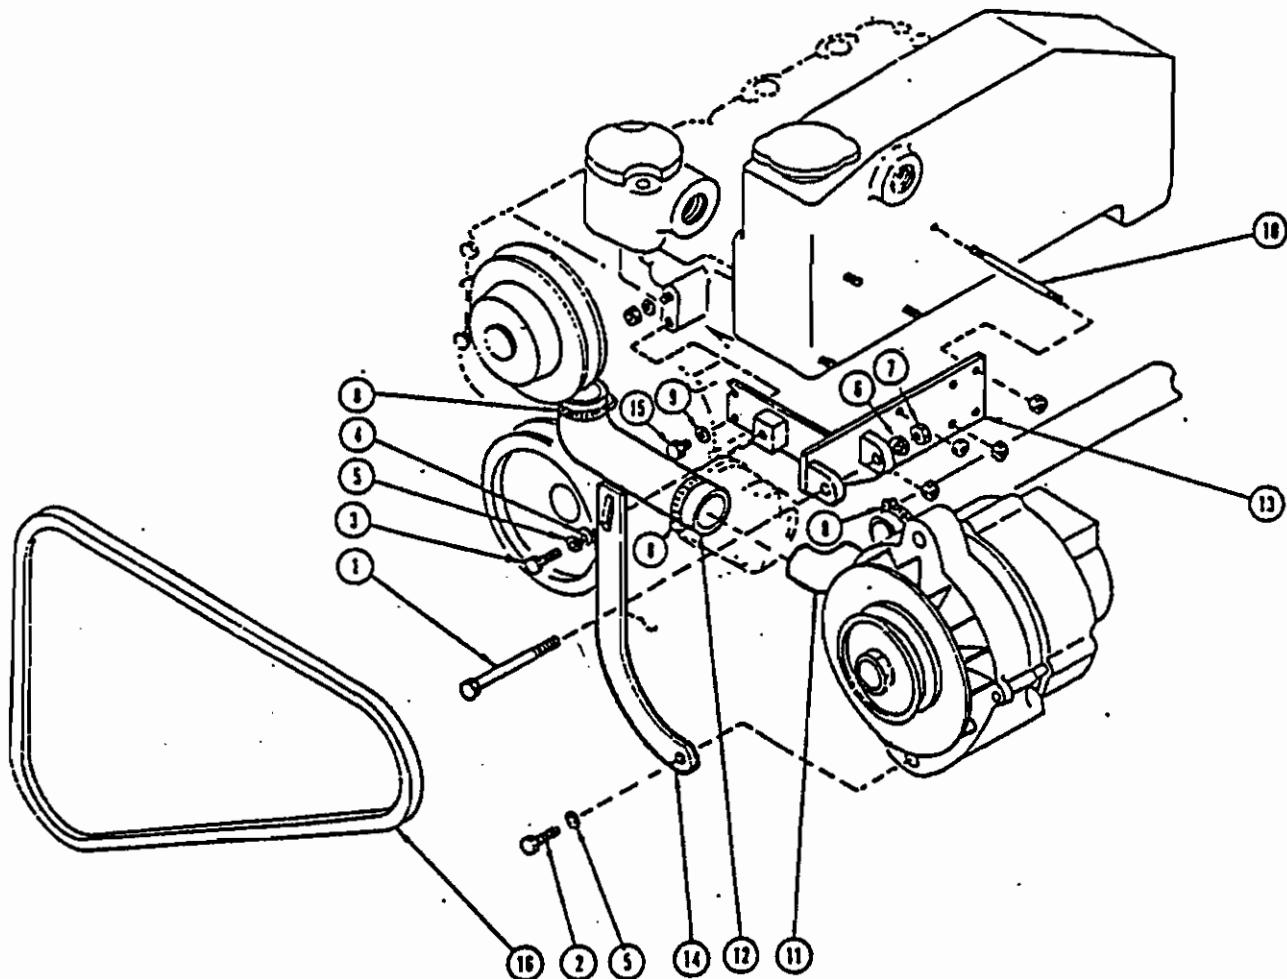
Alternator Mounting Kit #256891 Components

Westerbeke Corporation has become aware that some early model Universal M18, M25 and M25XP marine engines having the DC charging alternator mounted directly to the front gear case cover have experienced failure of the gear case cover at this mounting point.

Owners of these early Universal models are encouraged to inspect their units and if they find the DC charging alternator mounted directly to the front gear case cover that they purchase a conversion kit PN# 256891 that will allow for the mounting of the alternator on a bracket that is attached to the engine's exhaust manifold as later model engines were configured to. The illustration with this bulletin lists the kit components and shows their location on the engine.

If failure of the mounting area on the front gear case cover has occurred, two approaches can be taken to repair it.

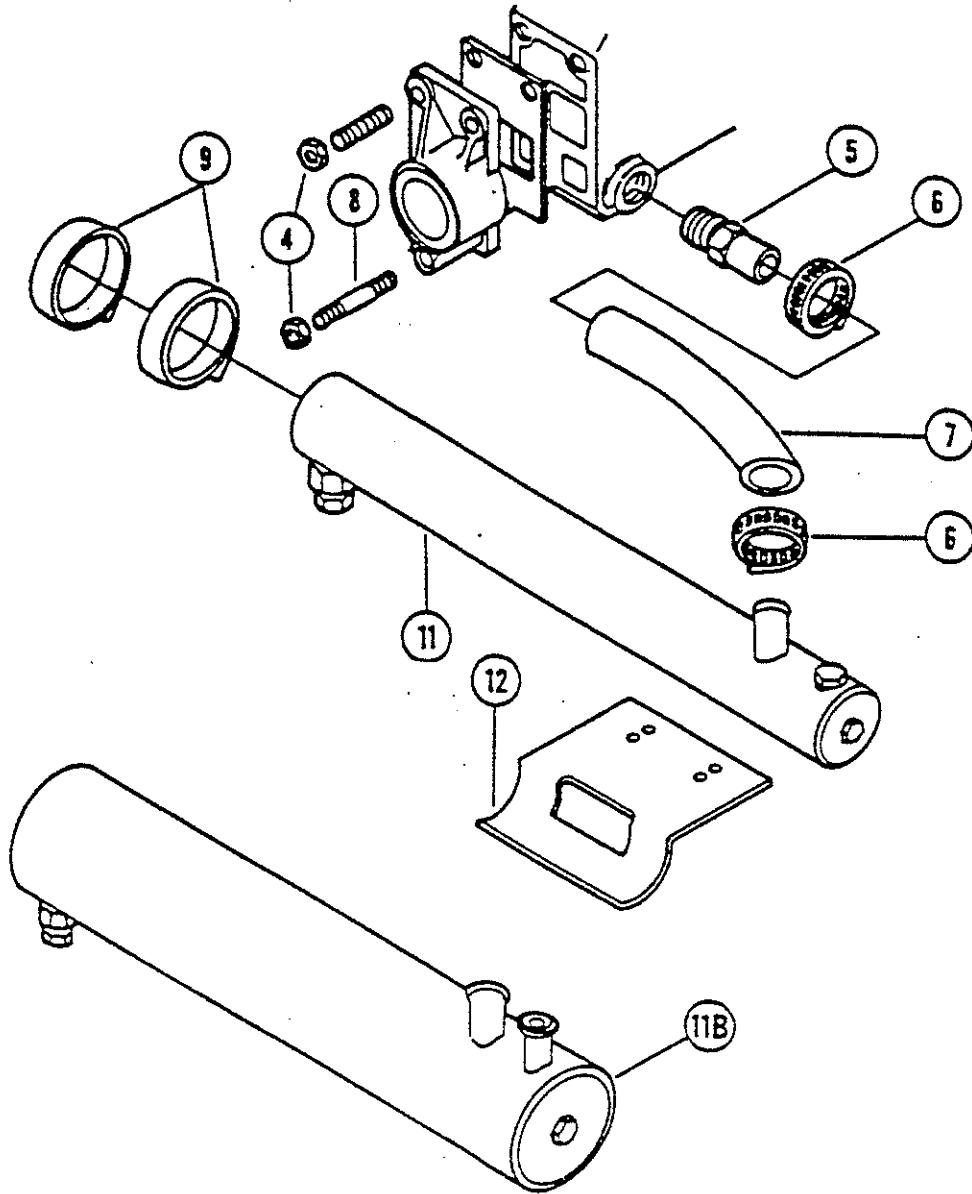
Heat Exchanger Group - New Style

Complaints have been received from the field on some of the above early model engines regarding high water operating temperatures (above 190 degrees F). Complaints of overheating when operating the engine at high or maximum rated engine r.p.m.

These complaints are possibly related to the heat exchanger size used on these early models. One should keep in mind that there are other components and areas of the engine's cooling system that could cause or contribute to high operating temperatures and overheating. These are:

If these areas 1-6 have been inspected and any faults that are found are corrected and overheating still occurs, it is recommended that the operator consider replacing the two inch diameter heat exchanger (P/N #299049) originally supplied with the engine with the three inch diameter heat exchanger Universal incorporated on later models (P/N #299835).

The illustration shows this larger heat exchanger, reference #11B. The contoured mounting bracket reference #12 will have to be reworked to fit the contour of the larger exchanger. This can easily be done by removing the bracket and using a piece of three inch iron pipe as a template to rework the bracket to the proper contour. Use two cushions #033487 between the exchanger body and the bracket along with heavy duty clamps (P/N #303070) when mounting the heat exchanger to the reworked bracket. The illustration helps show these components.

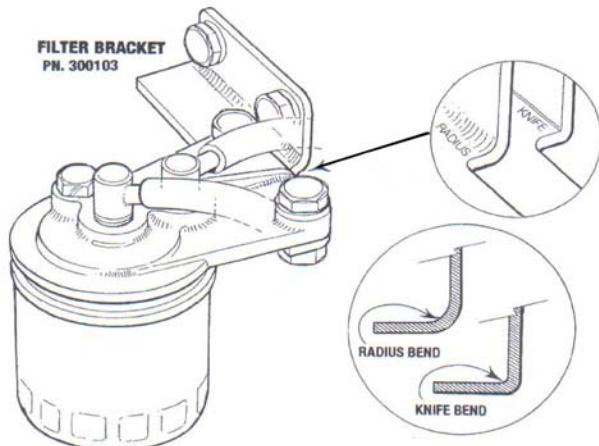
DETAIL: FRACTURES HAVE BEEN REPORTED FROM THE FIELD IN THE AREA OF THE 90-DEGREE BEND IN THE #300103 BRACKET. INSPECTION OF BRACKETS RETURNED FROM THE FIELD HAS SHOWN THAT THE 90- DEGREE BEND WAS INCORRECTLY PERFORMED USING A KNIFE-EDGE BENDER RATHER THAN A RADIUS BENDER.

THIS KNIFE EDGE BENDING PROCESS PLACES A NOTICEABLE CREASE ALONG THE BEND WHICH CAN STRESS THIS AREA OF THE METAL CREATING THE POSSIBILITY OF A FRACTURE TAKING PLACE ALONG THIS CREASE.

NOTE: TO LOW OF AN ENGINE IDLE SPEED WILL PRODUCE FILTER VIBRATIONS THAT CAN AFFECT THE FILTER BRACKET AND LED TO ITS FRACTURING AT THE 90 DEGREE BEND.

THE ILLUSTRATION BELOW SHOULD HELP TO SHOW THE DIFFERENCES IN THE 90 DEGREE BEND.

THE ABOVE SUBJECT MODELS USING THIS BRACKET MANUFACTURED PRIOR TO SEPTEMBER 2004 (E409) ARE SUSPECT. VISUALLY INSPECT THE BRACKET AND IF A CREASE IS VISIBLE ALONG THE BEND AREA. CONTACT WESTERBEKE CORPORATION AT 508-823-7677. PROVIDE THE ENGINE MODEL AND SERIAL NUMBER AND A SHIPPING ADDRESS AND A REPLACEMENT BRACKET WILL BE SENT AT NO CHARGE.
