WESTERBEKE

SERVICE BULLETIN 92

SUBJECT: Troubleshooting Water Temperature and Oil Pressure Gauges

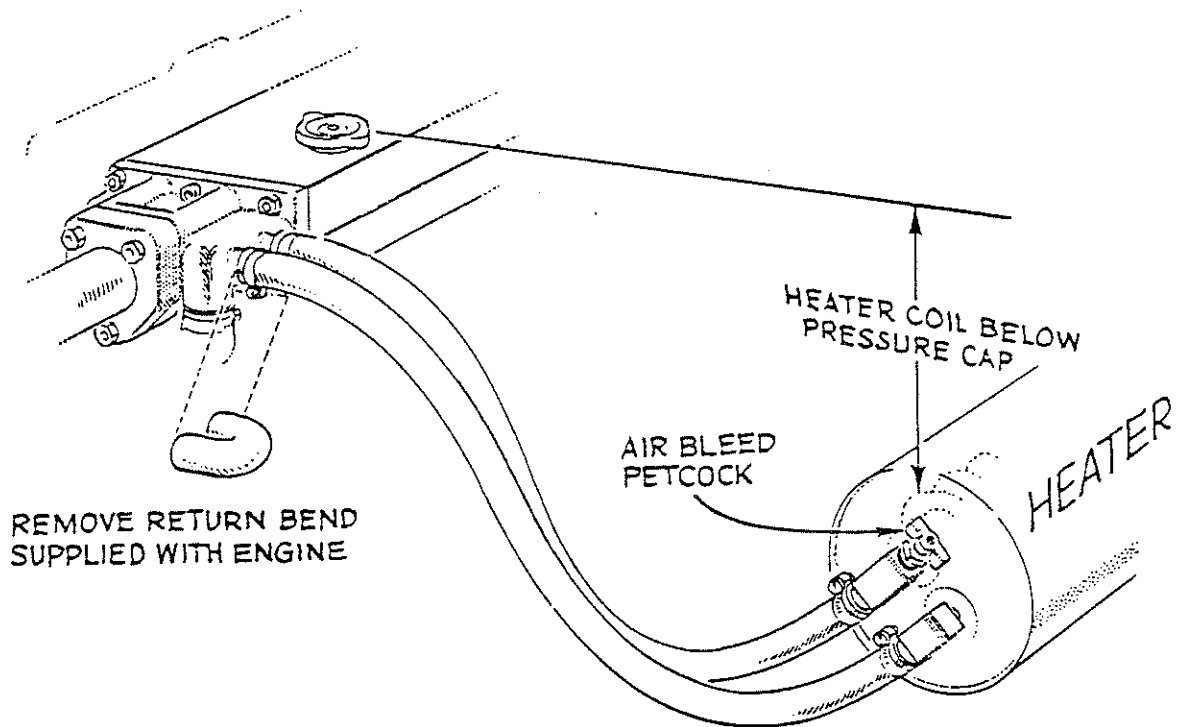
HEATER BELOW ENGINE

Hoses should rise continuously from their low point at the heater and to the engine so that trapped air will rise naturally from the heater to the engine. If trapped air can rise to the heater, then an air bleed petcock must be installed at the higher fitting at the heater for bleeding the air while filling the system. Avoid loops in hose runs which will trap air.

If any portion of the engine cooling water circuit to or from the heater rises above the engine's own pressure cap, then the pressurized remote expansion tank must be installed in the circuit to be the highest point. The tank kit Part Number is 24177. Install the remote expansion tank in a convenient location such as a sail locker for ease of checking fresh water coolant level.

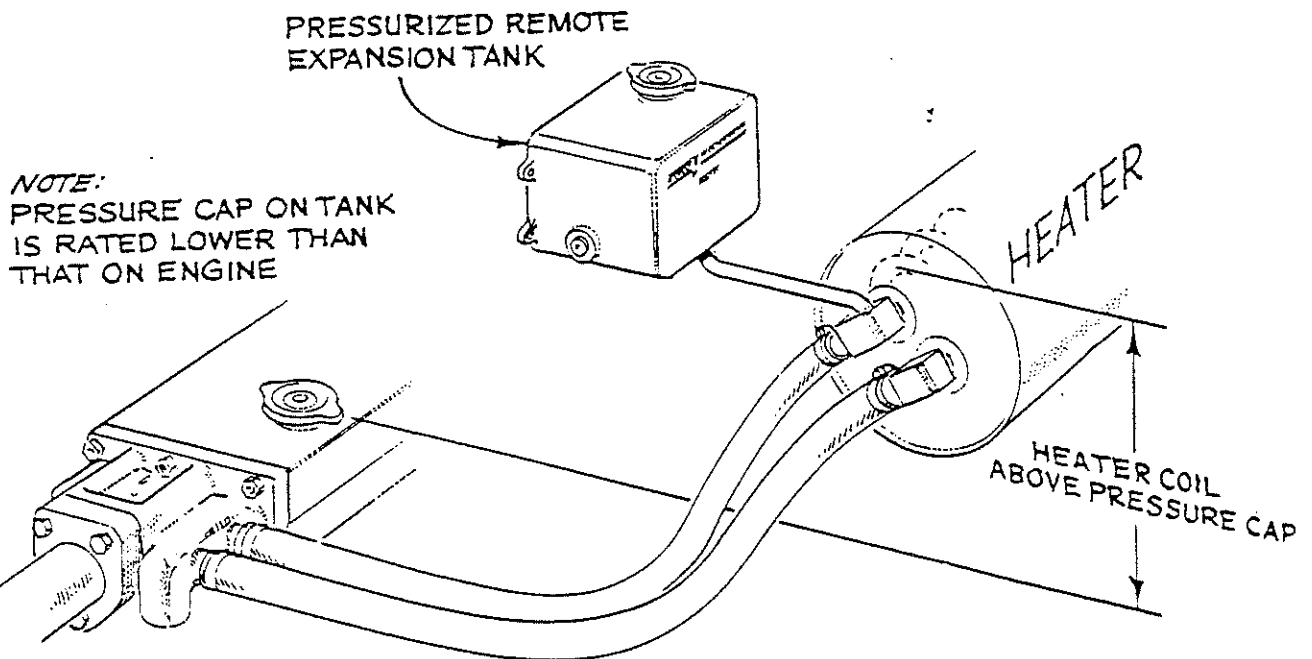
HEATER ABOVE ENGINE

The hose connection from the heater to the remote expansion tank should be routed and supported so as to rise continuously from the heater to the tank enabling any air in the system to rise.

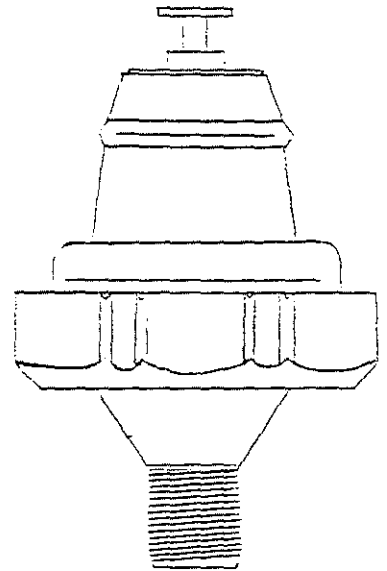
ILLUSTRATION

When removing and installing oil pressure switches of the type illustrated below, care should be taken to use the correct type socket specifically designed to correctly fit the metal circumference of these switches.

The correct socket can be acquired through well-known tool manufacturers such as Snap-On, New Britain, Cromwell, Proto and others. The use of channel lock pliers, vise-grips or pipe wrenches, is not advised, in that they may cause damage to the seal between the metal body and the plastic center insert, resulting in a leak and/or switch failure.

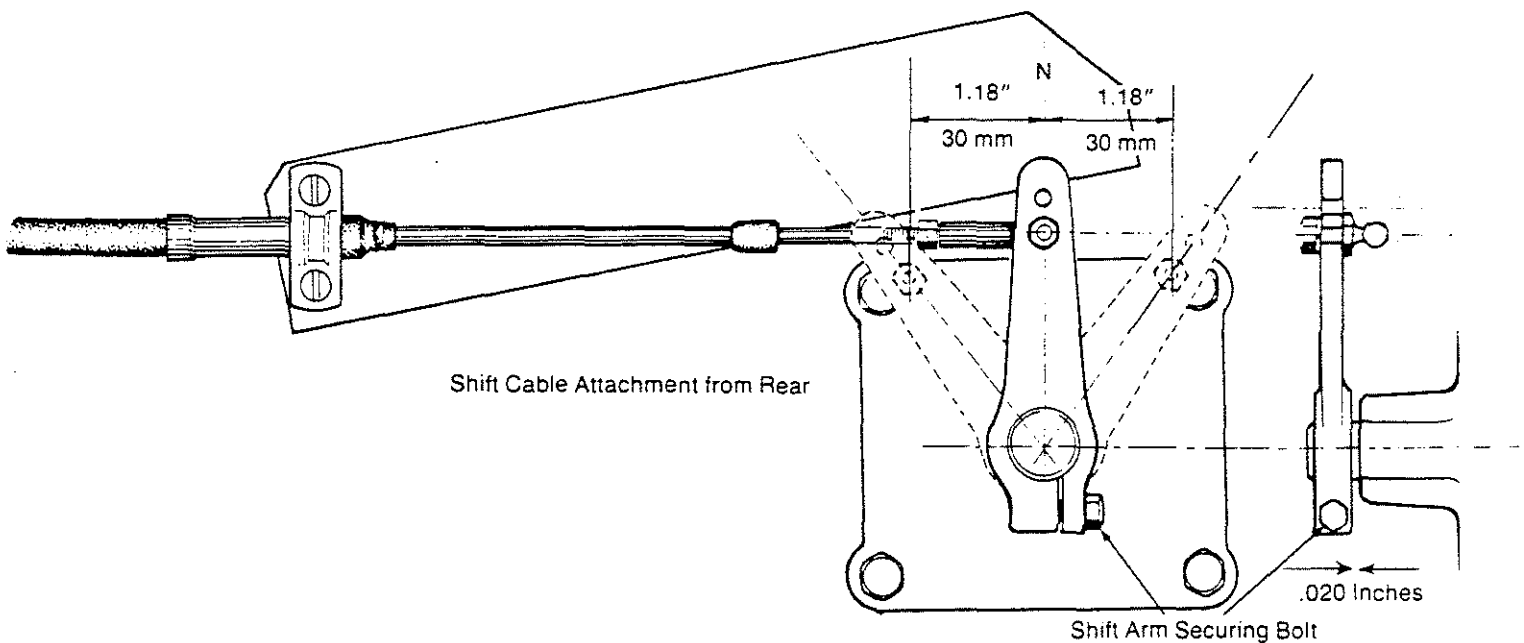
Minimum Travel (inner hole used)

The control cable, when attached to the transmission shift arm ball joint connector, should be attached so as to be at a 90° angle with the lever and transmission in the neutral position (Ref. Illustration).

The shift cable and pedestal control must allow the transmission shift arm to move from the neutral position into the forward or reverse engagement a MINIMUM of 1.37 inches (35mm) when the outermost ball joint attachment hole is used on the shift arm, or 1.18 inches (30mm) when the inner is used. Use of the inner attachment hole is preferred (Ref. Illustration).

Failure to properly adjust the shift arm and cable to produce the MINIMUM shift arm travel required for clutch engagement will result in clutch slippage and eventual failure.

The transmission shift arm can be rotated on the transmission side cover shifting shaft by loosening the securing bolt (13mm) and rotating the shift arm to produce the 90° angle between the arm and the shift cable when the transmission is in neutral. Insure that there is at least .020 inch clearance between the shift arm and the shift cover before retightening the securing bolt.

Adjusting the shift arm and shift cable to produce shift lever movement greater than the minimum is recommended.

Movement at the shift arm preferably should be 1.5 to 2 inches of arm movement into the forward and reverse position. Cockpit controls must be of a design that will allow for this desired cable travel.

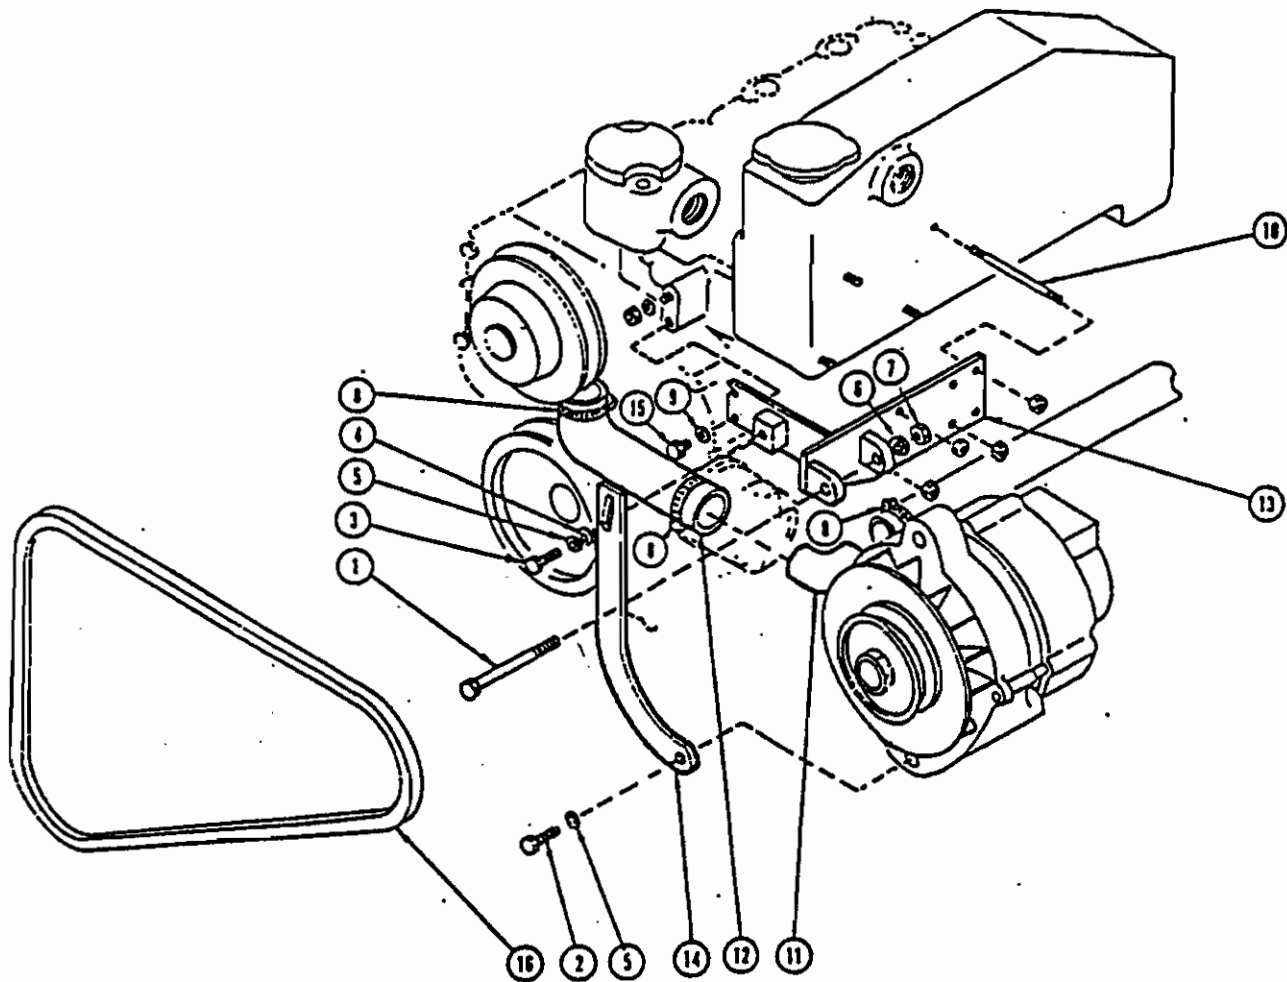
Alternator Mounting Kit #256891 Components

Westerbeke Corporation has become aware that some early model Universal M18, M25 and M25XP marine engines having the DC charging alternator mounted directly to the front gear case cover have experienced failure of the gear case cover at this mounting point.

Owners of these early Universal models are encouraged to inspect their units and if they find the DC charging alternator mounted directly to the front gear case cover that they purchase a conversion kit PN# 256891 that will allow for the mounting of the alternator on a bracket that is attached to the engine's exhaust manifold as later model engines were configured to. The illustration with this bulletin lists the kit components and shows their location on the engine.

Contact your local area Westerbeke/Universal dealer to order the alternator mount conversion kit #256891 and front gear case cover parts as needed.

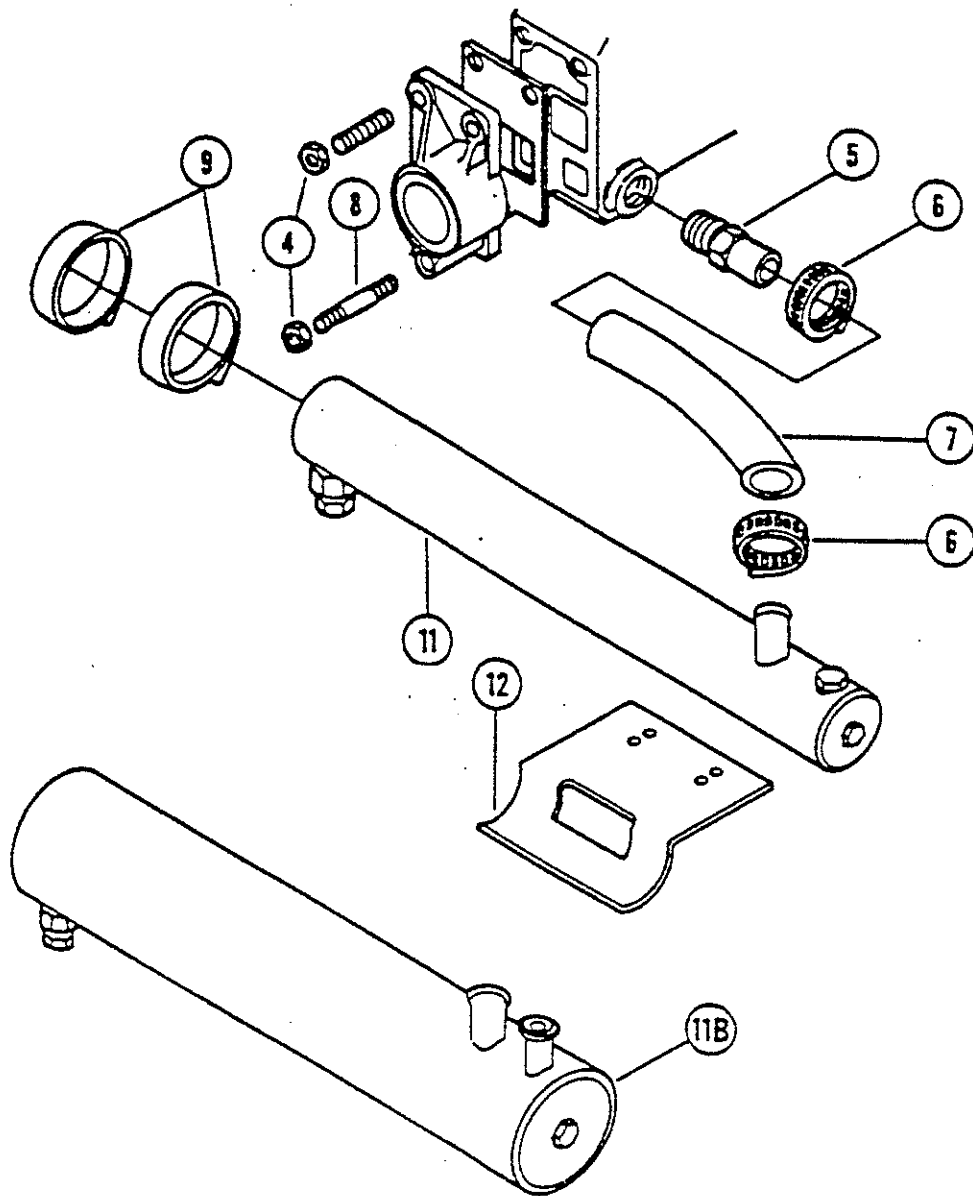
Heat Exchanger Group - New Style

Complaints have been received from the field on some of the above early model engines regarding high water operating temperatures (above 190 degrees F). Complaints of overheating when operating the engine at high or maximum rated engine r.p.m.

These complaints are possibly related to the heat exchanger size used on these early models. One should keep in mind that there are other components and areas of the engine's cooling system that could cause or contribute to high operating temperatures and overheating. These are:

If these areas 1-6 have been inspected and any faults that are found are corrected and overheating still occurs, it is recommended that the operator consider replacing the two inch diameter heat exchanger (P/N #299049) originally supplied with the engine with the three inch diameter heat exchanger Universal incorporated on later models (P/N #299835).

The illustration shows this larger heat exchanger, reference #11B. The contoured mounting bracket reference #12 will have to be reworked to fit the contour of the larger exchanger. This can easily be done by removing the bracket and using a piece of three inch iron pipe as a template to rework the bracket to the proper contour. Use two cushions #033487 between the exchanger body and the bracket along with heavy duty clamps (P/N #303070) when mounting the heat exchanger to the reworked bracket. The illustration helps show these components.

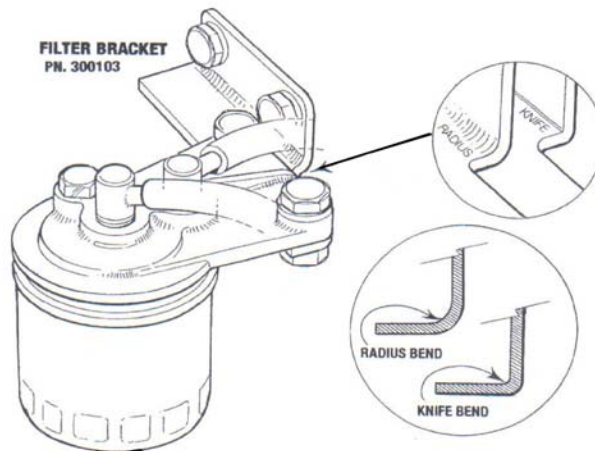
DETAIL: FRACTURES HAVE BEEN REPORTED FROM THE FIELD IN THE AREA OF THE 90-DEGREE BEND

THIS KNIFE EDGE BENDING PROCESS PLACES A NOTICEABLE CREASE ALONG THE BEND WHICH CAN STRESS THIS AREA OF THE METAL CREATING THE POSSIBILITY OF A FRACTURE TAKING PLACE ALONG THIS CREASE.

NOTE: TO LOW OF AN ENGINE IDLE SPEED WILL PRODUCE FILTER VIBRATIONS THAT CAN AFFECT THE FILTER BRACKET AND LED TO ITS FRACTURING AT THE 90 DEGREE BEND.

THE ILLUSTRATION BELOW SHOULD HELP TO SHOW THE DIFFERENCES IN THE 90 DEGREE BEND.

THE ABOVE SUBJECT MODELS USING THIS BRACKET MANUFACTURED PRIOR TO SEPTEMBER 2004 (E409) ARE SUSPECT. VISUALLY INSPECT THE BRACKET AND IF A CREASE IS VISIBLE ALONG THE BEND AREA. CONTACT WESTERBEKE CORPORATION AT 508-823-7677. PROVIDE THE ENGINE MODEL AND SERIAL NUMBER AND A SHIPPING ADDRESS AND A REPLACEMENT BRACKET WILL BE SENT AT NO CHARGE.
