CATALINA YACHTS

KEEL CRACK REPAIR

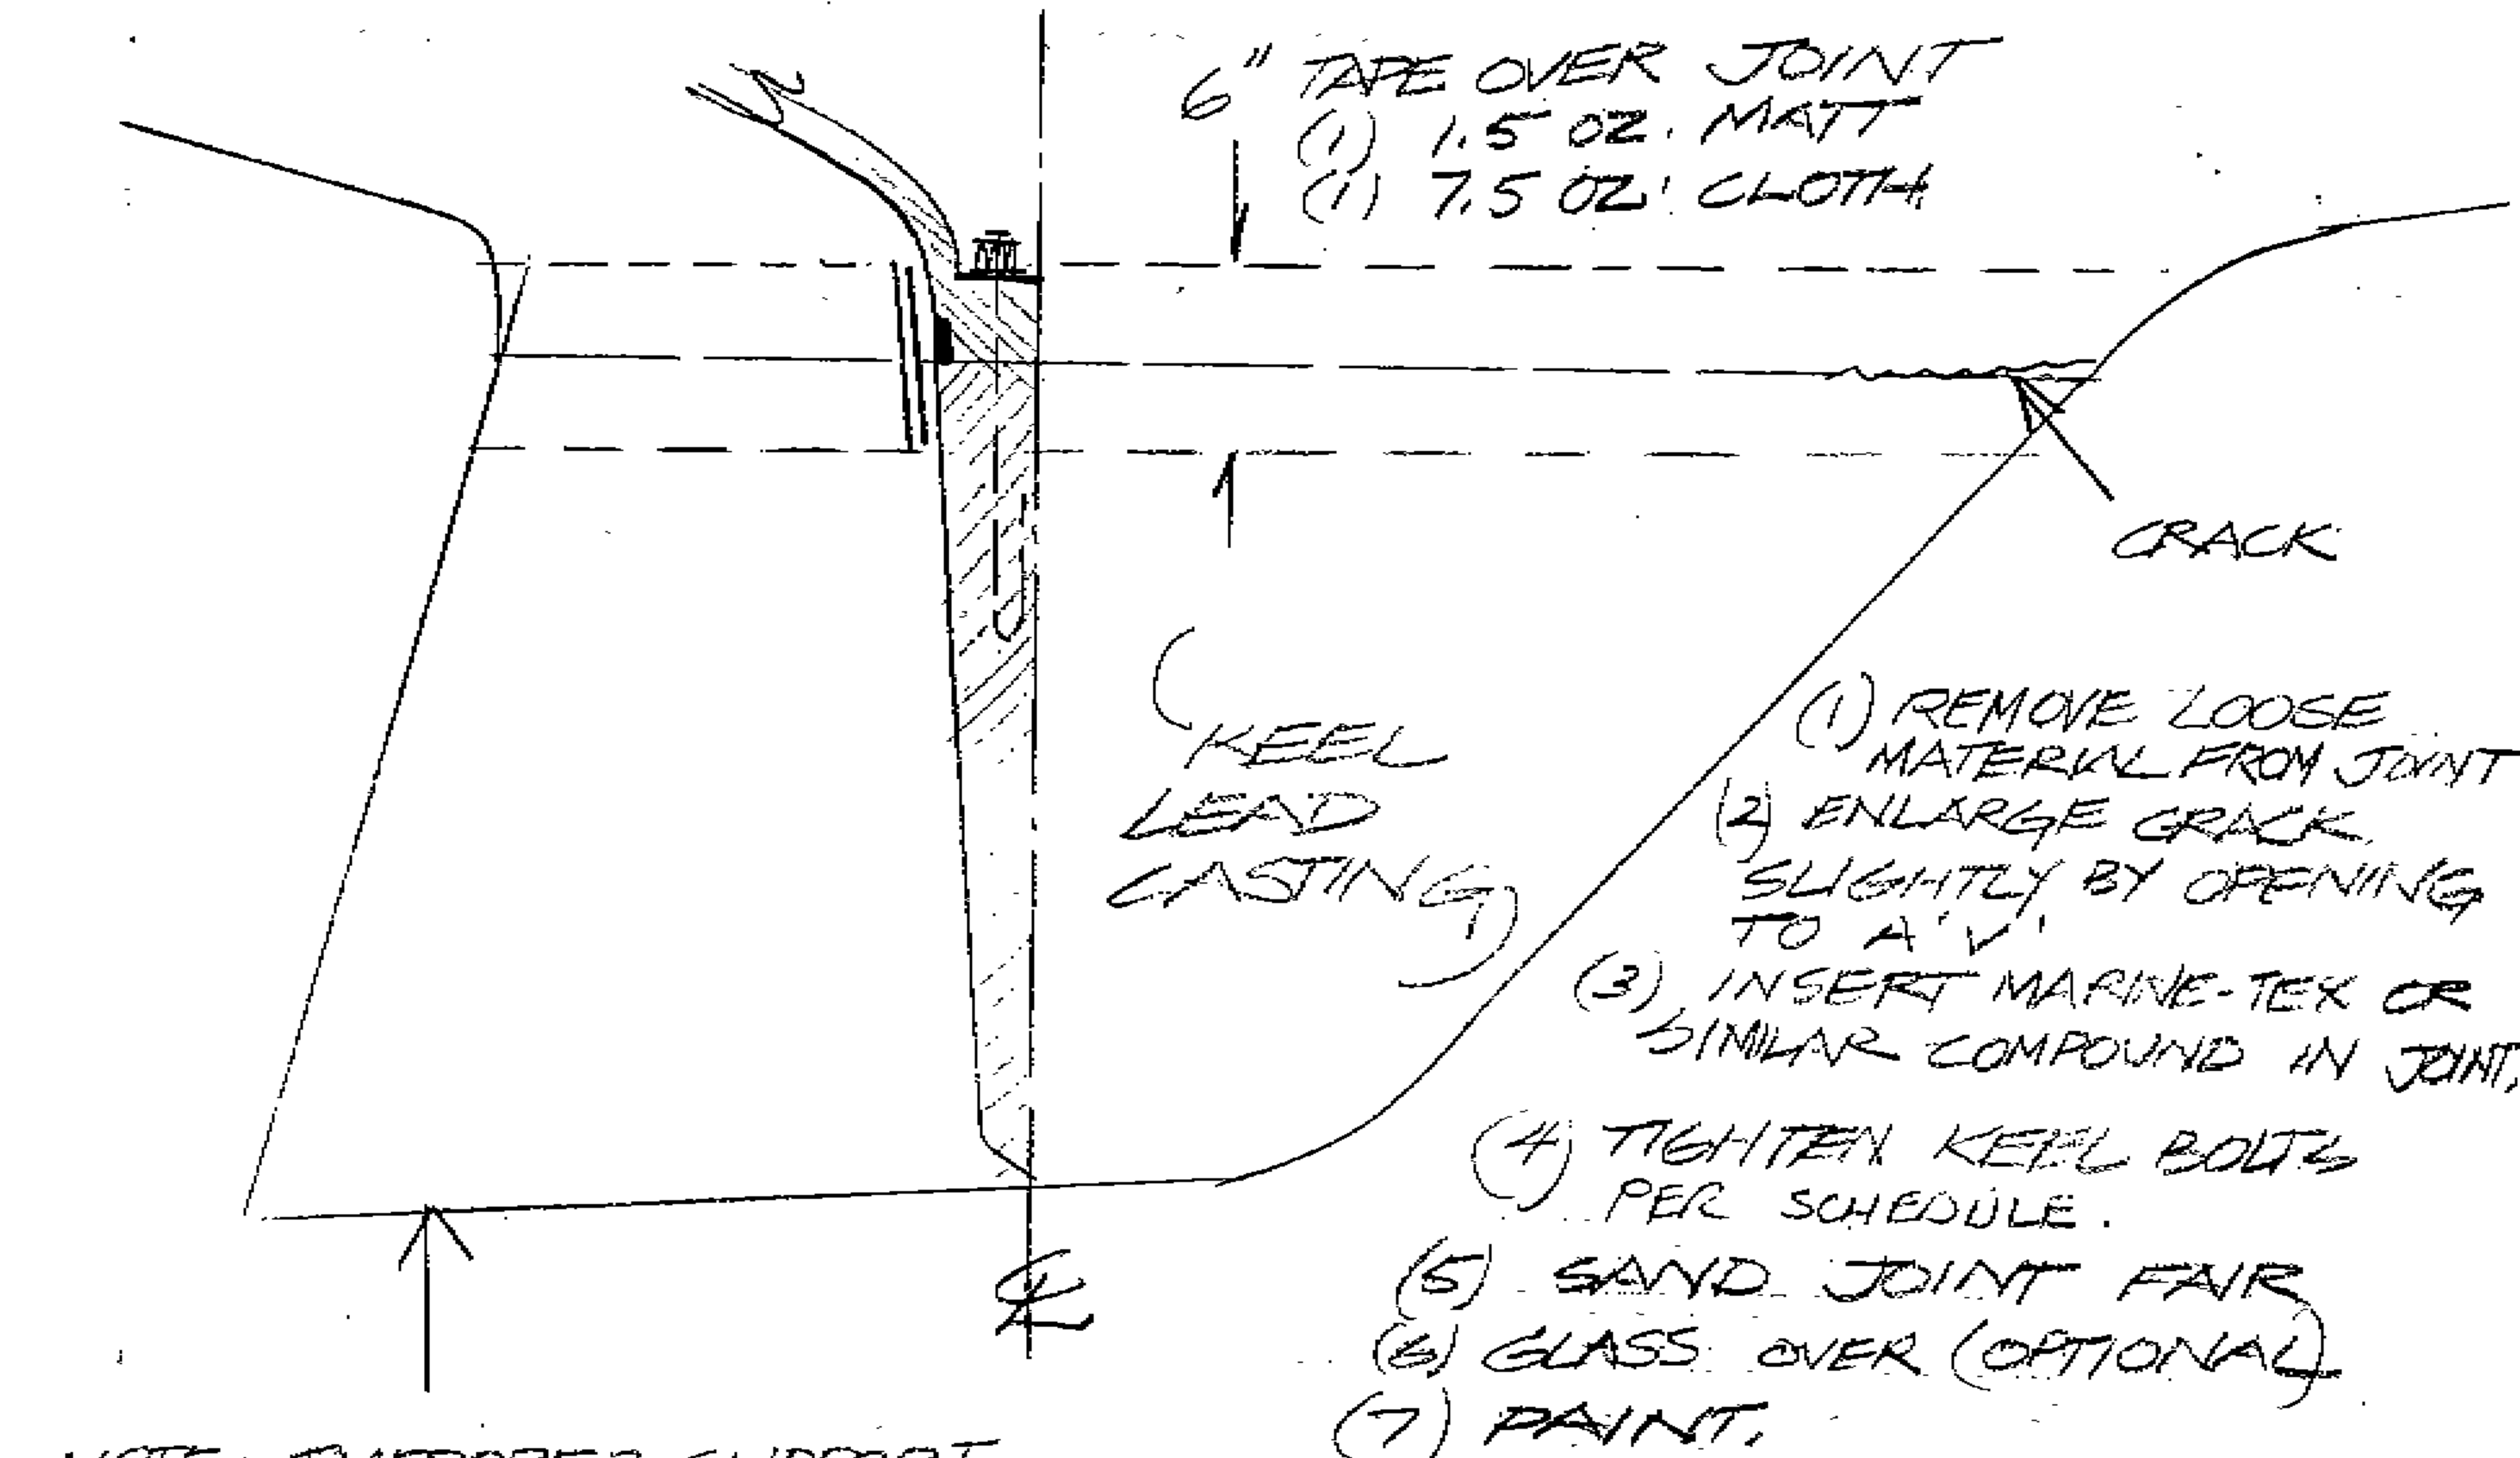
NOTE: IMPROPER SUPPORT OF KEEL FROM AFT END CAN CAUSE FRACTURE OF TAPE BOND AT JOINT AT FRONT OF KEEL
