1987 MK 1 Catalina 34 Electrical System Upgrade

By Jon Windt; s/v Della Jean

REVISION A – 7-31-2016 Section 11 was revised due to re-routing of the #1, 5, and 14 1 AWG cables directly to the engine compartment from the house bank. The Cable Planner Excel and pdf files, and the pdf file of this write up have been updated and attached to this write up to reflect the current routing. The schematic and cable ID #'s are unchanged, only the routing is different.

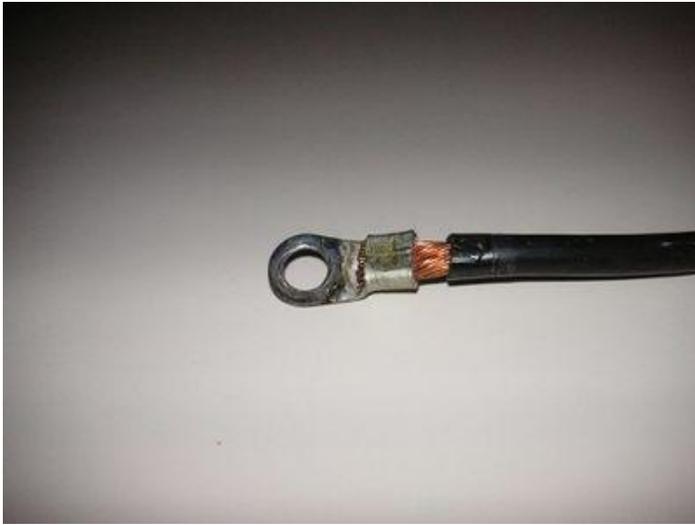
Photo (1) is one example of a negative battery cable and lug with electrical tape removed. Notice the crimp terminal and the exposed wire end by the ring. Photo (2) is looking down at the original red 4 AWG cable from the 105A alternator output to the starter. The other red 4 AWG cable runs from the starter, ~ 20 cable feet to the 1-2-Both switch at the Navigation Station. From there it ran another 15 cable feet to the battery in the battery compartment.

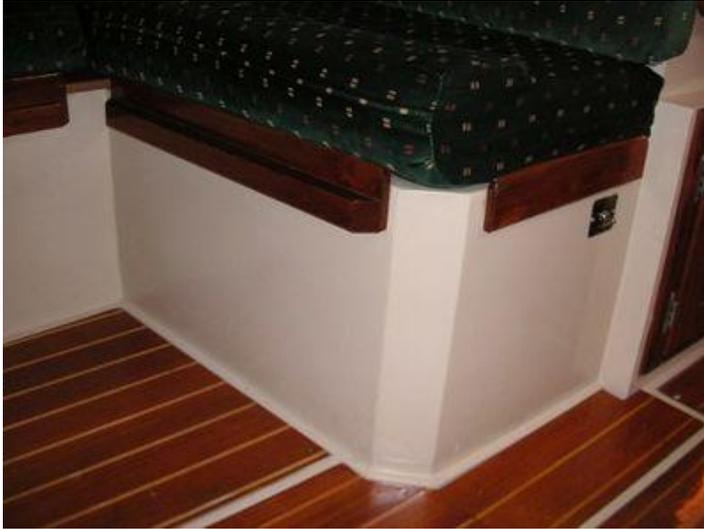
Photo (3) is the outside of the OEM battery compartment showing no ventilation openings. The switch in the upper right inboard side of the battery compartment is where the auto/on/off bilge pump switch was originally located. Photo (4) shows the original 2x Group 24 batteries, the 2 busbars, a Power Pulse battery maintenance widget, and a shunt for the Link 10 inside the battery compartment.

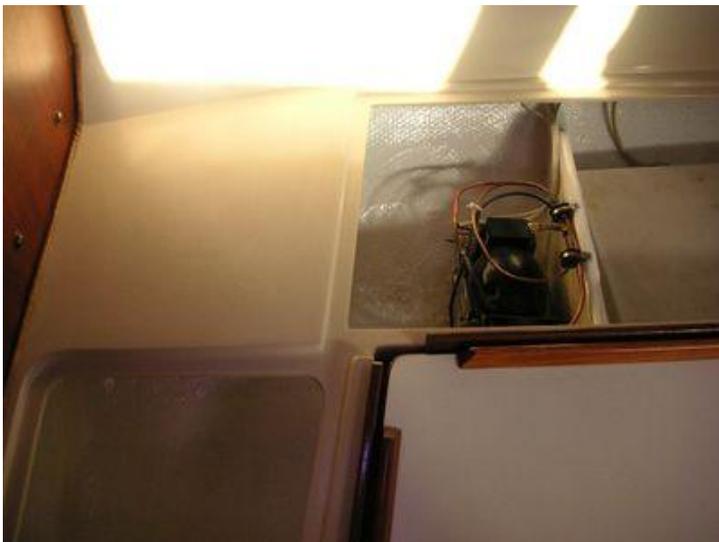
Photos (8) and (9) show the salon area with the wood covers removed. In Photo (8) you can see the fridge compressor attached to the bulkhead at the end of the starboard water tank. Photo (9) shows the water tank and ProMariner ProSport 20A AC charger. The wire from the breaker to the charger had a 3 prong plug connection (like an extension cord) at the charger, and the charger wasn't fastened to anything, just lying there on the hull waiting to flop around. Not very robust.

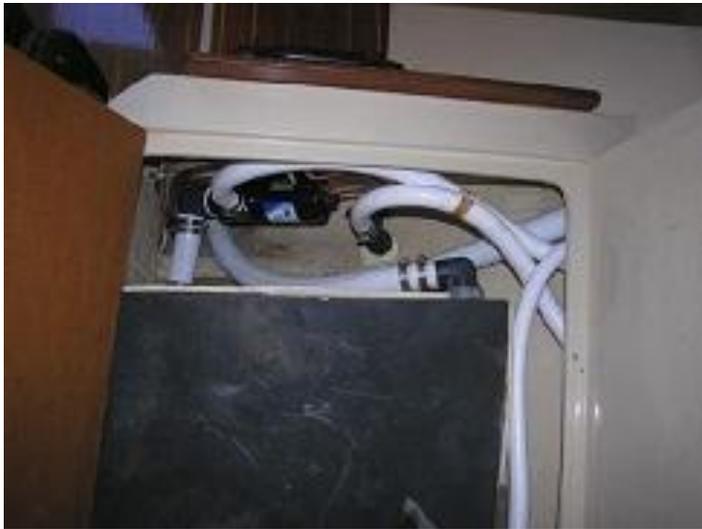
Photo (10) shows the holding tank, macerator pump, hoses, and if you look close the original wiring and cables running up to the master distribution panel at the Navigation Station.

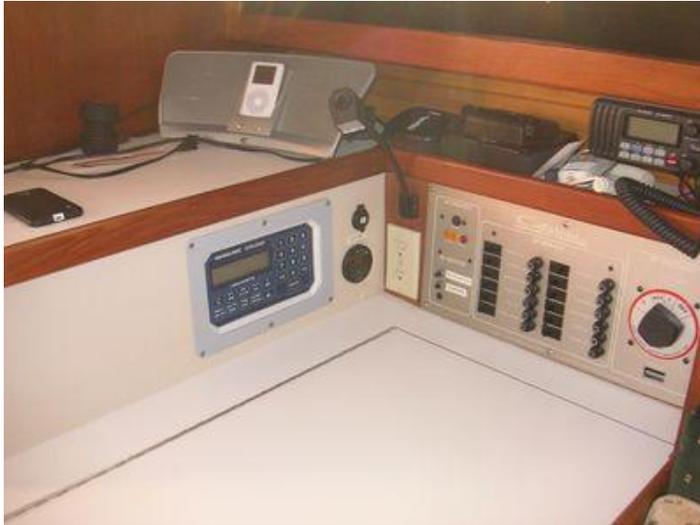
Photo (11) shows the Navigation Station with the OEM Main Panel, Link 10 battery monitor and 12VDC outlet installed by a PO. The panel has a single pole main, the polarity lights flickered, the lens for a light and the light under the battery switch were missing, the Link 10 did not operate.

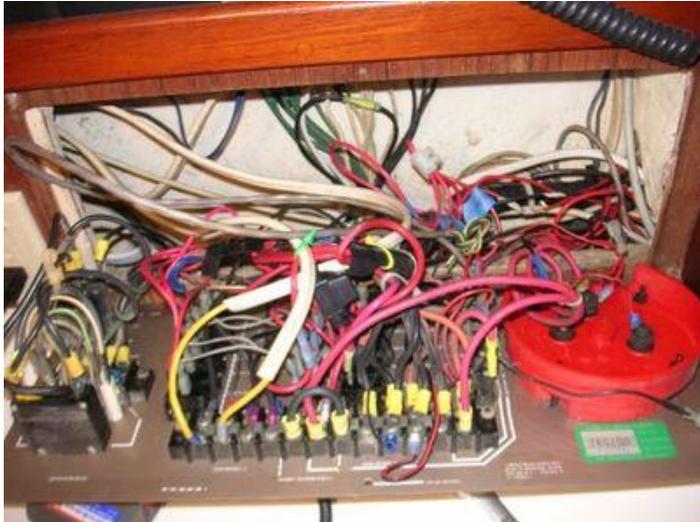
Photos (12) and (13) show the wires behind the main panel. To be polite, it was a corroded mess.

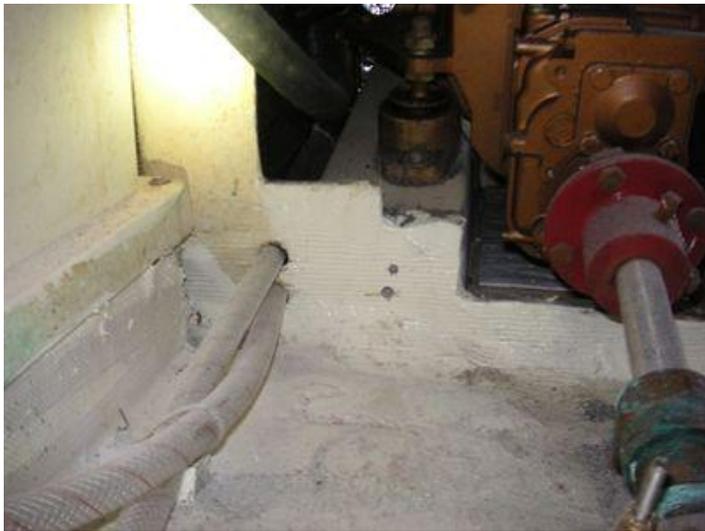
Photos (14) and (15) are taken under the aft cabin with the cushions and wood cover removed. My original plan was to run the cables from the battery compartment under the cabin floor and engine compartment through a hole in this area. (I recently painted this area with white bilgekote when I replaced all the fresh water and vent hoses). In photo (14), you can see 2 small pilot holes I drilled under the port engine mount. I drilled the pilot holes about 1" deep but did not break through. So I plugged the pilot holes with hardwood dowels and 3M 5200 and changed plans. My fall back plan was to run the cables through the opening shown in Photo (15) where the water hose from the aft tank went under the cabin floor to the sink area.

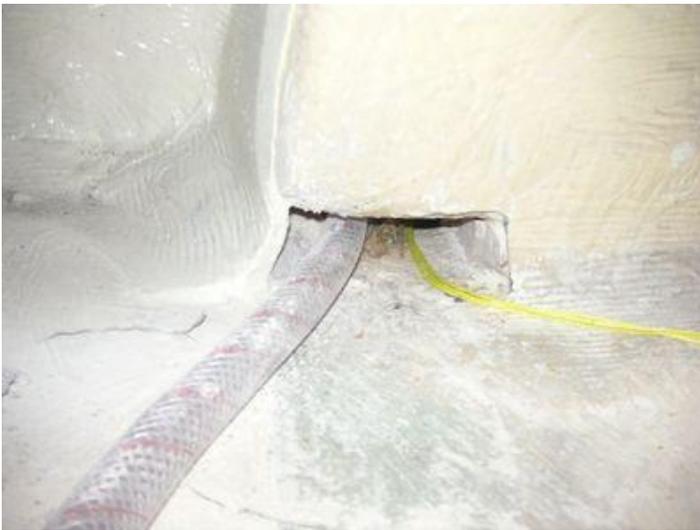
Barely visible in photo (16) is a dark clump of old adhesive sitting in the opening to the right of the aft tank water supply hose. It appeared to be excess adhesive for the conduit from the original build of the boat. A light tap with a screwdriver removed it, and now the path is clear to pass the 1 AWG cables through. The yellow strings are messenger lines to pull new cable. **However**, I found that I could reroute the hot and cold water hoses to the head sink between the manual bilge pump hose and the shower drain hose and reuse the now unused holes in the engine compartment to run the #1, 5, and 14 cables. See photos 55-57 for more clarity. This pass through from under the aft cabin to the galley will be used for my electric 1 1/8" bilge pump hose.

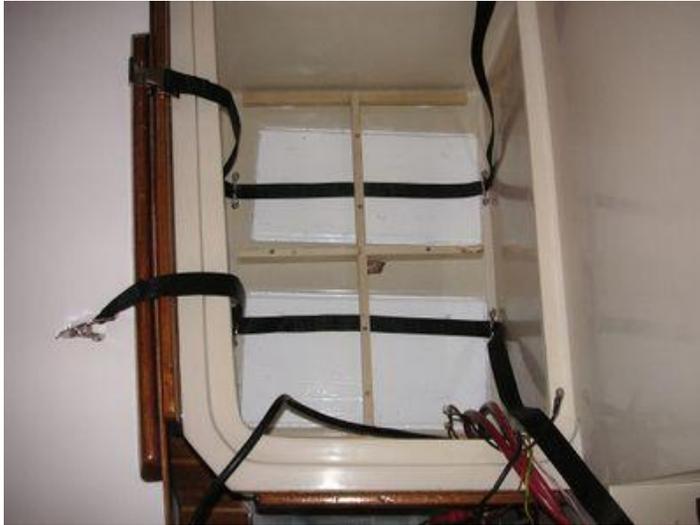
Photos (17) and (18) show the 2x8 painted wood fillers, the “egg crate” made from $\frac{3}{4}$ ” x $\frac{3}{4}$ ” hardwood strips screwed and countersunk to the bottom, and the battery straps all to keep the batteries in place while underway. Photo (18) shows 2 existing holes in the bottom of the box with new cables passing through. (I was later glad to have 2 entry holes). I drilled holes for #8 screws for wire ties along the upper battery box wall, and 2 thru holes for #8 screws in the radius at the bottom of the box on the water heater side. These are to attach wire ties outside of the box near the water heater for the cables that will run in that area. The 2 thru holes were covered with the same silicone caulk used earlier to seal them from a possible battery leak. Be sure the screws do not extend into the battery box or you’ll damage the batteries.

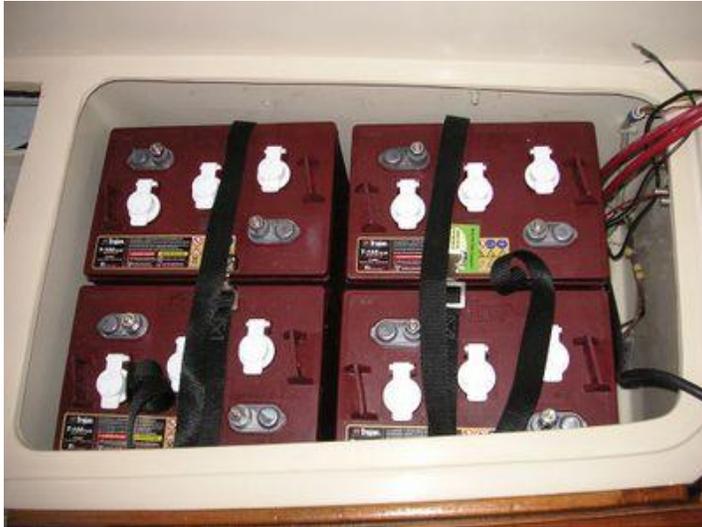
(19)

I didn't want to make the final attachments, and then find out the tie down straps interfered with the fill caps on the batteries. So I temporarily installed all of the house batteries to ensure the eggcrate matched up as intended, and the battery straps didn't interfere with the battery fill caps as shown in photo (19).

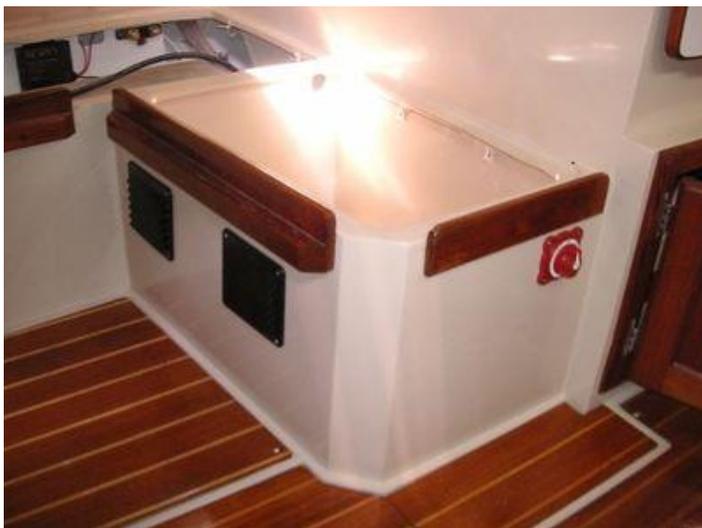
(20)

Photos (20 and (21) show the 2 new black ventilation covers installed in the battery box and the 1-2-Both battery switch installed where the bilge pump auto/on/off switch used to be. (In the background of photos you can see the breadboard for the Xantrex Digital Echo charge, house negative busbar, and BMV-700 shunt, but more on that later). The battery switch is a Blue Sea 6007 installed with the front panel mounted option. I used a 2 5/8" Milwaukee Dozer hole saw to drill the hole for the battery switch. It was tricky since I was using the hole saw to enlarge the existing smaller bilge switch hole. The battery box is two walls that are hollow in between. I wedged a piece of wood into the hollow section to give the hole saw pilot bit something to grab on to. I lined up the hole saw with the top of the existing bilge switch hole and went for it. It worked, but maybe not the safest couple of minutes I spent on this project.

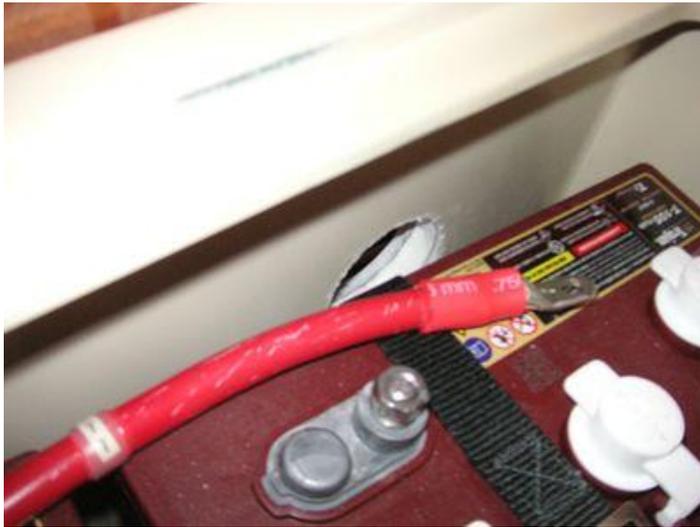
(22)

I used the same 2 5/8" hole saw for the vent covers along the forward side of the battery compartment instead of buying a larger hole saw for two holes. This surface is also two walls and hollow in between. To avoid gases collecting, I rolled up paper towels and stuffed them inside just below the edge of the hole to act as a backing for the caulk I used. The caulk provided a seal with a nice finished appearance as can be seen in photo (22).

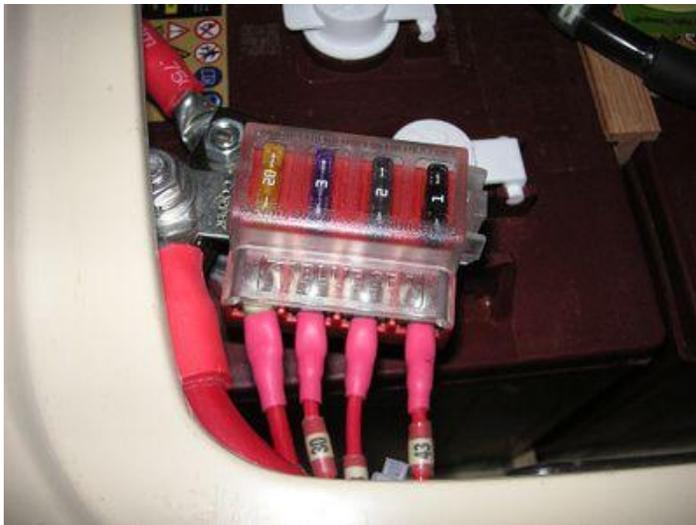
Photos (23) and (24) show the Trojan T105's installed waiting for inspection. I used the Blue Sea 5024 fuse block in the photo (23) to combine 4 fused runs into one small space with one connection point directly on the battery. The battery posts are short allowing connection of only 2 lugs comfortably. Many devices require connecting directly to the battery or as close as possible for best results, and is preferred by ABYC code. This does that neatly. In photo (24) I cut a piece of red oak into a "T" shape to fit between the batteries to avoid them tipping together when the battery strap is tightened. The black plastic clips came with the NAPA battery box for the reserve battery. I'm using a higher quality battery strap and stainless steel clips to hold the reserve battery to the shelf, so I decided to use the plastic clips here to keep the wood from sliding. The house bank connects to position 1 on the 1-2-Both battery selector switch. In photo (24), the schematic battery ID #'s starting from the bottom right are #1, bottom left is #2, upper right is #3, and upper left is #4. See the schematic attached in Section 14 of this write-up for the details.

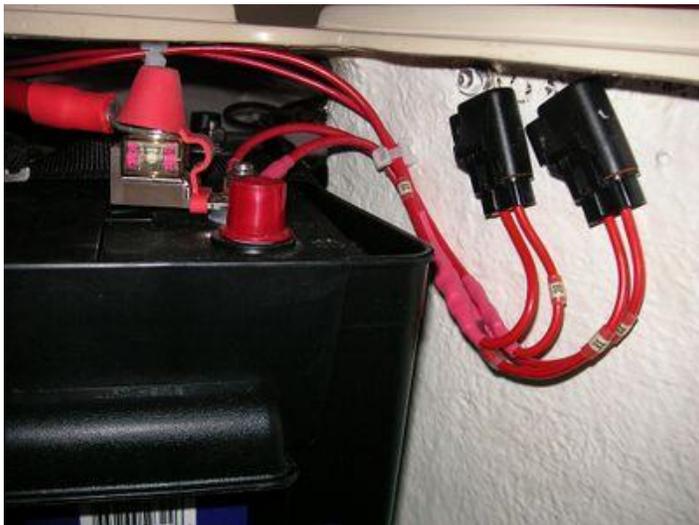
I added hardwood strips, and the same type battery strap as the house bank to keep the battery box from moving while underway. The terminal posts and all fuses are shown in photo (27) are easily accessible by removing a cushion and the wood cover. The SmartGauge and Digital Echo charge in-line fuses are shown mounted on the bulkhead. I also have space to stow a small tool bag as shown in photo (28).

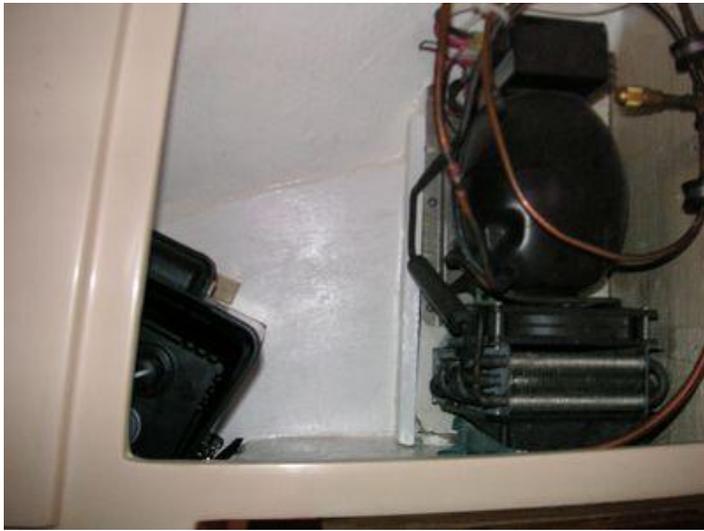
In photo (29) you can see that this arrangement also provides space for a future electric windlass breaker to fit between the battery and fridge compressor.

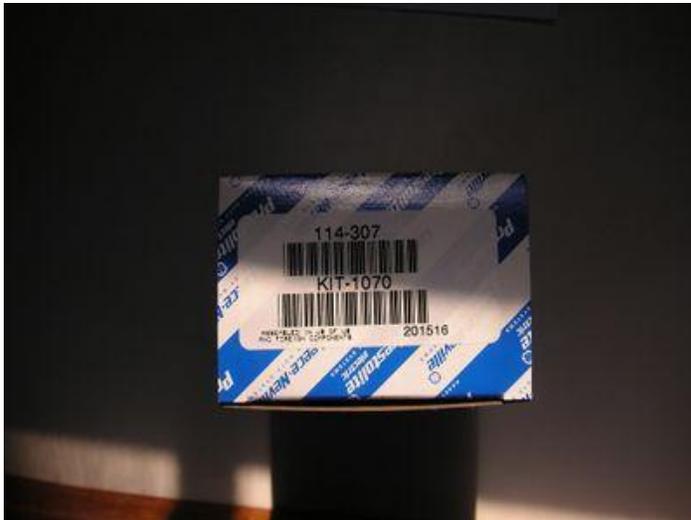
Internally regulated alternators are not designed to periodically recharge a large discharged battery bank rapidly. Technical details and graphs on this subject are discussed at length in my posting [1987 MK1 Electrical System Upgrade – Feedback Requested](#), and in [Electrical Systems 101](#). To take advantage of my existing 105A alternator, I installed an external regulator. This requires a conversion kit for Leece-Neville I purchased from ASE Supply Inc. Photo (30) shows the part # 114-307, Kit 1070. Photo (31) shows an outside view of the assembled kit before installation.

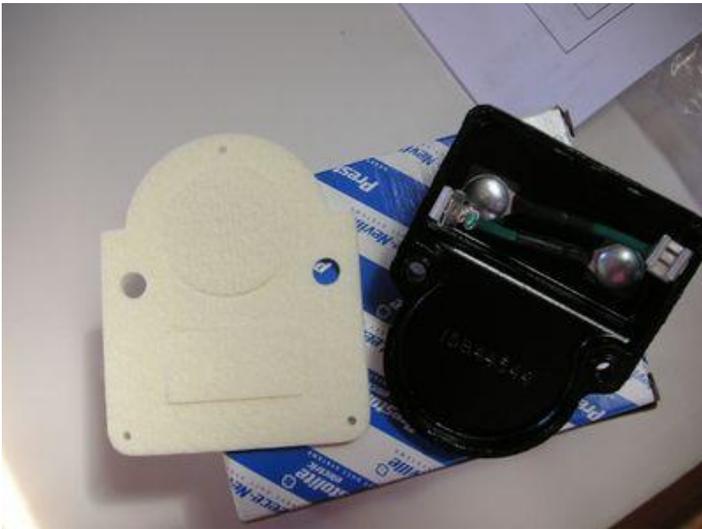
Photo (32) shows an inside view of the same assembled kit before installation.

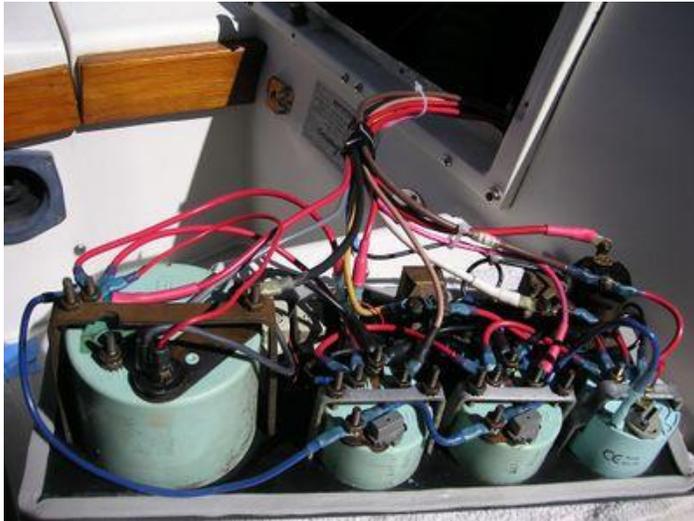
(35)

In photo (35), the brown ignition wire, ID # 50, connects to the ignition switch in the cockpit. The gray material around the perimeter of the cockpit panel is foam tape for weather protection when installed. FYI –I set the belt manager to level 4. The engine was started and run at 1500 rpm. The alternator was charging the house at 80 Amps, the alternator was at 32°C and the house bank was at 18°C. Just like advertised!

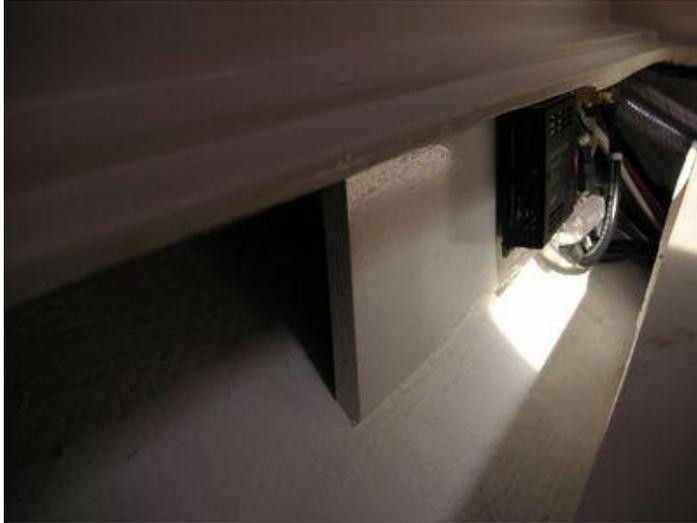
Photo (38) shows the bottom of the breadboard matched and bonded to the hull. After drying, it was repainted with white bilgekote before installing the components as shown in the next group of photos.

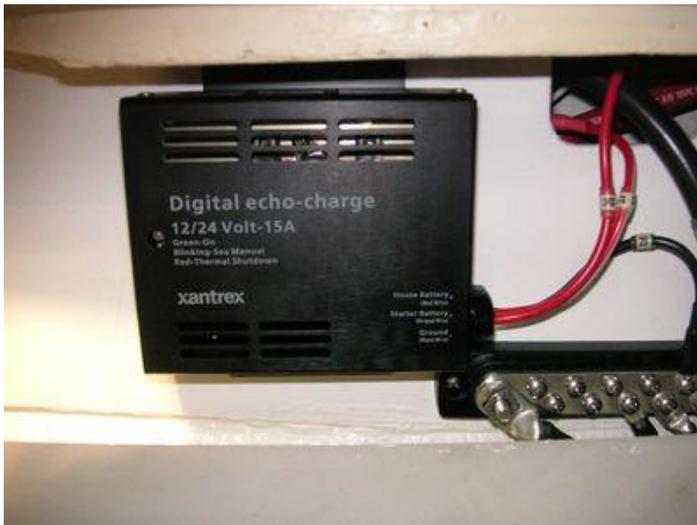
(39)

In photo (39), the Digital Echo Charge is shown installed and wired. The busbar comes with a cover that is removed for clarity. Installing the busbar and the wires connecting to it requires a stubby screwdriver due to limited space between it and the water tank. Photo (40) shows the house negative busbar with negative wires connected and labeled. The 1AWG negative cable to the main engine ground is on the right. The 1AWG negative from the shunt crosses over to the far left post on the busbar.

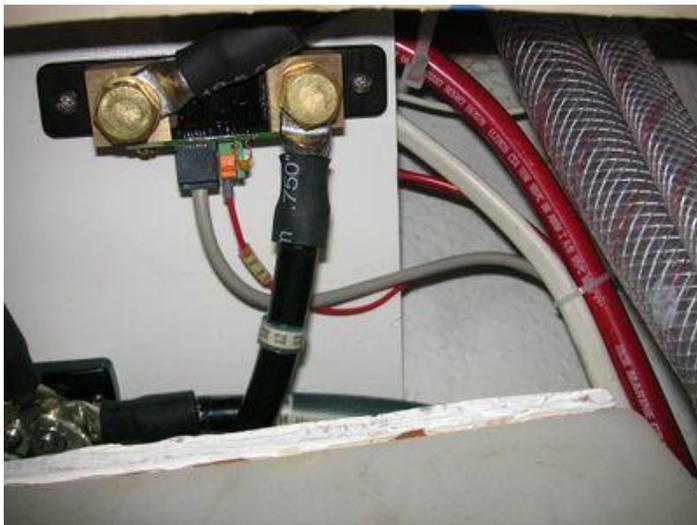
In photo (41) you see the shunt for the BMV-700. The house bank negative is connecting to the brass bolt on the left. This orientation of the shunt was used to have the battery monitor connections pointing down to reduce stress on the wires, and avoid condensation from humidity seeping into the connection points.

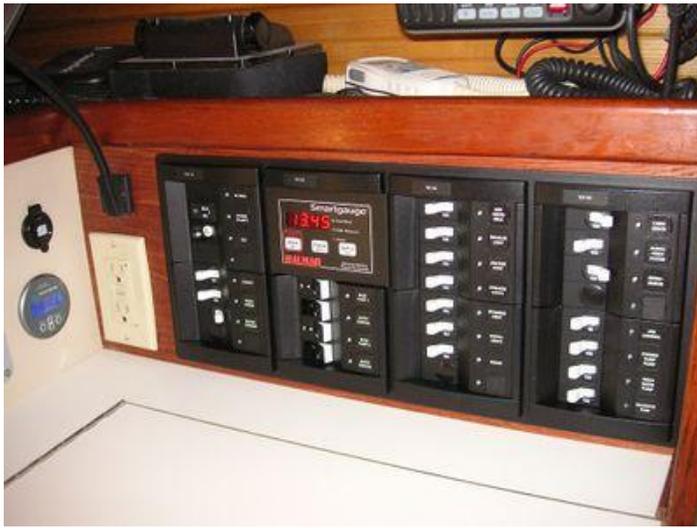
Photo (45) shows the Navigation Station with the new Blue Sea 360 Main Distribution Panel installed. The AC power is on the left side of the panel with a new ELCI 30A double pole main breaker, separate outlet, water heater, and AC battery charger breakers, plus two spares. Moving to the right is the SmartGauge battery monitor located above the bilge pump restricted off and manual on breakers, the right two columns are the 14 DC breakers plus 2 spares. One of the spares will be used for the future auto-pilot. Photo (46) shows the BMV-700 battery monitor and the 12VDC outlet that are installed on the bulkhead shared with the hanging locker, and to the left of the GFCI outlet.

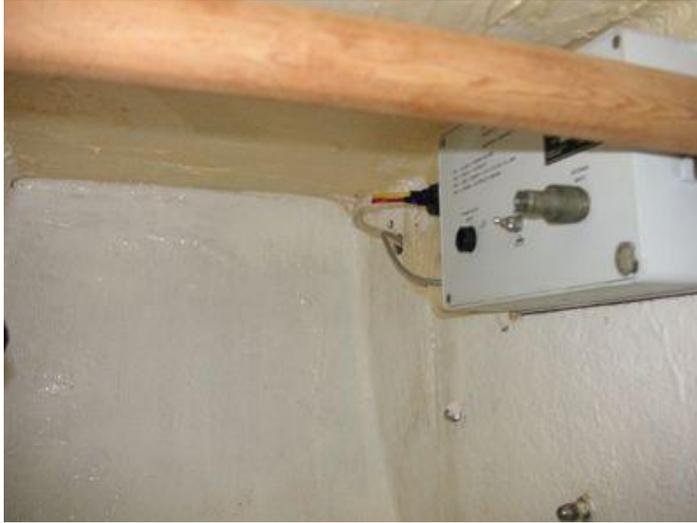
Photo (47) shows the cables from the back of the BMV-700 and the 12VDC outlet in the hanging locker running through the bulkhead, and behind the main panel.

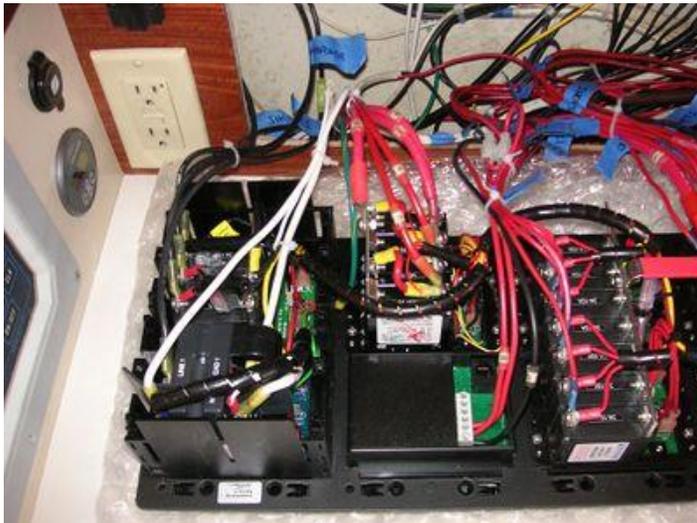
In photos (48) and (49), more breakers means more wires connecting to the main panel, but the organization of the wiring has been improved from the original.

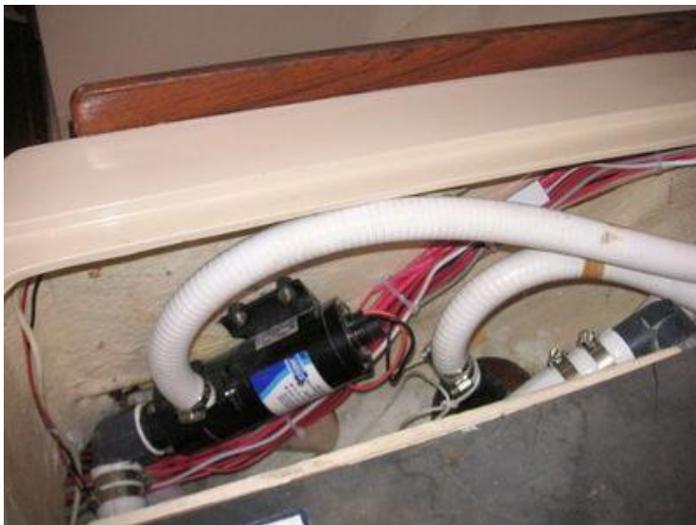
Here in photo (50) you see the wire bundle going by the macerator pump and motor up to the main distribution panel higher than before to get them off the hull and out of the way.

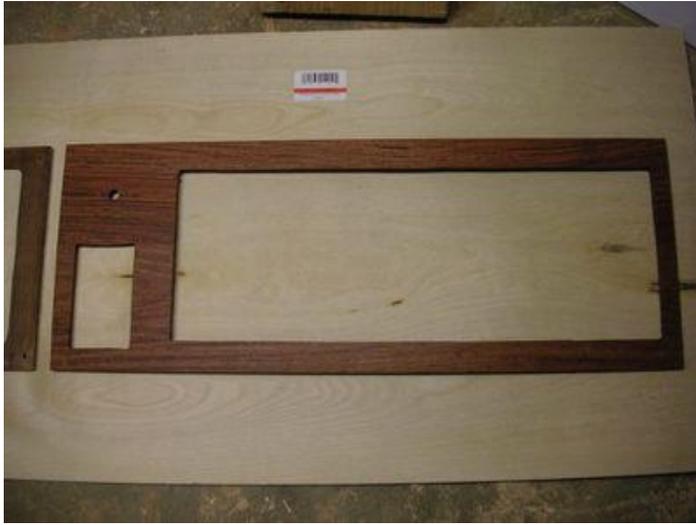
I also replaced the old 1/4" teak plywood with a new piece of solid teak 5/16" thick. The new teak is shown in photo (51) and the old is shown in photo (52). The new teak improvement is more dramatic in person, and is seen a little better in photos (53) and (54). New is shown in photo (54).

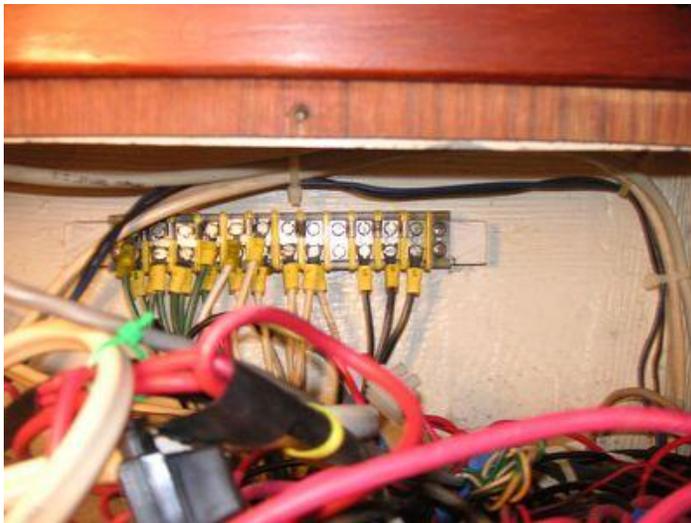
AC Busbar Replacement: I removed the original terminal strip in photo (53) and replaced it with a 10 screw dual busbar and a 5 screw dual busbar as shown in photo (54). In photo (53) you can see dark spots under the screw at the end of each wire. Those are corroded spade fittings with open crimps at both ends. I removed and replaced all with heat shrink adhesive lined ring terminals. They are now all nice and shiny new in photo (54). The 10 screw dual busbar is for most AC neutrals and all grounds. The smaller 5 screw dual busbar is dedicated to line and neutrals for the cabin, galley, and head protected AC outlets. The AC outlet power leaves the panel breaker and connects to the GFCI outlet at the Navigation Station. From there it connects to the 5 screw dual busbar for the downstream AC outlets, and is labeled "Protected Outlets". In this arrangement the cabin, galley, and head outlets are all protected by the Navigation Station GFCI outlet. The down side to this arrangement is the AC outlets are limited to a combined total of 30A. This may or may not be a nuisance item. I plan to wait and see if it is an issue before changing anything.

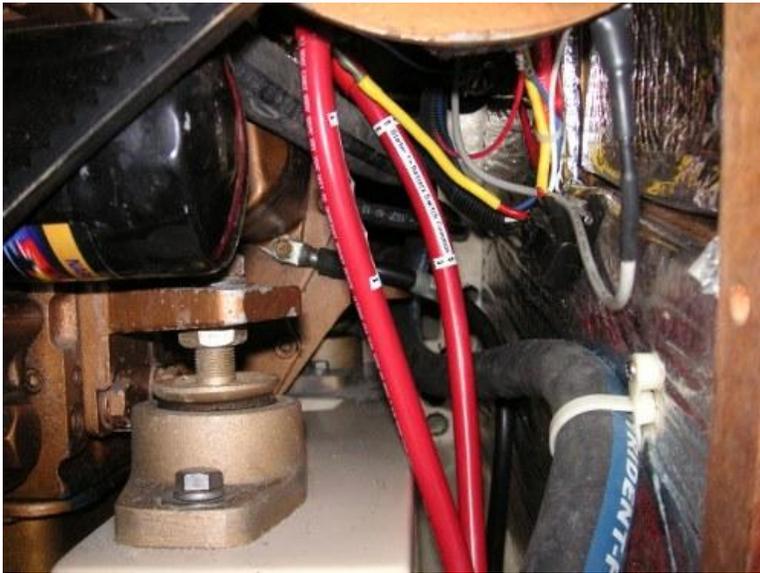
Photo (57) shows another view of the same three cables rising up to the alternator, starter, and main negative cable #14 connection on the starter motor mounting bolt.

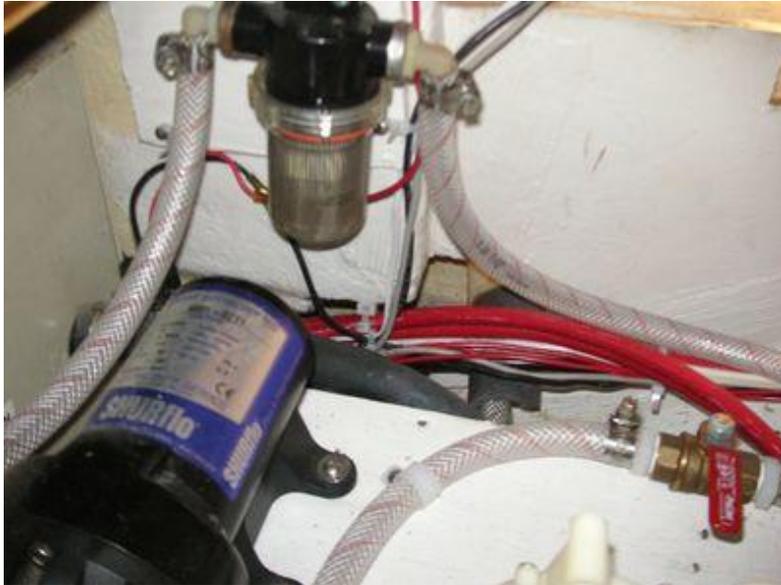
In photo (58) you can see I added insulation foam for $\frac{3}{4}$ " pipe on the water tank hose and band clamp to protect the cables and wires from chafing.

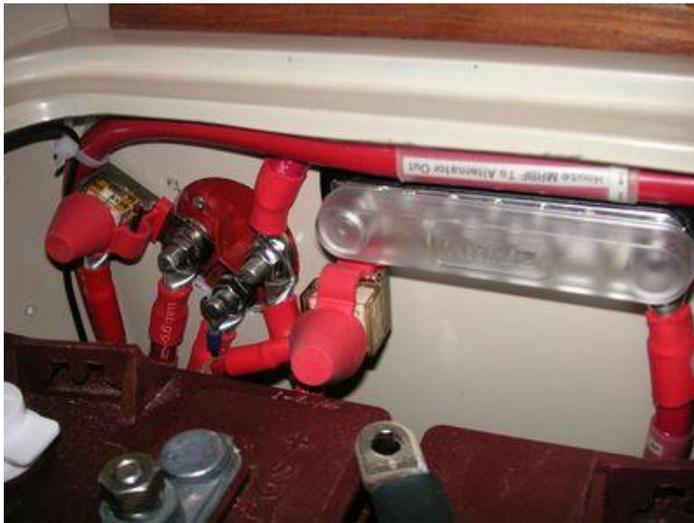
Battery Box Busbar: Photos (62) and (63) are looking inboard from the water tank to see inside the battery box. Photo (62) shows the primary cables inside the battery box connecting to the back of the 1-2-Both battery use switch. Position #1 (house bank) is on the right, Position #2 (reserve battery) is on the bottom, and Position C is on the left. The MRBF fuses (covered with the red caps) for the main distribution panel supply connecting to the C post, the AC battery charger, and power for the bilge pump breaker connecting to the “always on” busbar can also be seen. Photo (64) shows the alternator output cable running above the “always on” busbar. The protective cover is removed from the “always on” busbar for clarity. The alternator output cable is labeled upside down so it can be read from above when standing on the boat centerline looking down into the battery box. You can also see the jumper connecting position #1 of the 1-2-Both battery use switch to the “always on” busbar. The most critical DC item currently attached to the “always on” busbar are the bilge pumps. If the house battery bank were to fail, switching the 1-2-Both battery use switch to position #2 would not provide power to the always on busbar. To address this, I made the jumper long enough to be moved from position #1 to position #2 of the 1-2-Both battery use switch to provide temporary power. This failure mode is a remote possibility, but it could occur so I added this no cost redundancy feature.

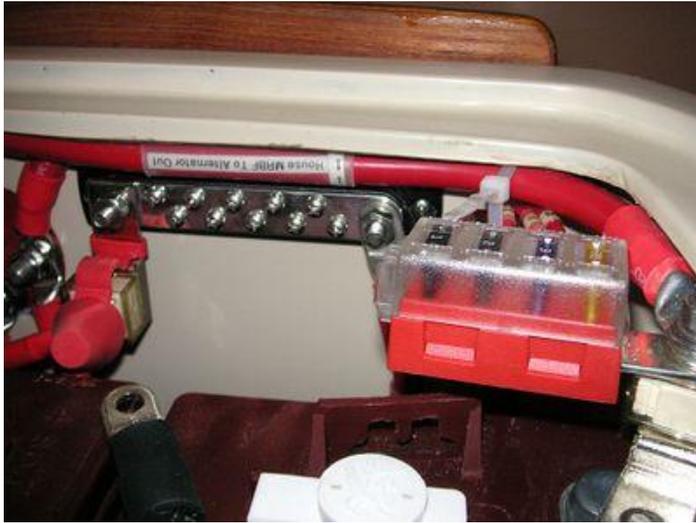
(64)

In photo (64), you see the end of the Blue Sea 5024 fuse block discussed in the House Battery section.

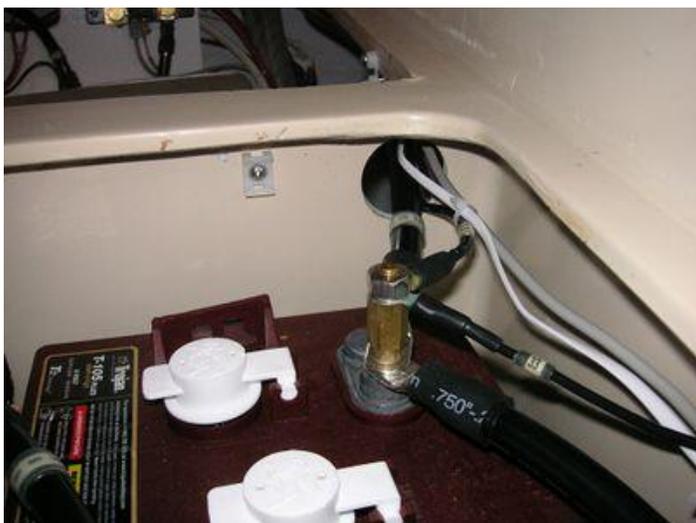
(65)

Looking at the bulkhead between the battery box and water tank in photo (65), you see the 1 AWG negative leaving battery #4 and going to the shunt through the hole in the battery box. Also visible are the temperature sense wires from the AC battery charger, and from the Balmar external voltage regulator. I separated most of the positive wires from the negative wires by running the positive's into the battery box through the two bottom holes shown earlier, and the negatives and temperature sense wires running through this hole at the top of the other end of the battery box near the water tank. I was only comfortable connecting two wires or cables to a battery post, so I purchased the extension from the battery supply house for ~ \$5. In photo (66), the 1AWG negative leaves the battery box and runs under the lip that the outboard salon cushion wood cover sits on.

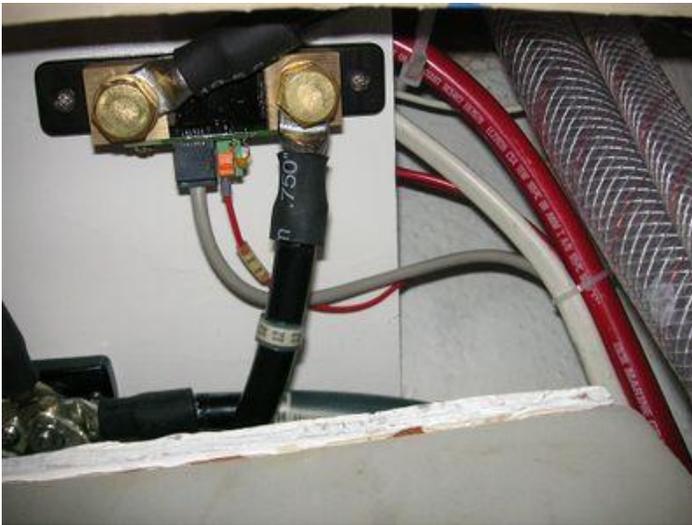
(67)

That same cable then connects to the left bolt on the BMV-700 shunt attached to the breadboard as shown in photo (67).

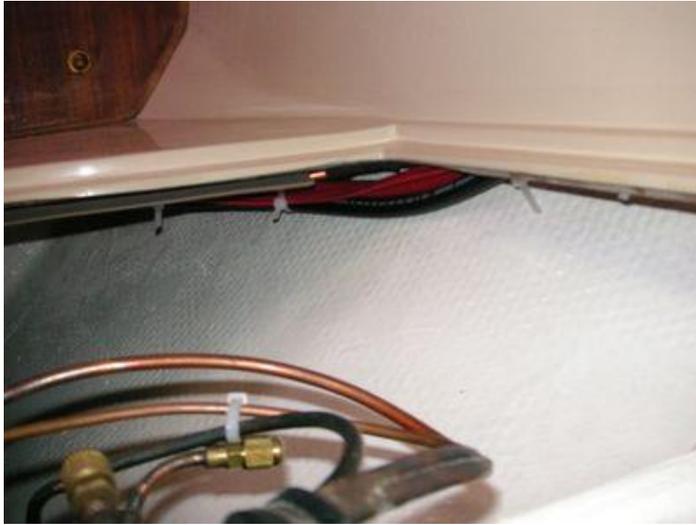
Photo (68) shows the positive and negative cables running to the reserve battery from the Digital Echo Charge, the SmartGauge, the 1-2-Both battery selector switch position #2, and from the house bank negative busbar. The shiny bit you see is the refrigeration line. To protect the refrigeration lines in case there is a gas leak from the maintenance free battery, I covered it with the material used to cover wires on the floor so you don't trip. Photo (69) shows the wires and cables from the reserve battery, Digital Echo Charge, and the SmartGauge running underneath the storage cubby holes behind the outboard salon seat cushion. The white Nomex is the existing DC wiring for the refrigerator compressor and fan. The wood you see is glassed in and is part of the boat. It wasn't added by me for this project.

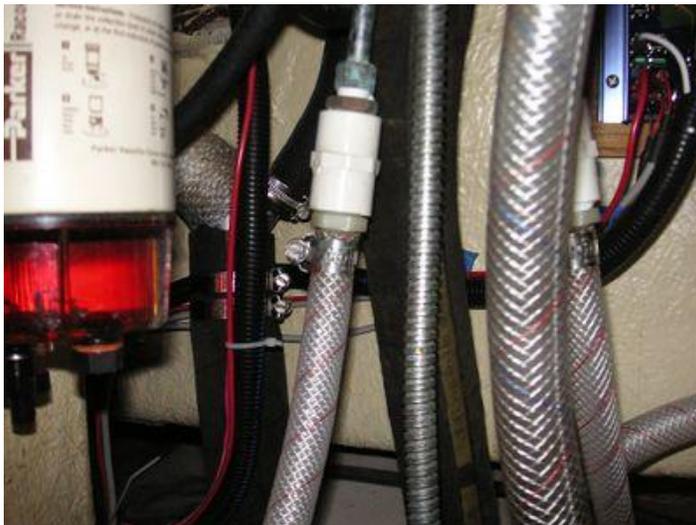
Photos (71) and (72) show the external regulator wiring under the head sink in the split loom, then is runs along the engine compartment bulkhead under the Racor filter.

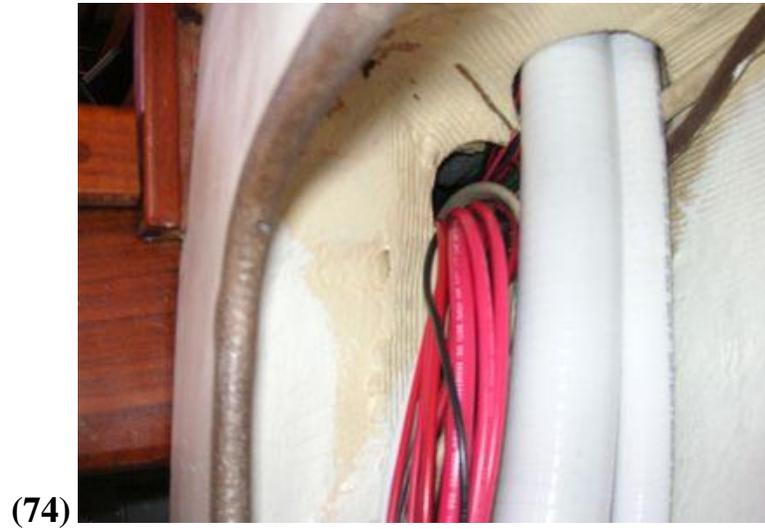
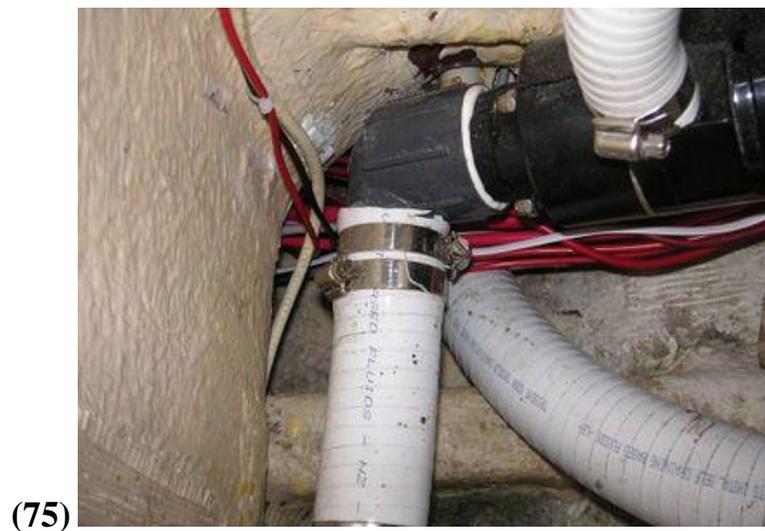
Finally photos of the wires running from behind the Main Distribution Panel, to the battery box area. Photo (74) shows the bundle exiting from behind the Main Distribution Panel, and photo (75) shows where they pass under the macerator pump/motor and pick up the external regulator wires.
