# 1987 MK 1 Catalina 34 Electrical System Upgrade

By Jon Windt; s/v Della Jean

**REVISION A – 7-31-2016** Section 11 was revised to re-route the #1, 5, and 14 1 AWG cables directly to the engine compartment from the house bank. The Cable Planner Excel and pdf files have been updated, the schematic and cable ID #'s are unchanged.

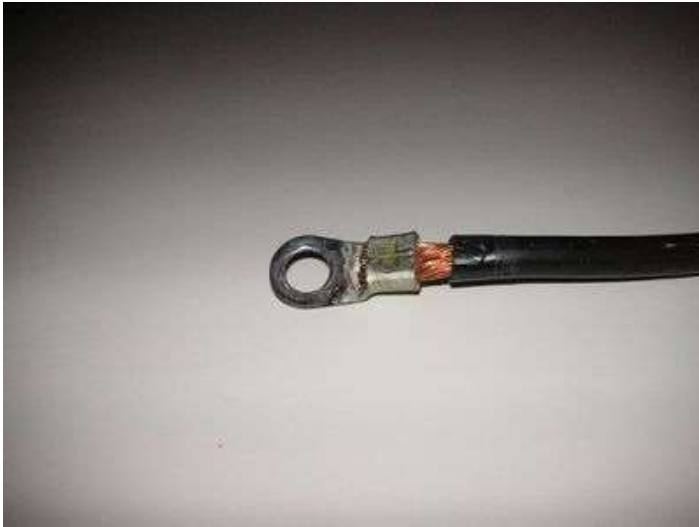
Photo (1) is one example of a negative battery cable and lug with electrical tape removed. Notice the crimp terminal and the exposed wire end by the ring. Photo (2) is looking down at the original red 4 AWG cable from the 105A alternator output to the starter. The other red 4 AWG cable runs from the starter, ~ 20 cable feet to the 1-2-Both switch at the Navigation Station. From there it ran another 15 cable feet to the battery in the battery compartment.

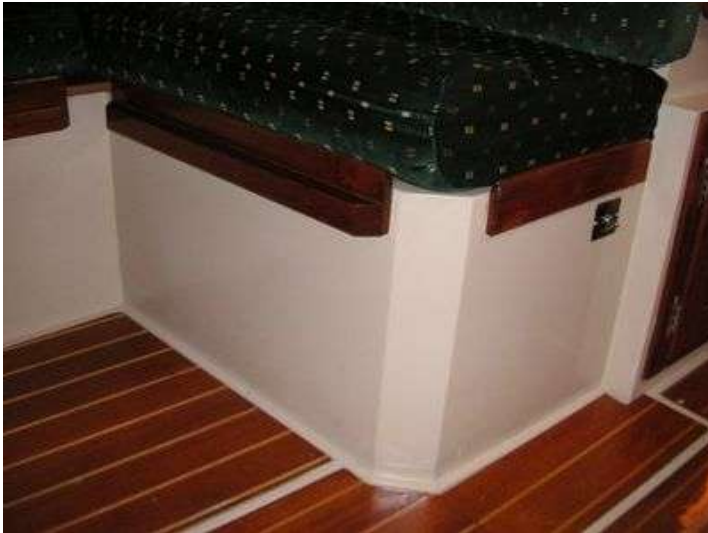
Photo (3) is the outside of the OEM battery compartment showing no ventilation openings. The switch in the upper right inboard side of the battery compartment is where the auto/on/off bilge pump switch was originally located. Photo (4) shows the original 2x Group 24 batteries, the 2 busbars, a Power Pulse battery maintenance widget, and a shunt for the Link 10 inside the battery compartment.

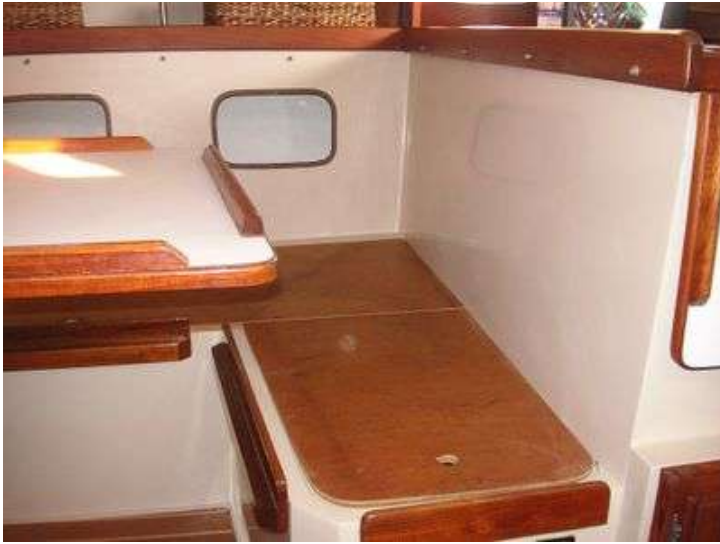
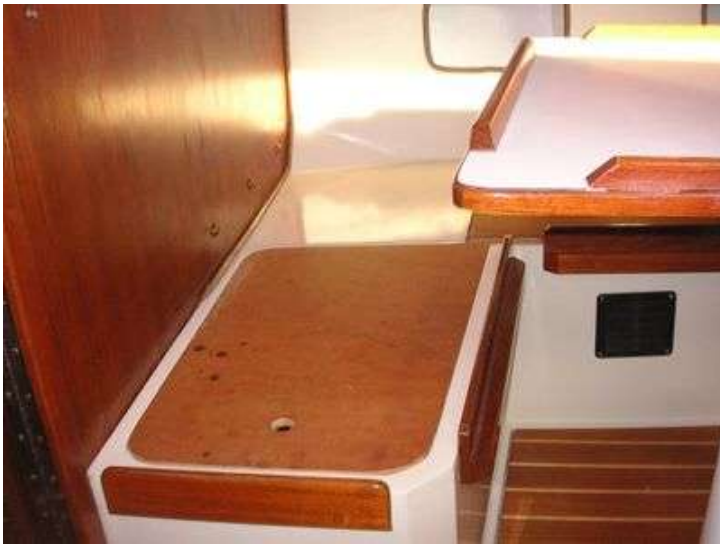
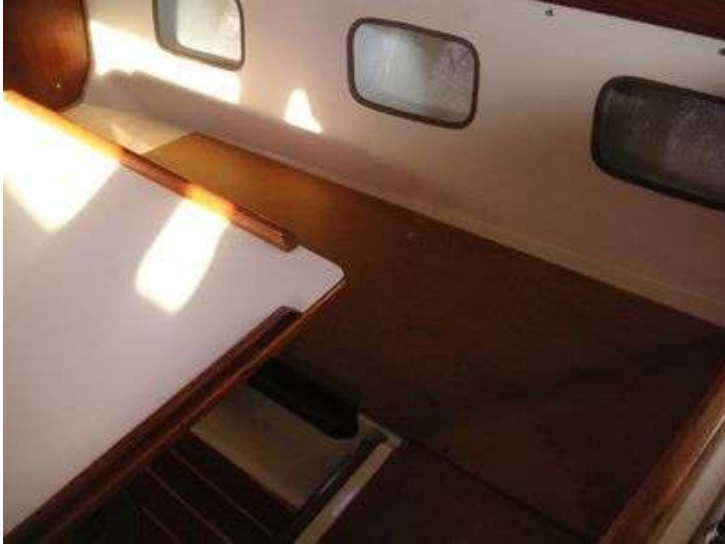
Photos (5) through (7) are of the traditional C34 salon area with all of the cushions removed. The black cover in the Photo (6) is the existing ventilation cover for the DC refrigerator compressor.

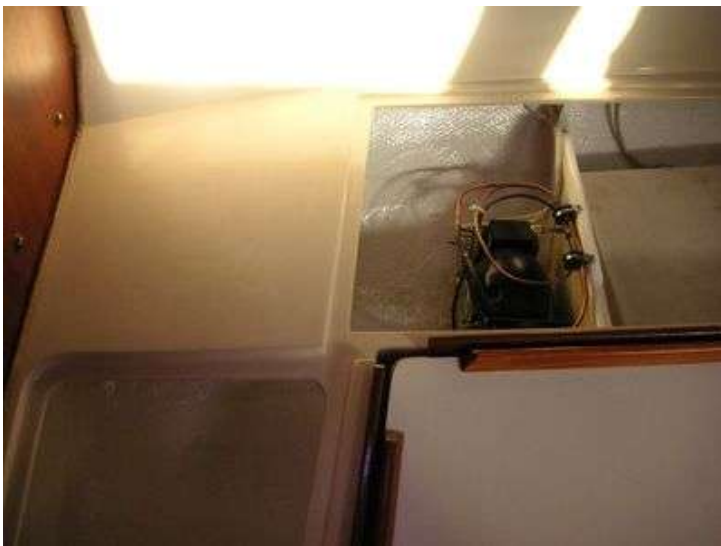
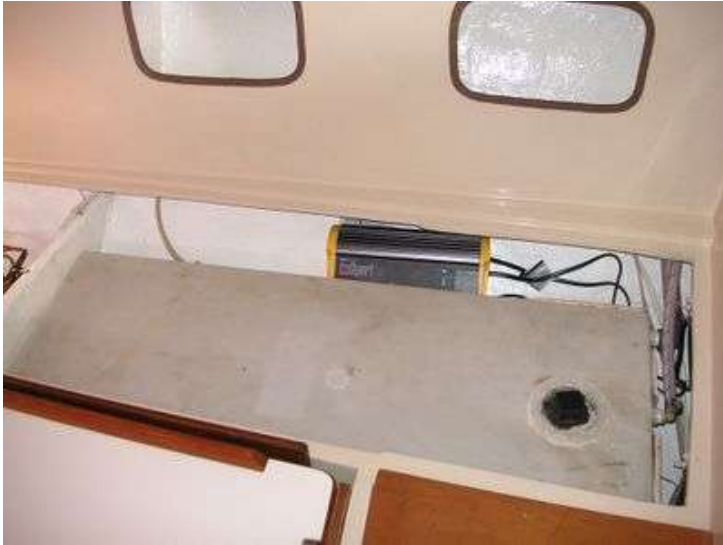
Photos (8) and (9) show the salon area with the wood covers removed. In Photo (8) you can see the fridge compressor attached to the bulkhead at the end of the starboard water tank. Photo (9) shows the water tank and ProMariner ProSport 20A AC charger. The wire from the breaker to the charger had a 3 prong plug connection (like an extension cord) at the charger, and the charger wasn't fastened to anything, just lying there on the hull waiting to flop around. Not very robust.

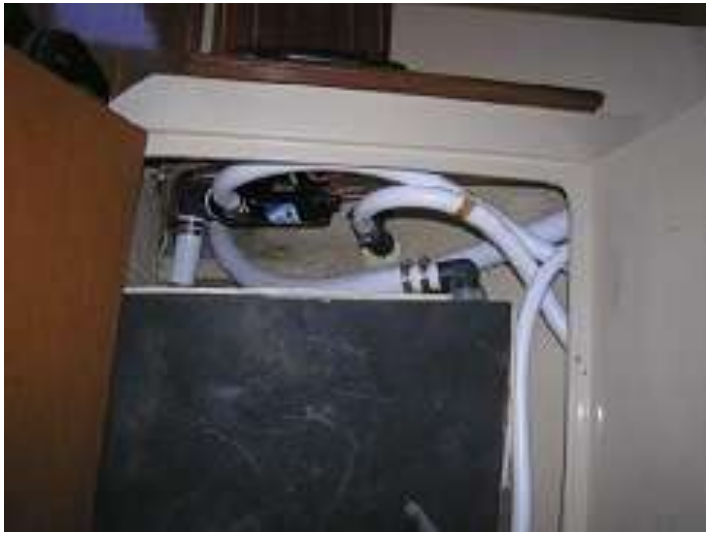
Photo (10) shows the holding tank, macerator pump, hoses, and if you look close the original wiring and cables running up to the master distribution panel at the Navigation Station.

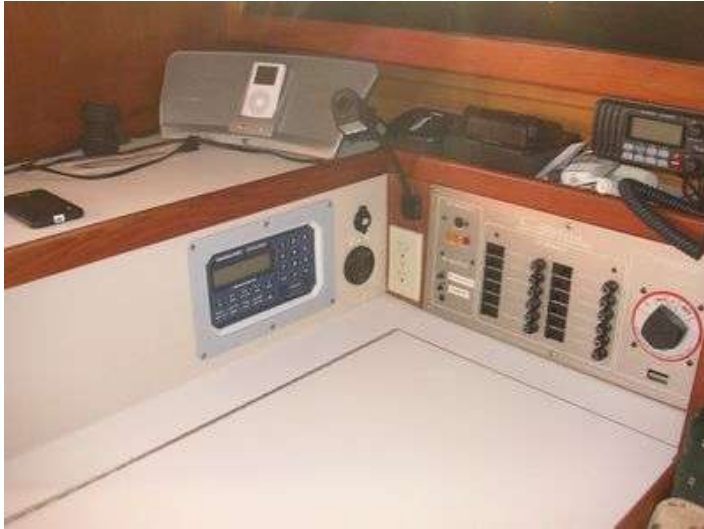
Photo (11) shows the Navigation Station with the OEM Main Panel, Link 10 battery monitor and 12VDC outlet installed by a PO. The panel has a single pole main, the polarity lights flickered, the lens for a light and the light under the battery switch were missing, the Link 10 did not operate.

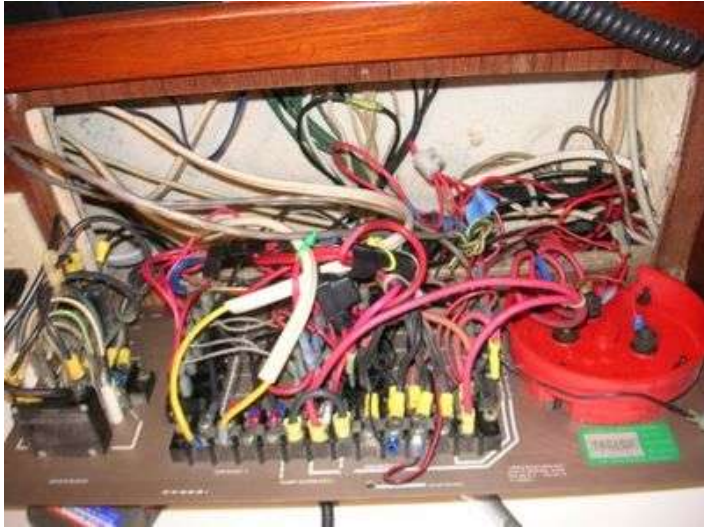
Photos (12) and (13) show the wires behind the main panel. To be polite, it was a corroded mess.

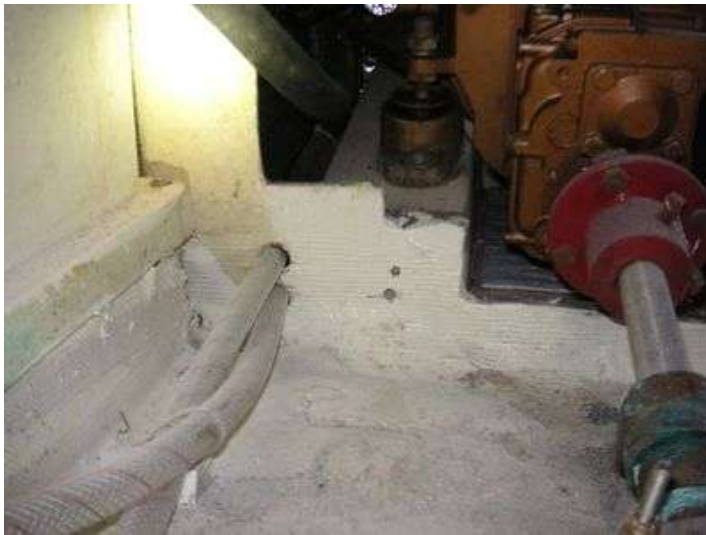
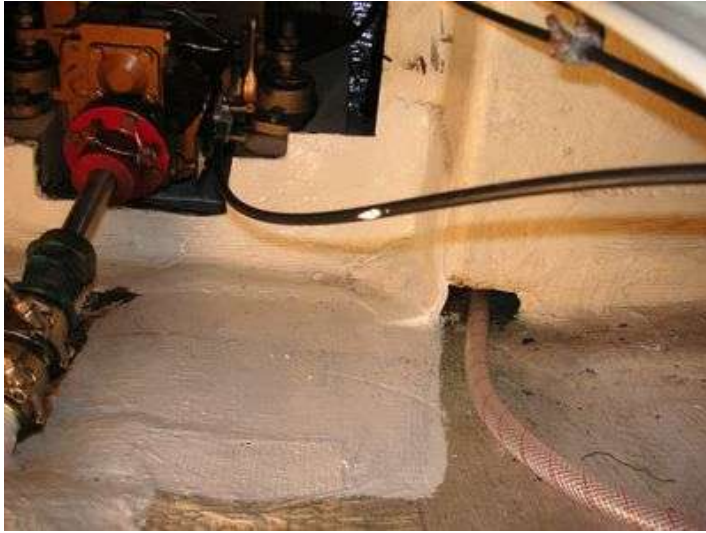
Photos (14) and (15) are taken under the aft cabin with the cushions and wood cover removed. My original plan was to run the cables from the battery compartment under the cabin floor and engine compartment through a hole in this area. (I recently painted this area with white bilgekote when I replaced all the fresh water and vent hoses). In photo (14), you can see 2 small pilot holes I drilled under the port engine mount. I drilled the pilot holes about 1" deep but did not break through. So I plugged the pilot holes with hardwood dowels and 3M 5200 and changed plans. My fall back plan was to run the cables through the opening shown in Photo (15) where the water hose from the aft tank went under the cabin floor to the sink area.

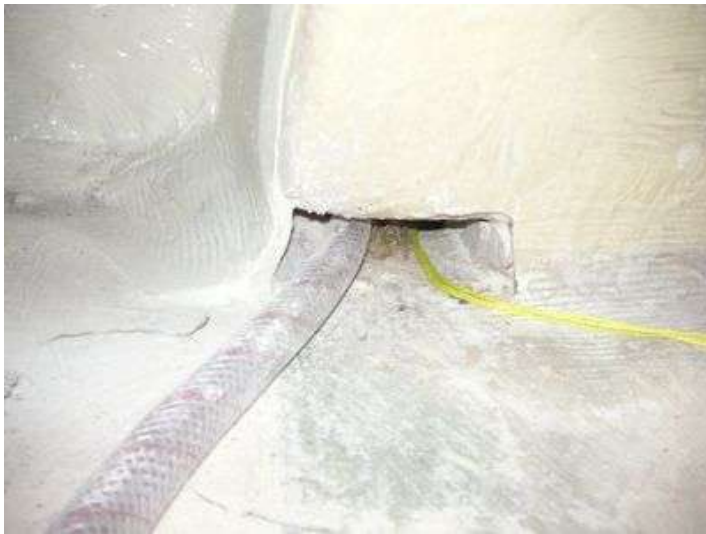
Barely visible in photo (16) is a dark clump of old adhesive sitting in the opening to the right of the aft tank water supply hose. It appeared to be excess adhesive for the conduit from the original build of the boat. A light tap with a screwdriver removed it, and now the path is clear to pass the 1 AWG cables through. The yellow strings are messenger lines to pull new cable. **However**, I found that I could reroute the hot and cold water hoses to the head sink between the manual bilge pump hose and the shower drain hose and reuse the now unused holes in the engine compartment to run the #1, 5, and 14 cables. See photos 55-57 for more clarity. This pass through from under the aft cabin to the galley will be used for my electric 1 1/8" bilge pump hose.

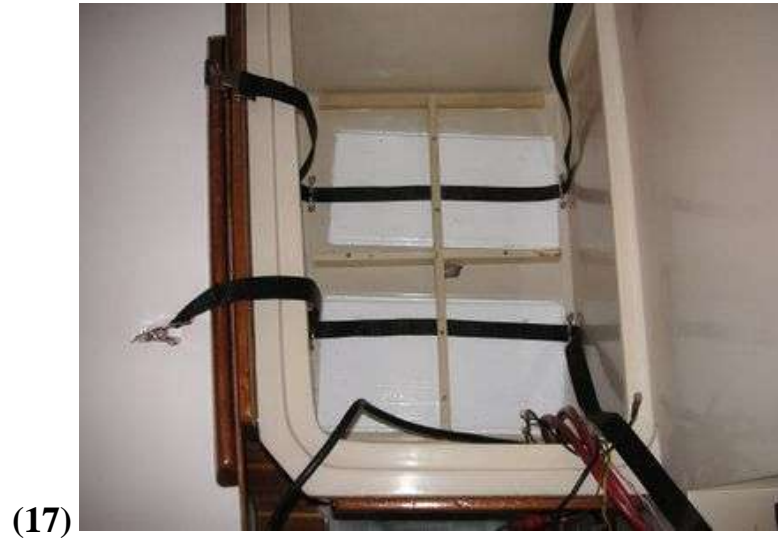
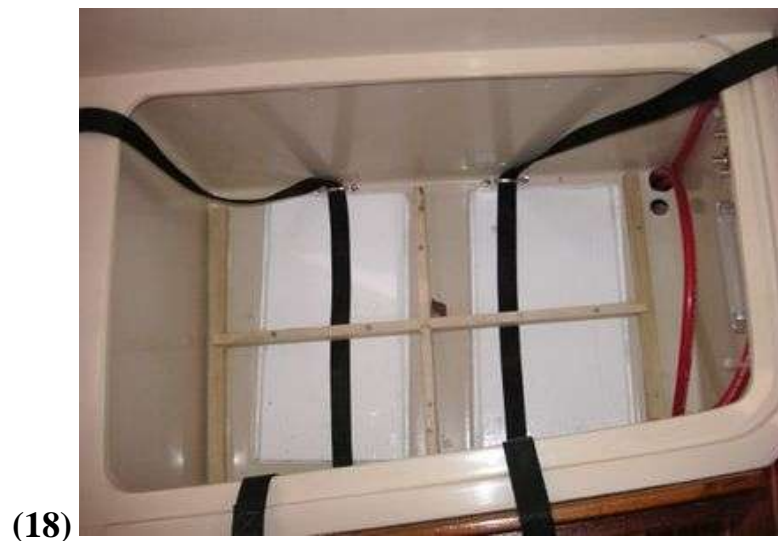
Photos (17) and (18) show the 2x8 painted wood fillers, the “egg crate” made from  $\frac{3}{4}$ ” x  $\frac{3}{4}$ ” hardwood strips screwed and countersunk to the bottom, and the battery straps all to keep the batteries in place while underway. Photo (18) shows 2 existing holes in the bottom of the box with new cables passing through. (I was later glad to have 2 entry holes). I drilled holes for #8 screws for wire ties along the upper battery box wall, and 2 thru holes for #8 screws in the radius at the bottom of the box on the water heater side. These are to attach wire ties outside of the box near the water heater for the cables that will run in that area. The 2 thru holes were covered with the same silicone caulk used earlier to seal them from a possible battery leak. Be sure the screws do not extend into the battery box or you’ll damage the batteries.

To keep the batteries as low as possible in the battery box I elected to fill the recess using a 2x8 piece of wood. I cut it into 2  $\sim 14\frac{1}{4}$ " long by  $\sim 1\frac{9}{16}$ " thick pieces and chamfered the bottom to fit the recessed pan radius and painted them with white bilgekote. I countersunk screws to fasten them to the bottom of the recessed pan, then used a white silicone caulk to fill the gap between the wood edges and the pan. CAUTION - In my case each pan size was slightly different, so I had to customize each to fit and have a flush surface. Measure yours to get your dimensions before cutting anything. An alternative to filling the recess is to use a plywood cover with a support underneath in each recessed pan. The down side to this method is reduced height.

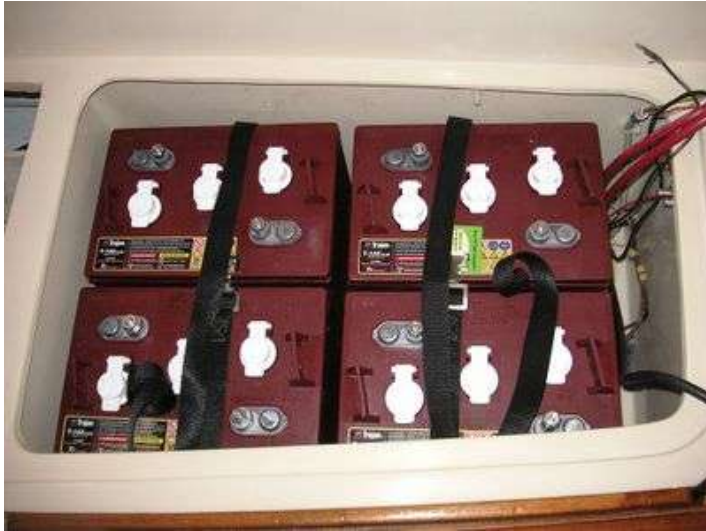
(19)

I didn't want to make the final attachments, and then find out the tie down straps interfered with the fill caps on the batteries. So I temporarily installed all of the house batteries to ensure the eggcrate matched up as intended, and the battery straps didn't interfere with the battery fill caps as shown in photo (19).

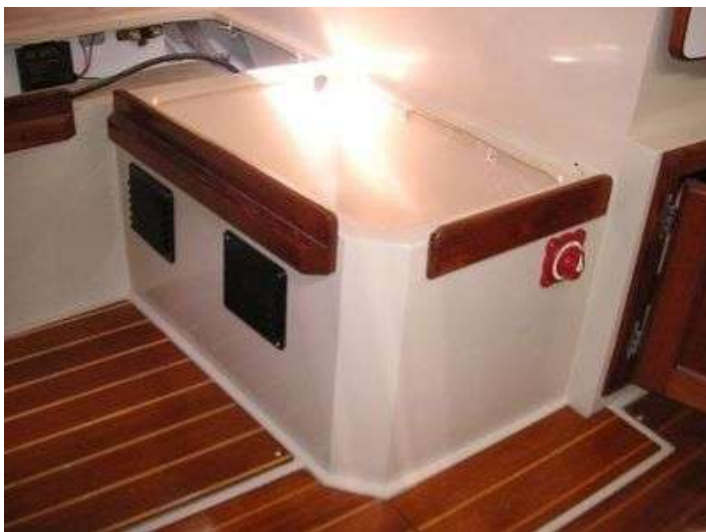
(20)

Photos (20 and (21) show the 2 new black ventilation covers installed in the battery box and the 1-2-Both battery switch installed where the bilge pump auto/on/off switch used to be. (In the background of photos you can see the breadboard for the Xantrex Digital Echo charge, house negative busbar, and BMV-700 shunt, but more on that later). The battery switch is a Blue Sea 6007 installed with the front panel mounted option. I used a 2 5/8" Milwaukee Dozer hole saw to drill the hole for the battery switch. It was tricky since I was using the hole saw to enlarge the existing smaller bilge switch hole. The battery box is two walls that are hollow in between. I wedged a piece of wood into the hollow section to give the hole saw pilot bit something to grab on to. I lined up the hole saw with the top of the existing bilge switch hole and went for it. It worked, but maybe not the safest couple of minutes I spent on this project.

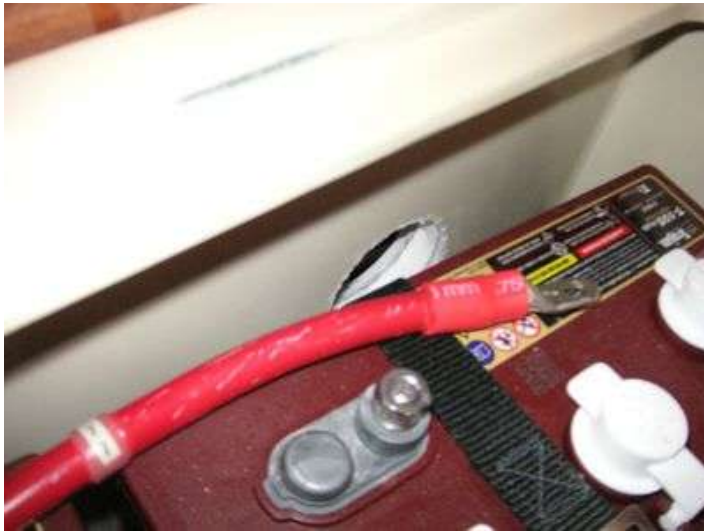
(22)

I used the same 2 5/8" hole saw for the vent covers along the forward side of the battery compartment instead of buying a larger hole saw for two holes. This surface is also two walls and hollow in between. To avoid gases collecting, I rolled up paper towels and stuffed them inside just below the edge of the hole to act as a backing for the caulk I used. The caulk provided a seal with a nice finished appearance as can be seen in photo (22).

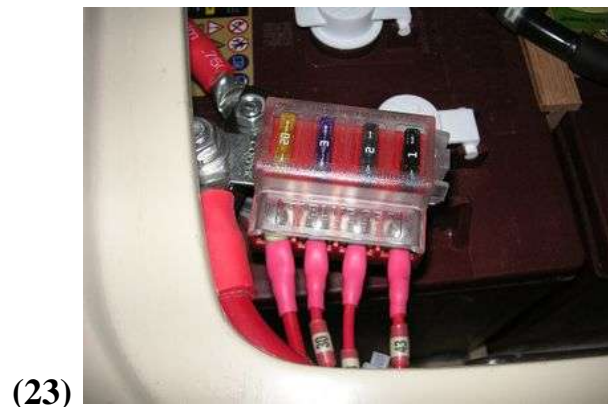
(23)

Photos (23), and (23A) show the Blue Sea 5024 fuse block I used to combine 4 fused runs into one small space with one connection point directly on the battery. The battery posts are short allowing connection of only 2 lugs comfortably. Photo (23A) shows the stack sequence on the battery terminal as the Blue Sea terminal block 5191, positive cable #7, then the nut. On the Blue Sea terminal block 5191, the stack sequence is 250A MRBF, Blue Sea 5024 fuse block, positive cable #2, positive cable #1, then the nut. (The cable #'s are shown in the schematic included with this write-up). Many devices require connecting directly to the battery or as close as possible for best results, and is preferred by ABYC code. This does that neatly.

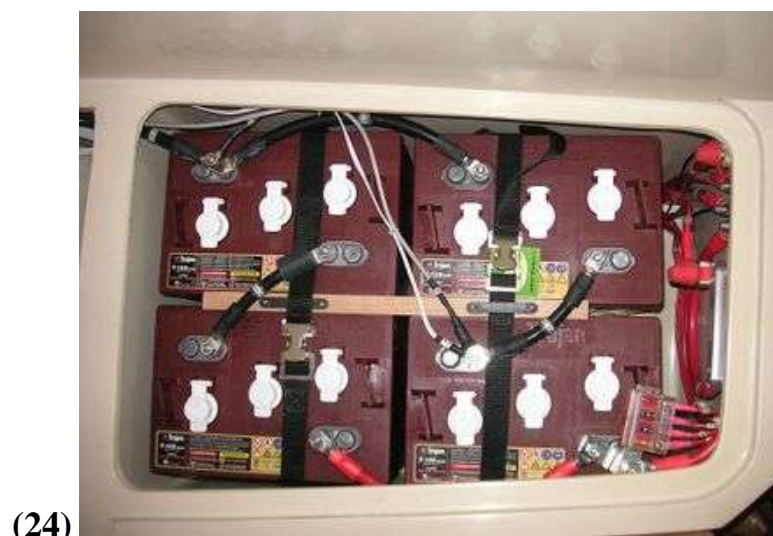
Photo (24) shows the Trojan T105's installed waiting for inspection. I cut a piece of red oak into a "T" shape to fit between the batteries to avoid them tipping together when the battery strap is tightened. The black plastic clips came with the NAPA battery box for the reserve battery. I'm using a higher quality battery strap and stainless steel clips to hold the reserve battery to the shelf, so I decided to use the plastic clips here to keep the wood from sliding. The house bank connects to position 1 on the 1-2-Both battery selector switch. In photo (24), the schematic battery ID #'s starting from the bottom right are #1, bottom left is #2, upper right is #3, and upper left is #4. See the schematic attached in Section 14 of this write-up for the details.

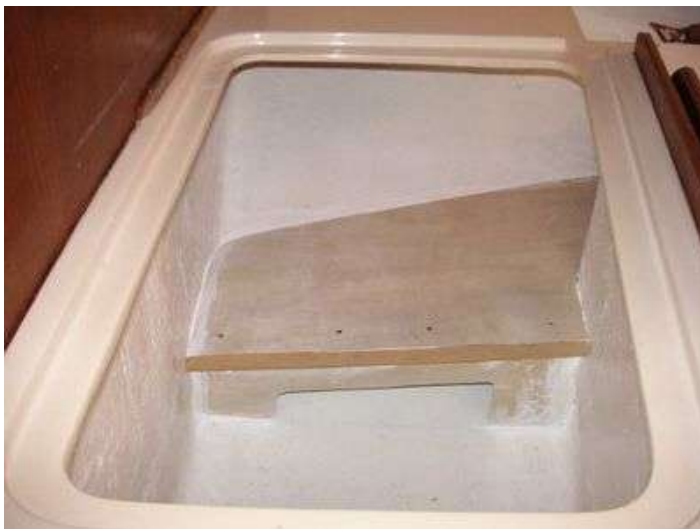
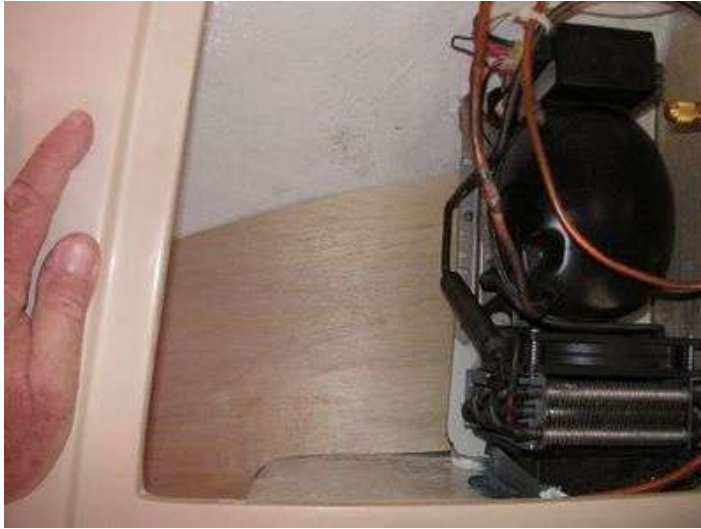
(25)

The most common location others install a reserve/start battery on a C34 is under the aft cabin. When I looked at under aft cabin installations, although done well, it was cramped, dark, wet, and hard to service. I chose to add a shelf under the forward outboard starboard corner section of the salon shown in work in photo (25). A loss of storage area, but my storage is limited here due to the refrigerator compressor anyway which you can see in phot (26). Using ½" birch plywood I fabricated a shelf to match the hull, bulkheads, and refrigerator compressor shelf. I cut an opening in the vertical leg of the new shelf for water drainage and access. The underside was painted in the non-bonding areas with white bilgekote before final installation. The hull and bulkheads were sanded for good adhesion, I then used 3M 5200 to bond the shelf to the hull and countersunk screws to bond the top and vertical leg of the shelf together. The screws were covered with a ½" cove molding for looks and a little additional ledge surface to help when removing the battery. The reserve battery was used as a weight to apply pressure while the 3M 5200 cured. The exterior is finished with white bilgekote.

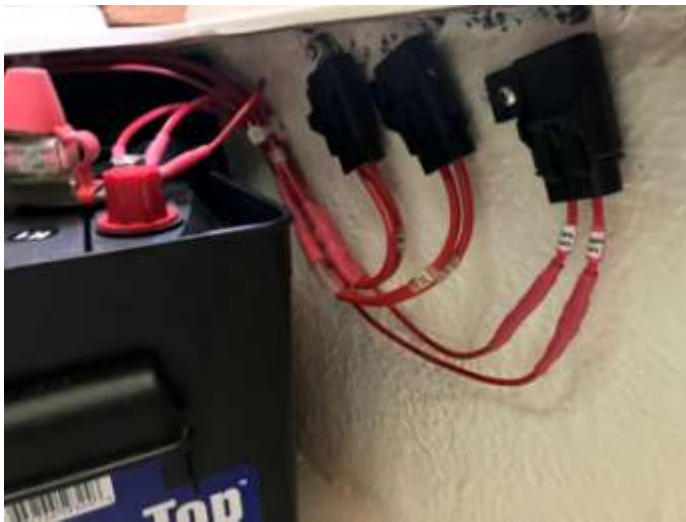
I added hardwood strips, and the same type battery strap as the house bank to keep the battery box from moving while underway. The terminal posts and all fuses are shown in photo (27) are easily accessible by removing a cushion and the wood cover. The SmartGauge, Digital Echo Charge, and BMV 712 Smart battery monitor in-line fuses are shown mounted on the bulkhead. I also have space to stow the 12VDC air pump for the dinghy as shown in photo (28).

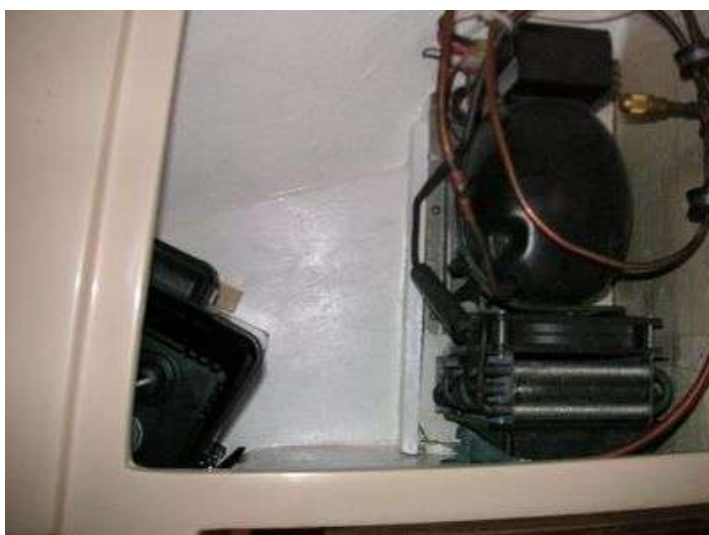
In photo (29) you can see that this arrangement also provides space for a future electric windlass breaker to fit between the battery and fridge compressor.

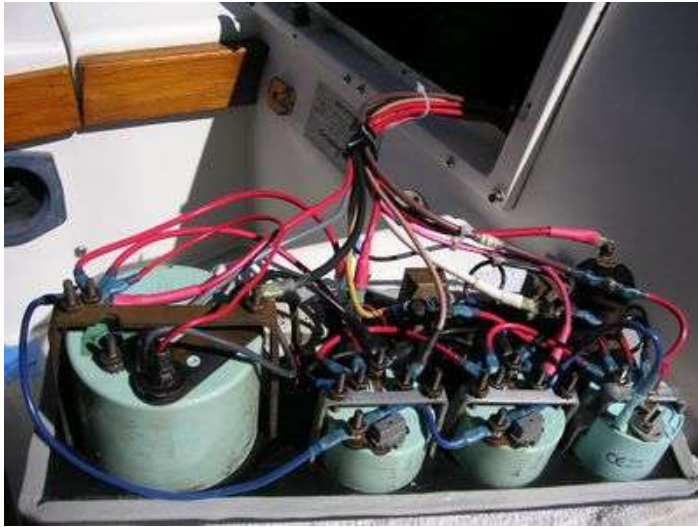
(35)

In photo (35), the brown ignition wire, ID # 50, connects to the ignition switch in the cockpit. The gray material around the perimeter of the cockpit panel is foam tape for weather protection when installed. FYI –I set the belt manager to level 4. The engine was started and run at 1500 rpm. The alternator was charging the house at 80 Amps, the alternator was at 32°C and the house bank was at 18°C. Just like advertised!

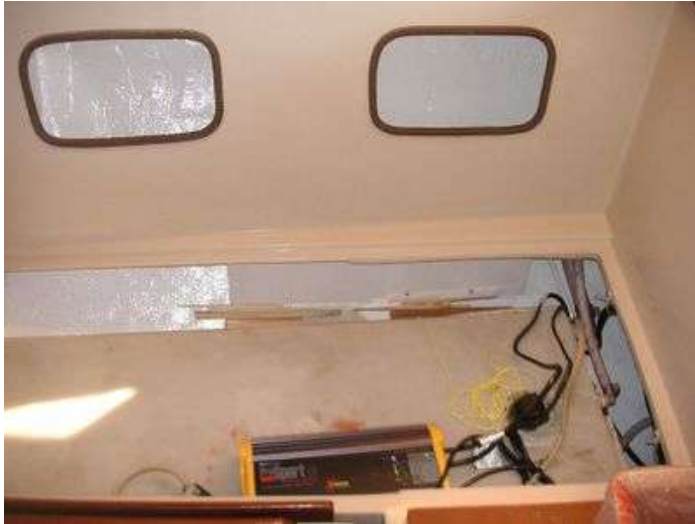
(37)

Photo (36) shows the vertical breadboard that is made out of ½” birch plywood cut to match the hull shape and the underside of the storage area behind the starboard salon seat where it’s dry and has good ventilation. **Before** installation, I located all the parts to be mounted on the breadboard for best fit of the cables, and screws, then drilled the mounting holes. I then cut a notch into the top edge of the breadboard to make a pass through for the cables and wires to run. The breadboard extends from the end of the water tank ~24” forward and sits back from the fiberglass opening to the water tank ~4” to protect the components from falling items or liquids. The breadboard was then painted with white bilgekote on all sides except for the bonding surface. The hull bonding area was sanded and the breadboard was bonded to the hull and underside of the storage area with 3M 5200. It was held in place with wood shims to apply pressure as it cured as shown in photo (37).

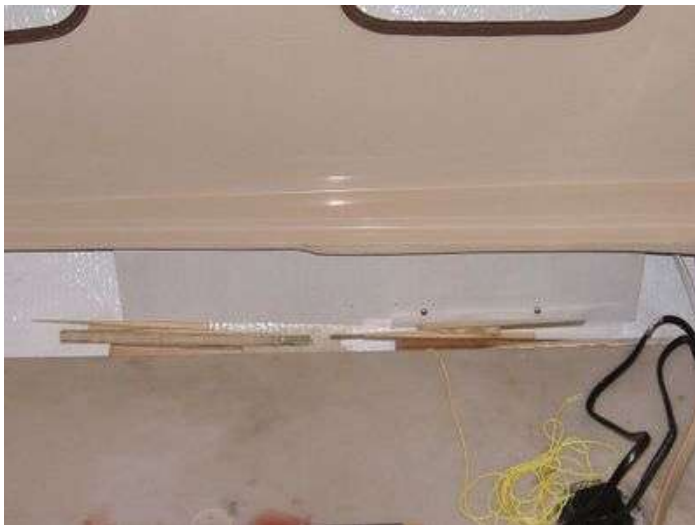
Photo (38) shows the bottom of the breadboard matched and bonded to the hull. After drying, it was repainted with white bilgekote before installing the components as shown in the next group of photos.

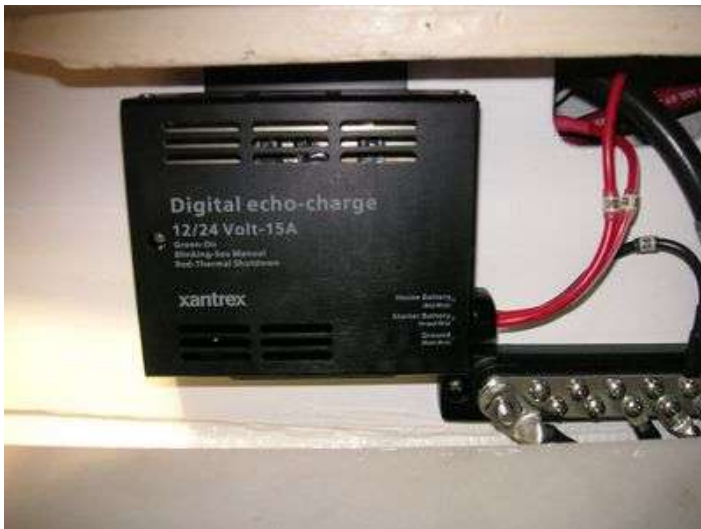
(39)

In photo (39), the Digital Echo Charge is shown installed and wired. The busbar comes with a cover that is removed for clarity. Installing the busbar and the wires connecting to it requires a stubby screwdriver due to limited space between it and the water tank. Photo (40) shows the house negative busbar with negative wires connected and labeled. The 1AWG negative cable to the main engine ground is on the right. The 1AWG negative from the shunt crosses over to the far left post on the busbar.

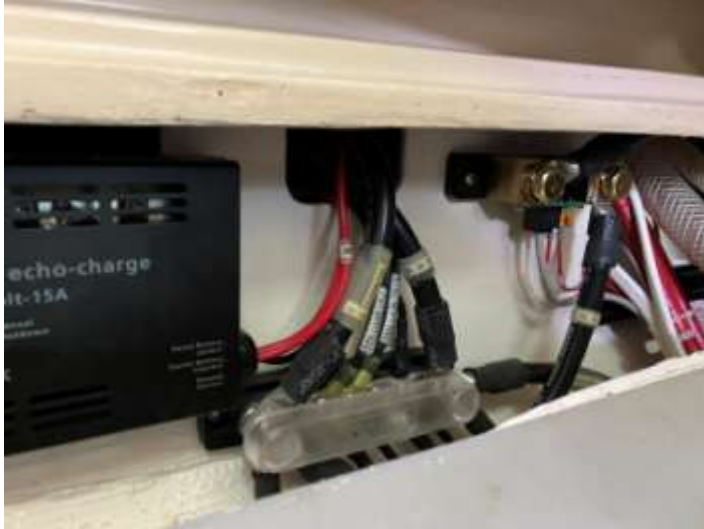
(40)

In photo (41) you see the shunt for the BMV-700. The house bank negative is connecting to the brass bolt on the left. This orientation of the shunt was used to have the battery monitor connections pointing down to reduce stress on the wires, and avoid condensation from humidity seeping into the connection points.

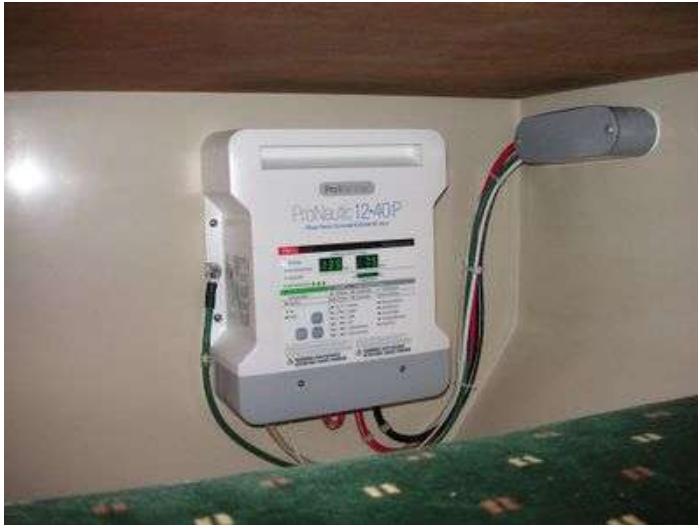
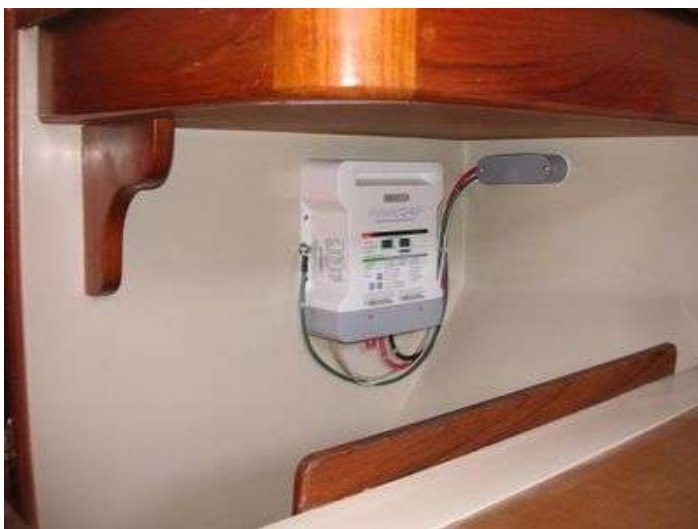
I removed the original ProMariner ProSport 20A AC battery charger that was lying on the hull **unattached** to anything, and replaced it with a ProNautic 40A multistage smart charger. The ProNautic uses battery temperature sensing, and can be programmed for several battery types and profiles for safe and efficient charging. I installed it with 4 screws on the common hanging locker bulkhead underneath the Navigation Station desk, see photos (42) and (43). This allows vertical mounting with plenty of ventilation in a relatively cool dry area. The location does not interfere with my knees when sitting at the desk, but is close enough to get at and change programming if needed. The AC charger wires run through the outboard bulkhead through a conduit LB under the Navigation Station desk. This reduces wires running in the hanging *wet* locker, provides a shorter run to the back of the Main Distribution Panel which is directly above it, and the conduit LB hides the hole.

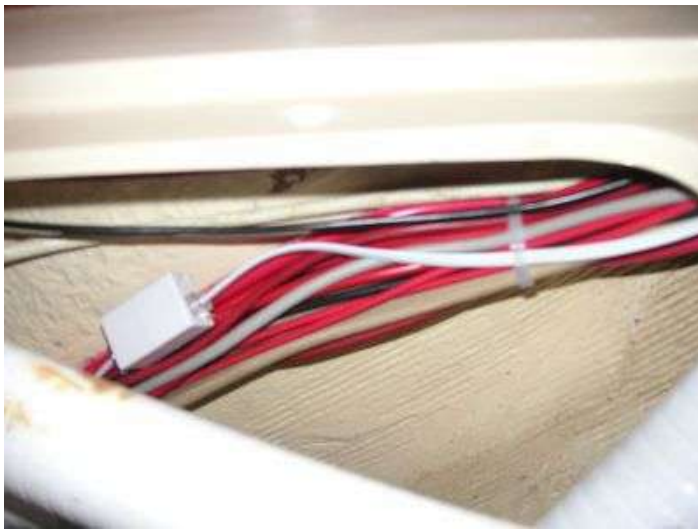
Unfortunately the temperature sense wire provided with the charger is only 10 feet long and will not reach the house bank from here. To solve this, ProMariner suggested using an RJ6 phone coupler and an RJ6 telephone line the length needed. Photo (44) shows the RJ6 phone coupler and the added 12 foot RJ6 wire tied to the main wire bundle just before the macerator pump/motor. Not sure yet if I'll plug the open RJ6 phone coupler ends with butyl tape and rescue tape to seal it from moisture.

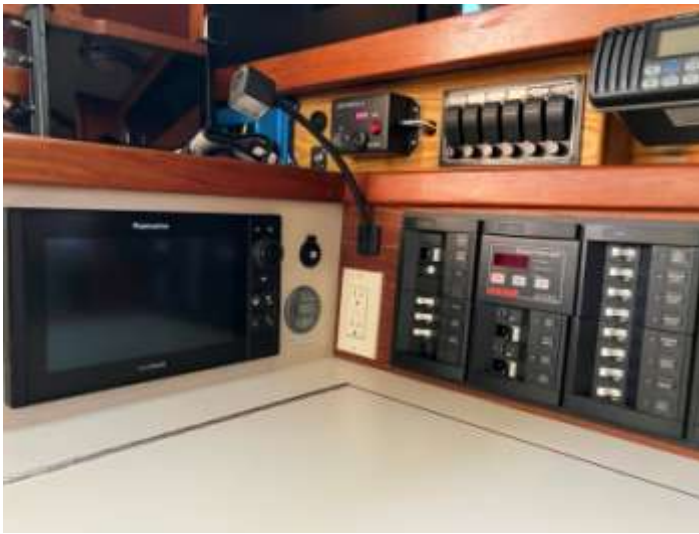
Photo (45) shows the Navigation Station with the new Blue Sea 360 Main Distribution Panel installed. The AC power is on the left side of the panel with a new ELCI 30A double pole main breaker, separate outlet, water heater, and AC battery charger breakers, plus two spares. Moving to the right is the SmartGauge battery monitor located above the bilge pump restricted off and manual on breakers, the right two columns are the 14 DC breakers plus 4 spares. One of the spares will be used for the future auto-pilot. Photo (46) shows the BMV-712 Smart battery monitor and the 12VDC outlet that are installed on the bulkhead shared with the hanging locker, and to the left of the GFCI outlet.

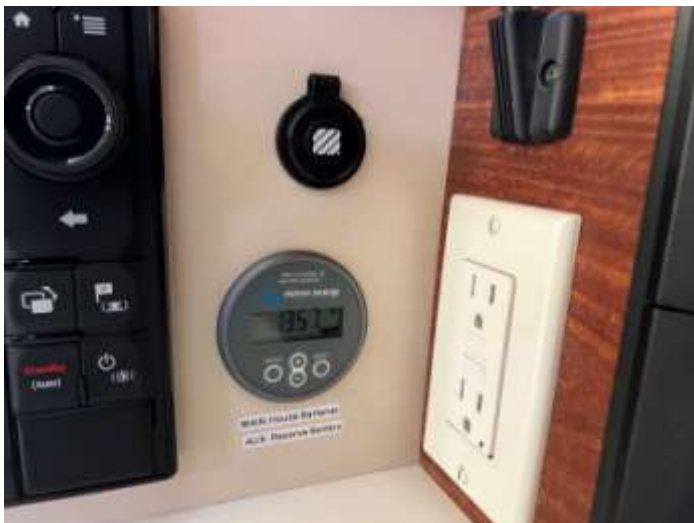
(46)

Photo (47) shows the cables from the back of the BMV-712 and the 12VDC outlet in the hanging locker running through the bulkhead, and behind the main panel.

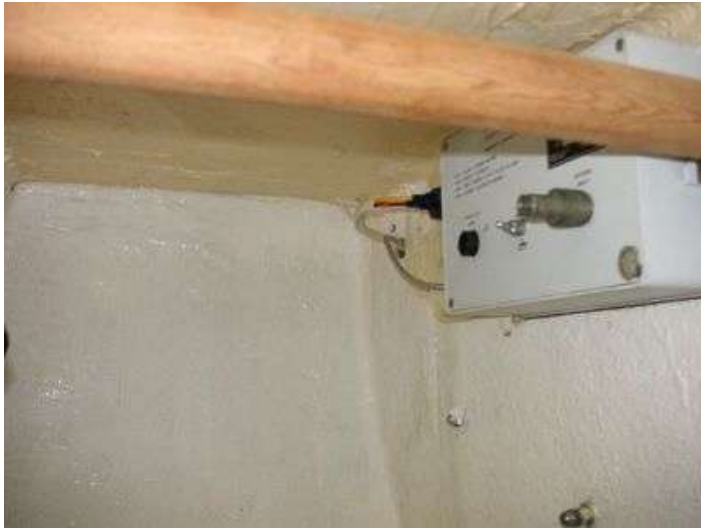
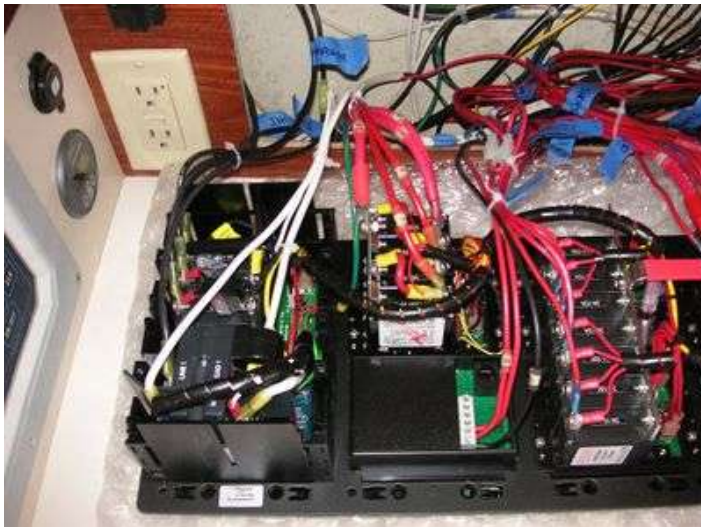
In photos (48) and (49), more breakers means more wires connecting to the main panel, but the organization of the wiring has been improved from the original.

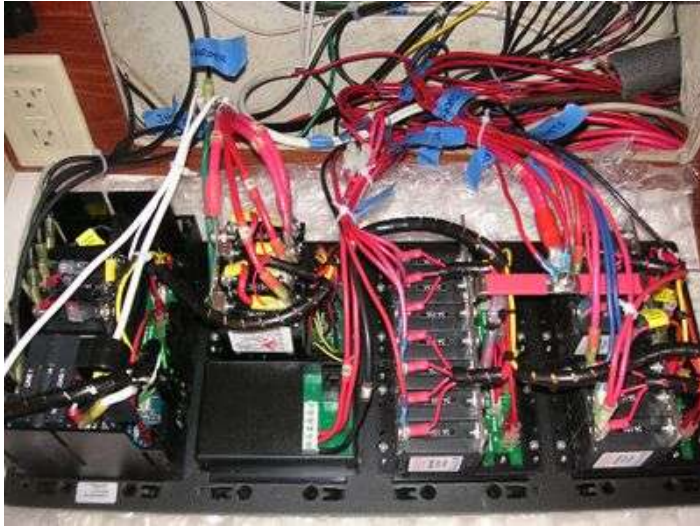
Here in photo (50) you see the wire bundle going by the macerator pump and motor up to the main distribution panel higher than before to get them off the hull and out of the way.

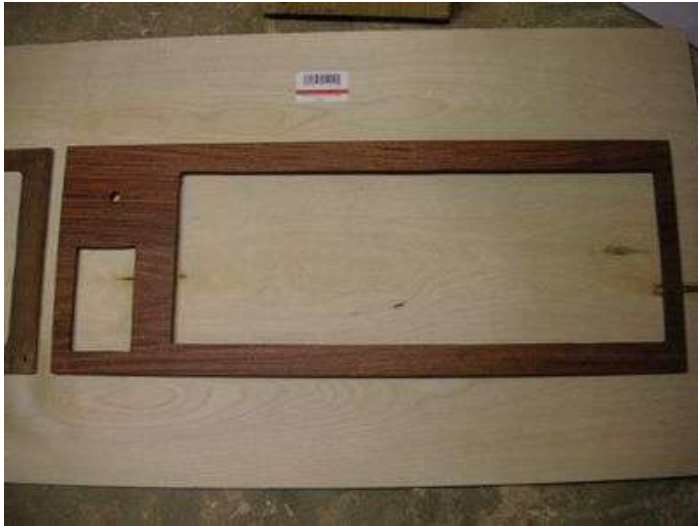
(52)

I also replaced the old 1/4" teak plywood with a new piece of solid teak 5/16" thick. The new teak is shown in photo (51) and the old is shown in photo (52). The new teak improvement is more dramatic in person, and is seen a little better in photos (53) and (54). New is shown in photo (54).

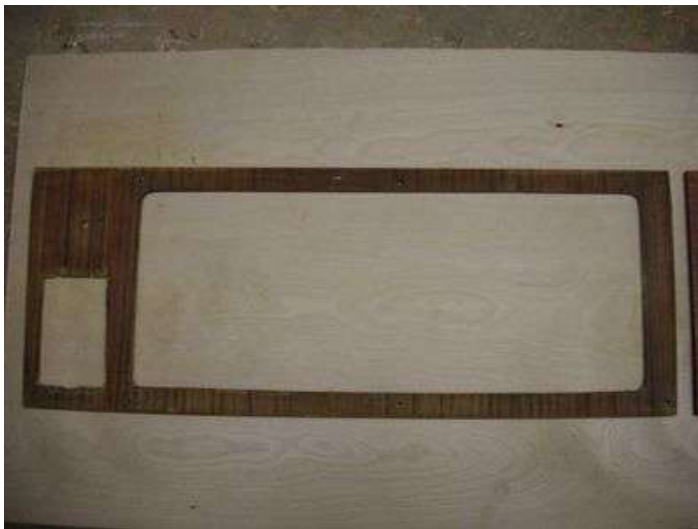
**AC Busbar Replacement:** I removed the original terminal strip in photo (53) and replaced it with a 10 screw dual busbar and a 5 screw dual busbar as shown in photo (54). In photo (53) you can see dark spots under the screw at the end of each wire. Those are corroded spade fittings with open crimps at both ends. I removed and replaced all with heat shrink adhesive lined ring terminals. They are now all nice and shiny new in photo (54). The 10 screw dual busbar is for most AC neutrals and all grounds. The smaller 5 screw dual busbar is dedicated to line and neutrals for the cabin, galley, and head protected AC outlets. The AC outlet power leaves the panel breaker and connects to the GFCI outlet at the Navigation Station. From there it connects to the 5 screw dual busbar for the downstream AC outlets, and is labeled “Protected Outlets”. In this arrangement the cabin, galley, and head outlets are all protected by the Navigation Station GFCI outlet. The down side to this arrangement is the AC outlets are limited to a combined total of 30A. This may or may not be a nuisance item. I plan to wait and see if it is an issue before changing anything.

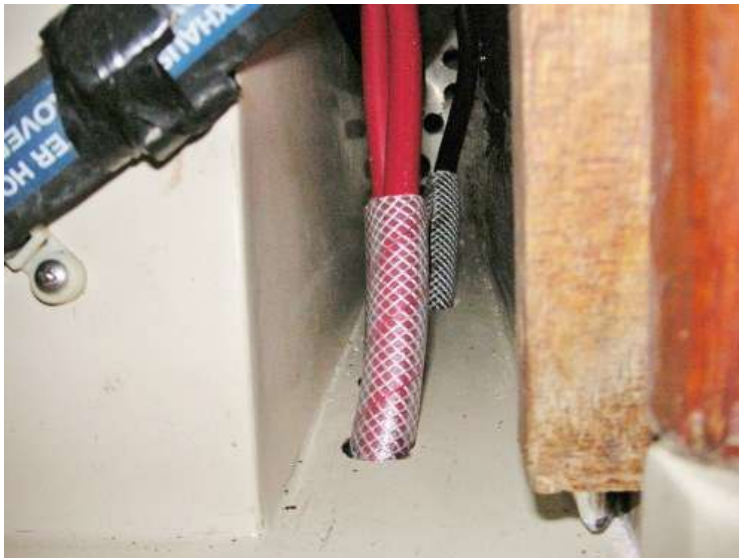
For the primary battery and charging circuit cables I used 1 AWG. There was a lot of discussion on what is the proper cable size to use on the Message Board. Refer to my post [1987 MK1 Electrical System Upgrade – Feedback Requested](#). The following photos (55) and (56) show how the starter, alternator output, and main negative (from the house negative busbar) cables run under the floor between the galley sink and enter the engine compartment where the hot and cold water hoses to the head used to be. I drilled a third 1” hole aft of the first two for the main negative to pass through. I was able to re-route the hot and cold water hoses directly to the head sink. There was just enough room for the two hoses to slide between the shower drain and the manual bilge pump hose. This is a shorter hose run to the head sink than the original route, which went from the galley sink area through the engine compartment, around the aqua lift muffler then back and up to the head sink. I used some of the extra ½” hose for chafe protection where the cables pass through the engine compartment floor.

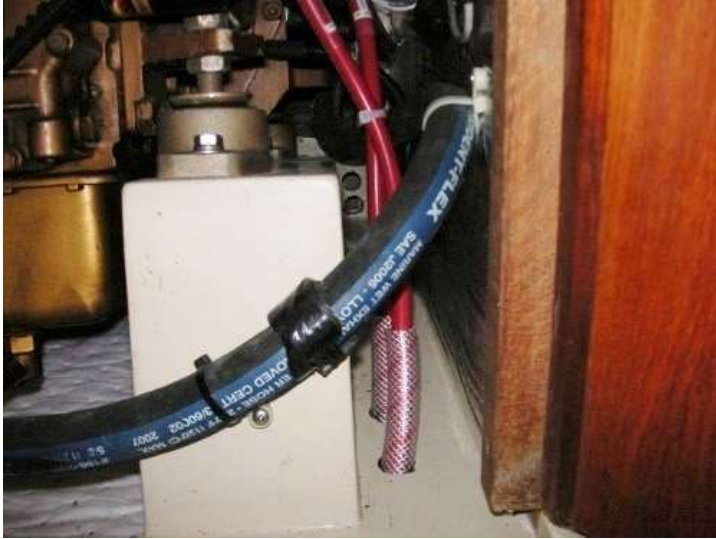
Photo (57) shows another view of the same three cables rising up to the alternator, starter, and main negative cable #14 connection on the starter motor mounting bolt.

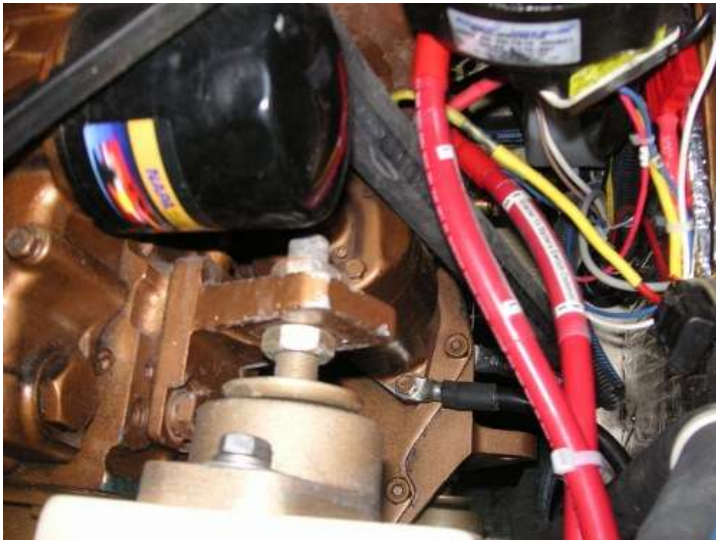
In photo (58) you can see I added insulation foam for  $\frac{3}{4}$ " pipe on the water tank hose and band clamp to protect the cables and wires from chafing.

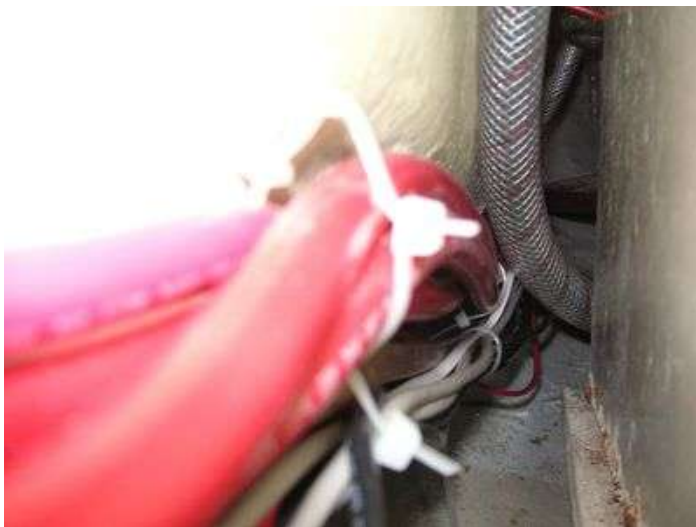
Photo (59) shows cables running between the water heater and the outside of the battery box. The wire tie mounts are attached to the thru holes I drilled in the battery box in the beginning. No other way to get in there and drill a hole. Photo (60) shows another use of the insulation material to cover the corner of the water heater support and shelf to avoid any cable or wire chafe. The insulation is attached to the heater shelf with a #8 SST screw fastened to the wood shelf so it doesn't move and leave the wires/cables exposed to the corner.

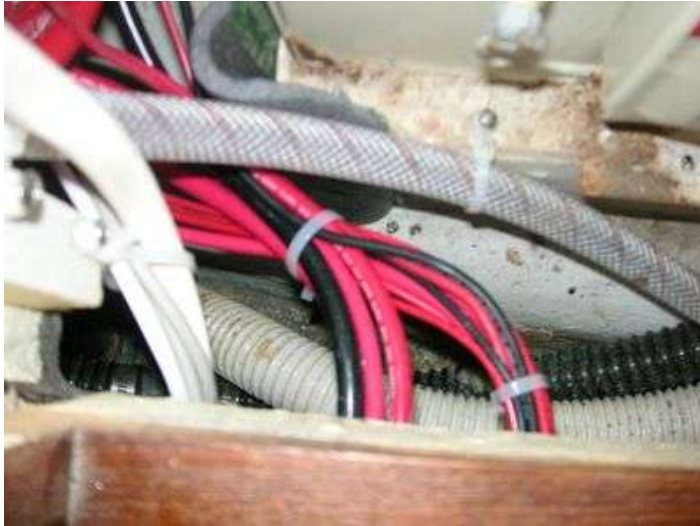
Photo (61) shows the cables entering the bottom of the battery box thru the larger of the two existing holes and connecting to the back of the 1-2-Both battery selector switch in the battery box, the “always on” busbar, and the house battery bank. Remember I said I was glad there were two holes? This is why, it is big stuff. *NOTE: although the battery selector switch posts extended into the battery compartment, the back of the switch was slightly recessed so I was not able to tighten down the cables. Adding 2 copper washers to each post allowed me to tighten each post and get full contact as required.*
