# 1987 MK 1 Catalina 34 Electrical System Upgrade

By Jon Windt; s/v Della Jean

**REVISION A – 7-31-2016** Section 11 was revised to re-route the #1, 5, and 14 1 AWG cables directly to the engine compartment from the house bank. The Cable Planner Excel and pdf files have been updated, the schematic and cable ID #'s are unchanged.

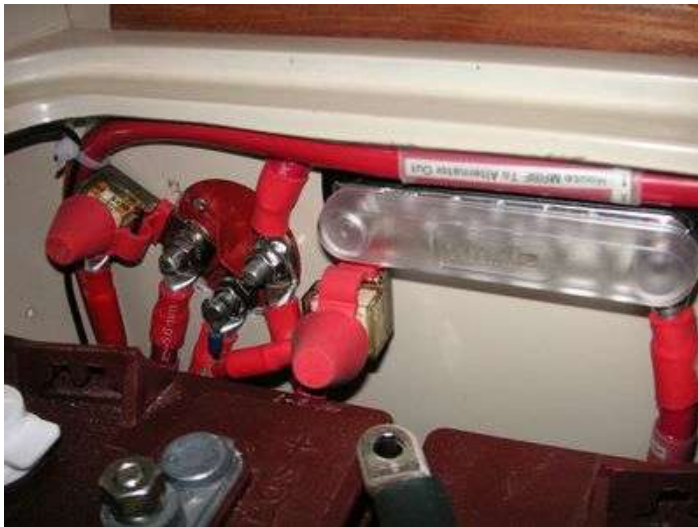
**Battery Box Busbar:** Photos (62) and (63) are looking inboard from the water tank to see inside the battery box. Photo (62) shows the primary cables inside the battery box connecting to the back of the 1-2-Both battery use switch. Position #1 (house bank) is on the right, Position #2 (reserve battery) is on the bottom, and Position C is on the left. The MRBF fuses (covered with the red caps) for the main distribution panel supply connecting to the C post, the AC battery charger, and power for the bilge pump breaker connecting to the “always on” busbar can also be seen. Photo (64) shows the alternator output cable running above the “always on” busbar. The protective cover is removed from the “always on” busbar for clarity. The alternator output cable is labeled upside down so it can be read from above when standing on the boat centerline looking down into the battery box. You can also see the jumper connecting position #1 of the 1-2-Both battery use switch to the “always on” busbar. The most critical DC item currently attached to the “always on” busbar are the bilge pumps. If the house battery bank were to fail, switching the 1-2-Both battery use switch to position #2 would not provide power to the always on busbar. To address this, I made the jumper long enough to be moved from position #1 to position #2 of the 1-2-Both battery use switch to provide temporary power. This failure mode is a remote possibility, but it could occur so I added this no cost redundancy feature.

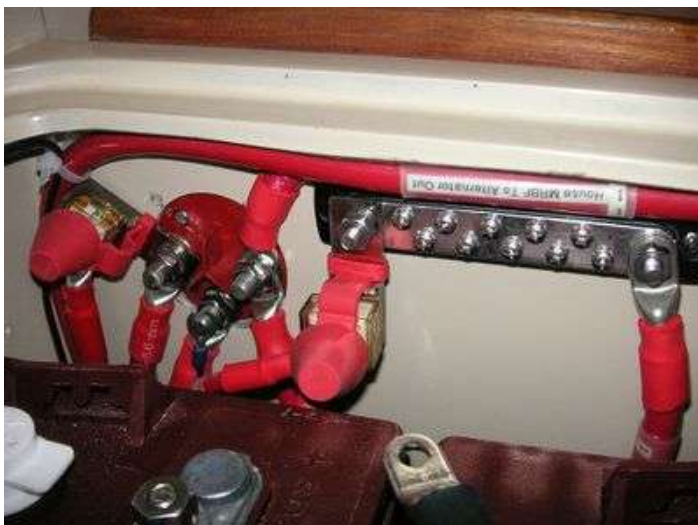
In photo (64), you see the end of the Blue Sea 5024 fuse block discussed in the House Battery section.

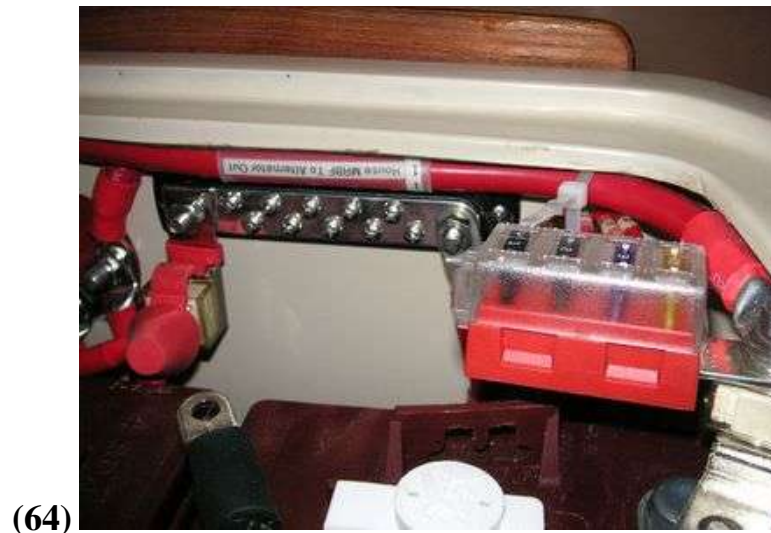
Looking at the bulkhead between the battery box and water tank in photo (65), you see the 1 AWG negative leaving battery #4 and going to the shunt through the hole in the battery box. Also visible are the temperature sense wires from the AC battery charger, and from the Balmar external voltage regulator. I separated most of the positive wires from the negative wires by running the positive's into the battery box through the two bottom holes shown earlier, and the negatives and temperature sense wires running through this hole at the top of the other end of the battery box near the water tank. I was only comfortable connecting two wires or cables to a battery post, so I purchased the extension from the battery supply house for ~ \$5. In photo (66), the 1AWG negative leaves the battery box and runs under the lip that the outboard salon cushion wood cover sits on.

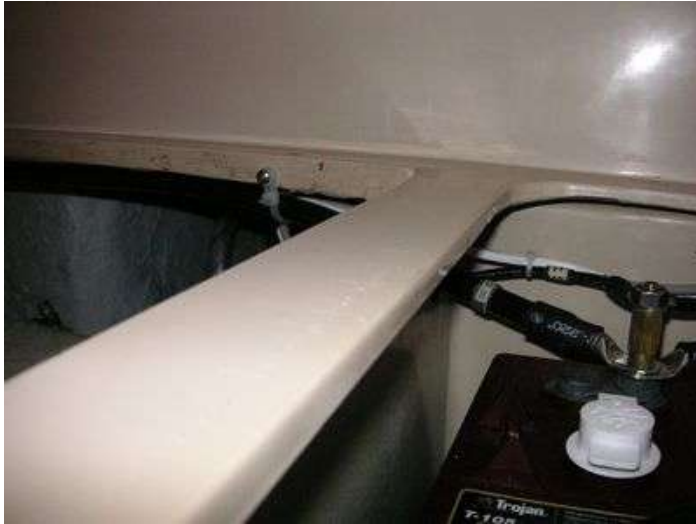
(67)

That same cable then connects to the left bolt on the BMV-712 shunt attached to the breadboard as shown in photo (67).

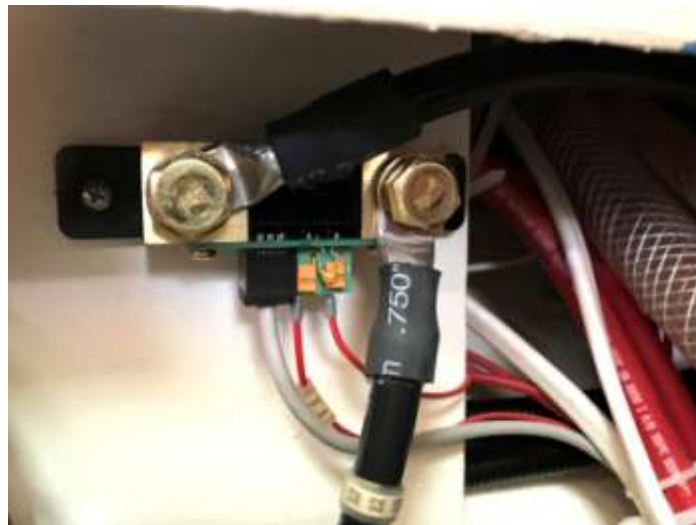
Photo (68) shows the positive and negative cables running to the reserve battery from the Digital Echo Charge, the SmartGauge, the 1-2-Both battery selector switch position #2, and from the house bank negative busbar. The shiny bit you see is the refrigeration line. To protect the refrigeration lines in case there is a gas leak from the maintenance free battery, I covered it with the material used to cover wires on the floor so you don't trip. Photo (69) shows the wires and cables from the reserve battery, Digital Echo Charge, and the SmartGauge running underneath the storage cubby holes behind the outboard salon seat cushion. The white Nomex is the existing DC wiring for the refrigerator compressor and fan. The wood you see is glassed in and is part of the boat. It wasn't added by me for this project.

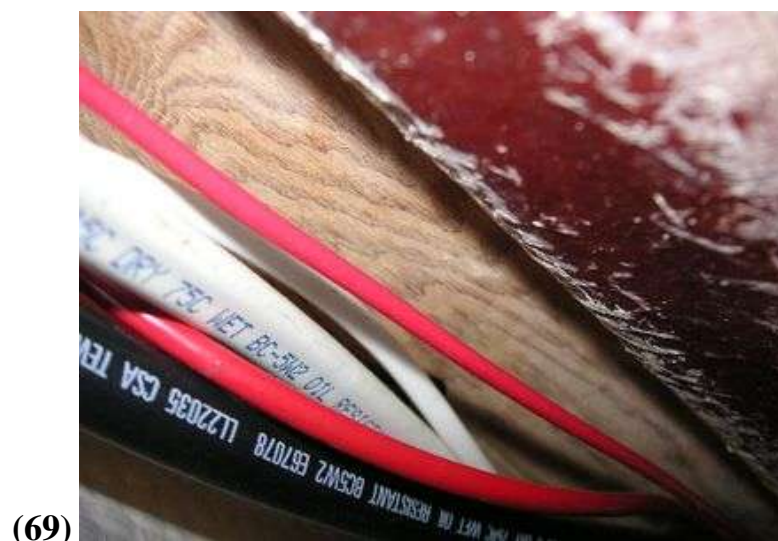
(70)

The 1 AWG negative continues to the breadboard where it passes through the cutout to connect to the right post on the house negative busbar as shown in photo (70).

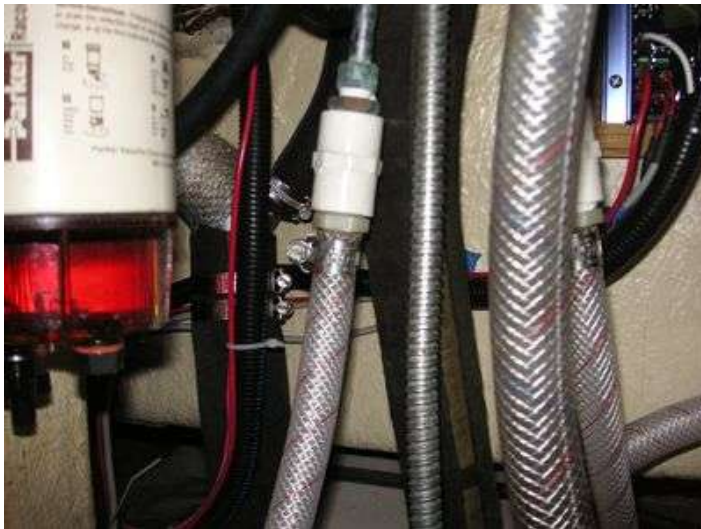
Photos (71) and (72) show the external regulator wiring under the head sink in the split loom, then it runs along the engine compartment bulkhead under the Racor filter.

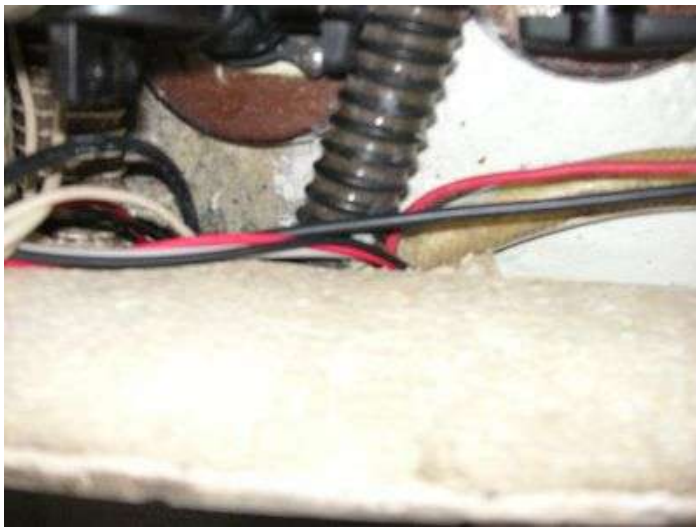
Photo (73) the external regulator wires enter the  $\frac{3}{4}$ " conduit under the shower pan. They exit the conduit by the macerator pump/motor in photo (75) of the next photo group. The black box by the Racor is part of my non-working depth/temp/speed system.

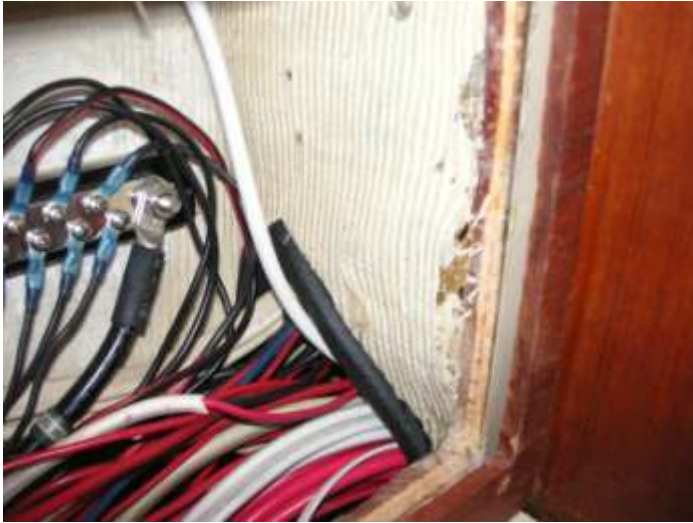
Finally photos of the wires running from behind the Main Distribution Panel, to the battery box area. Photo (74) shows the bundle exiting from behind the Main Distribution Panel with a chafe guard I made from some extra fuel hose, and photo (75) shows where they pass under the macerator pump/motor and pick up the external regulator wires.

**REVISION B – 10-11-2016** Section 10 was revised to change photo #74 to show the chafe guard to protect wires passing through the bulkhead behind the Main Distribution Panel.

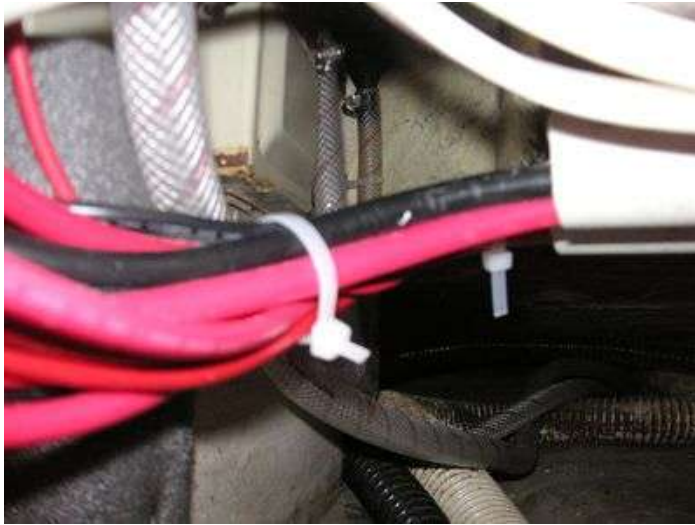
Photo (76) is where they cross over above the bilge. The hoses lying on the hull are for the hot and cold water to the head and the existing manual and electric bilge pumps.

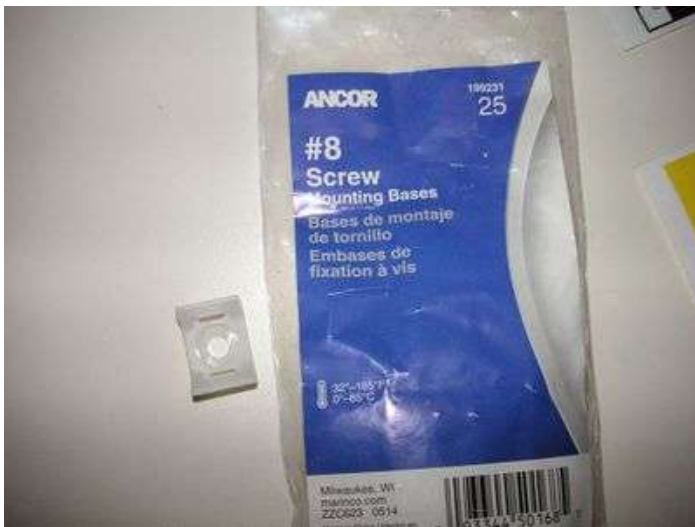
(77)

Lots of wire ties are used throughout to secure the wire and cable. A great fitting I used is #8 mounting bases; Ancor part # 199231 from West Marine shown in photo (77). Drill a hole for a #8 screw, screw it in, slip the wire tie through the slots, wrap around the wire/cable and tighten. Very secure. A valuable tool to have is a 90 degree drill. I didn't have one, so bought the 90 degree adaptor shown in photo (78) from Harbor Freight for ~\$20 before shipping and handling. It's a light duty tool, but worked well to get into tight areas to drill holes I wasn't able to without it.

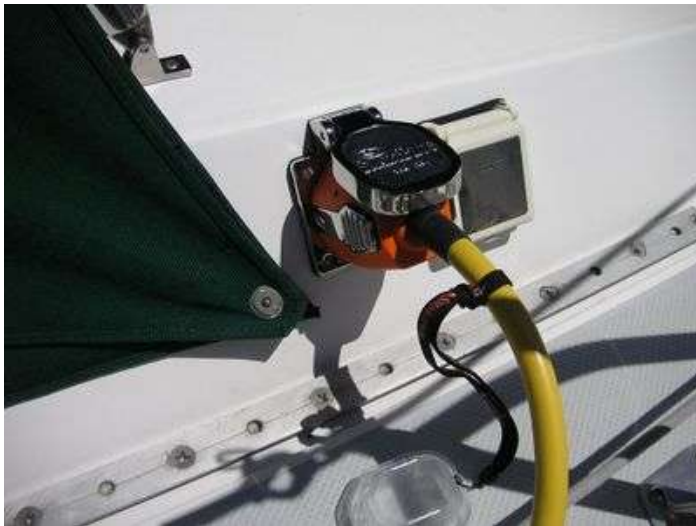
Photo (79) shows the final upgrade in this extensive electrical upgrade. What I thought would be a quick 30 minute job, turned out to be about 1 1/2 hours. The reason being the OEM boatside AC wire terminations to the old shore power connection used ring terminals (not heat shrunk by the way), with zero slack in it. When the ring terminals were cut off, the stripped wire conductor would not reach the SmartPlug terminal. To solve this, I added 8-10" long 10AWG pigtails to each conductor of the OEM 12 AWG cable with adhesive lined heat shrink butt connectors. Worked fine, and in the end I replaced my original twist on AC shore power plug with the more secure SmartPlug assembly, a new cable, and the optional protective cover that can be used when the plug is disconnected from the boat. The cover to the right of the SmartPlug is an old Marincor fitting for cable and telephone. It isn't connected to anything that I can find and will eventually be removed. Not sure what I'll replace it with.
