# 1987 MK 1 Catalina 34 Adding A 2<sup>nd</sup> Electric Bilge Pump

By **Jon Windt**; s/v Della Jean

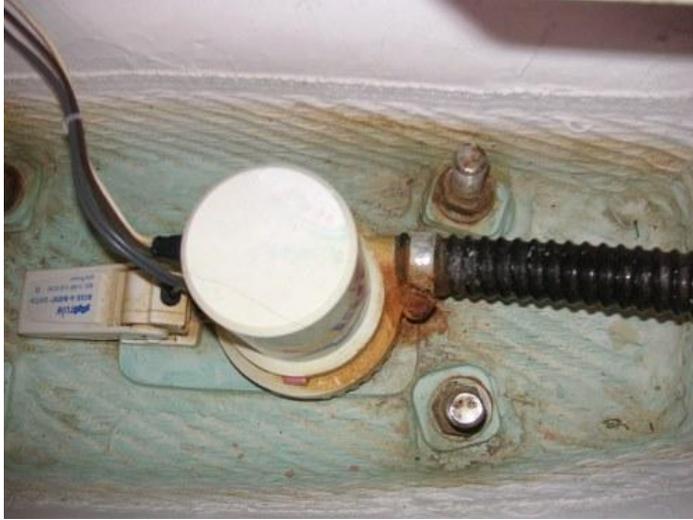
Photo (1) is the existing Rule 1500 pump and switch mounted on an ~ 5/16" raised surface glassed into the bottom of the bilge. Notice the severely rusted hose clamp. I was not able to loosen it so used my Dremel tool to cut the metal band to remove it. Photo (2) is the aft most bilge section. The 1 1/8" hose for the Rule 1500 and one of the in line check valves ran along the bottom of the bilge and through a ~2" hole in the port to starboard stringer to attach to the pump located in the center bilge section. Also in this bilge section is the end of 1 1/2" manual bilge pump hose. It had a screen tie wrapped over the end to keep debris from being drawn into the hose and eventually the pump. The screen was torn and the hose clamp for the in-line check valve was rusted.

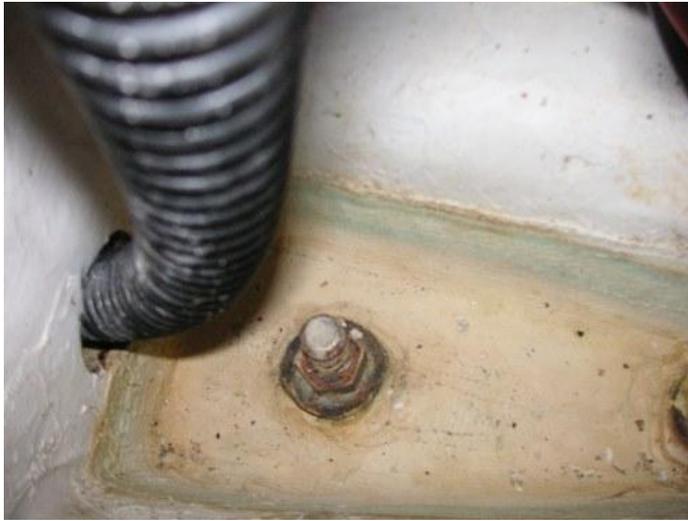
Photo (3) is the 1<sup>st</sup> keel bolt in the aft bilge section with the bilge hoses moved out of the way. Photo (4) is the 2<sup>nd</sup> keel bolt in the aft bilge section also with the bilge hoses moved out of the way. Both showed quite a bit of corrosion from the standing water that **used** to sit in this section. One of my first upgrades was to install a SST propeller shaft and change the packing gland material to a Gortex product. Now this section remains dry. Later in this write up are photos after I cleaned all the keel bolts With Davis brand FSR.

As I mentioned earlier in the description, the keel bolts were very corroded in the aft section of the bilge due to the standing water that used to always be there. I used a product called FSR from Davis to clean them up. Photos (14) and (15) show the results. Not like new, but a lot better.

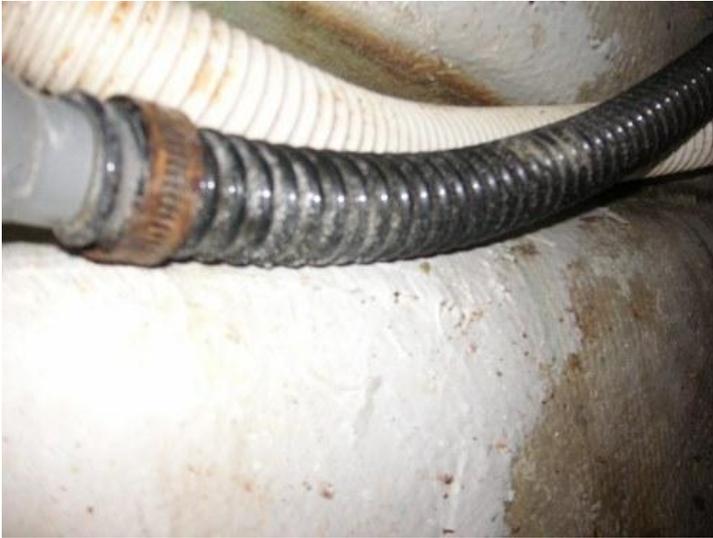
Photo (5) is the same bilge section but farther aft under the subfloor showing another rusted hose clamp on the 1 1/8" bilge hose. I point these out because this is the primary bilge pump system that could fail, even with a good pump and switch. I suggest you look at your bilge hoses and clamps, even if not planning to change anything.

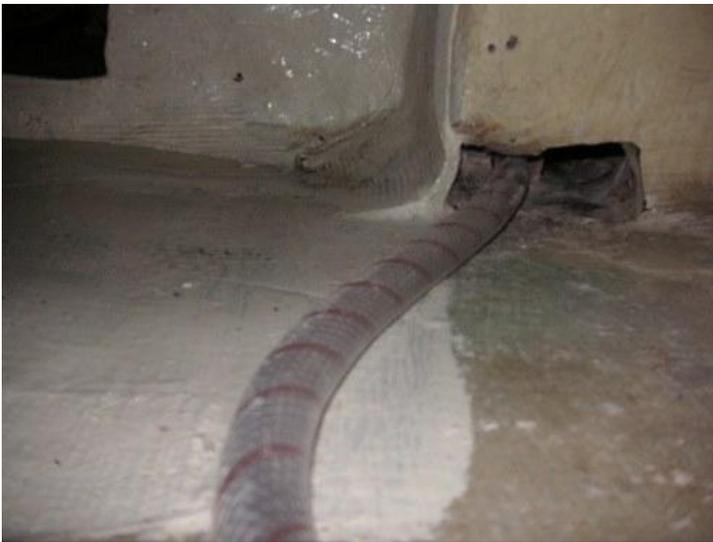
Photo (6) is under the aft cabin on the starboard side. The hose shown is the 1/2" fresh water supply line from the aft water tank going to the galley sink area where it connects into the main fresh water line with the starboard water tank prior to the fresh water pump. Previously I had run the starter, alternator out, and main negative cables through this opening. I found a way to route those cables more directly to the engine compartment. See photo (7). This routing change is both better electrically, and it gets the hot and cold fresh water hoses to the head sink out of the engine compartment which then frees up this opening to run the 1 1/8" bilge hose for the Rule 1500.

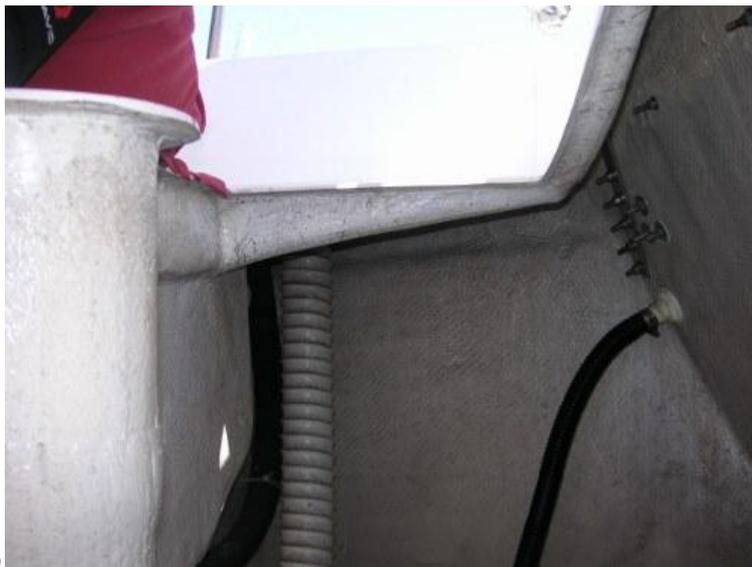
Photo (8) shows the thru hull for the 1 1/8" bilge hose. The thru hull is located high on the starboard side of the transom near the split back stay chain plate.

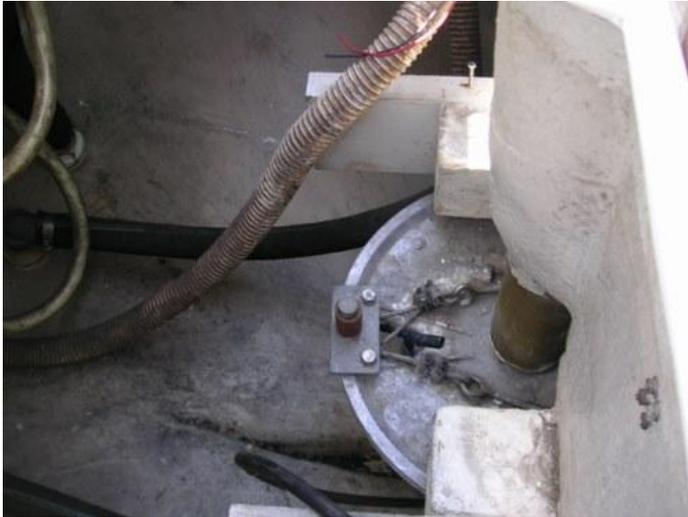
Photo (9) shows the manual bilge pump hose in the aft lazarette with the propane locker and shelf protecting the radial removed. The manual bilge hose discharge thru hull is very low on the transoms centerline just barely out of the photo. The two light colored hoses are the vent lines from the propane locker moved out of the way to get in this area to work.

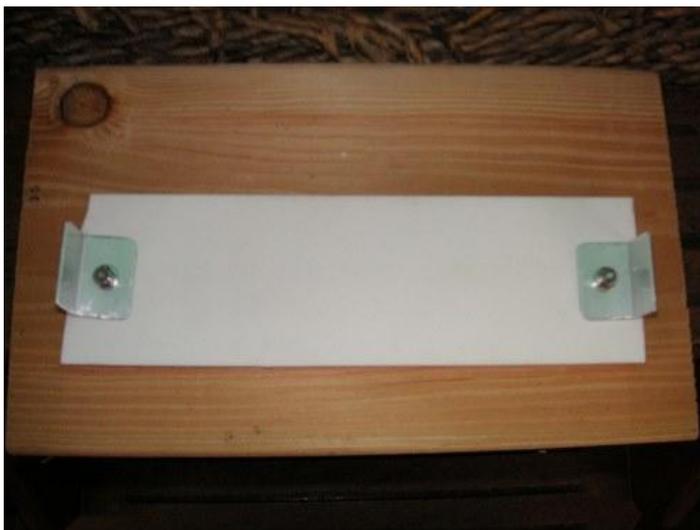
Photo (10) shows an example of the aluminum angle mounting method ready to be bonded into the bilge. To bond the aluminum angles to the bilge, I used West Systems 610 to epoxy. This is the float switch shelf with the aluminum angle fastened with SST #8 pan head machine screws, washers, and nyloc lock nuts at each end. The shelf is upside down to show the angles.

What I did was make two shelves out of 1/4" Starboard. One for the float switch, and one for the pump. They would each be fastened with screws and locknuts to mounting points made of 1 x 1 x 1/16" aluminum angle. The float switch will be installed in the bilge section just aft of the mast step, and the pump will be installed in the center bilge section over the forward two keel bolts.

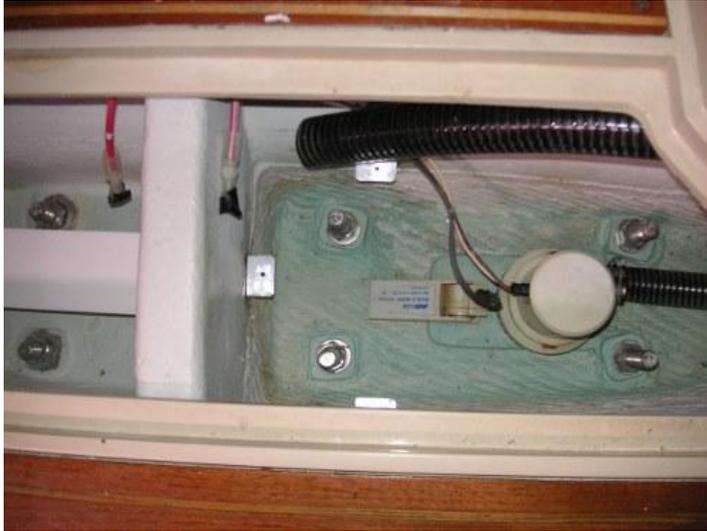
I then used each shelf to hold the angles snug against the bilge while the epoxy cured. This method also helped ensure the shelf was flat and at the right height in the bilge. Photo (11) shows the new float switch shelf installed in the bilge section just aft of the mast step, and the 3 aluminum angles to mount the new pump shelf over the keel bolts and Rule 1500 float switch in the center bilge section. The pump shelf was removed for clarity.

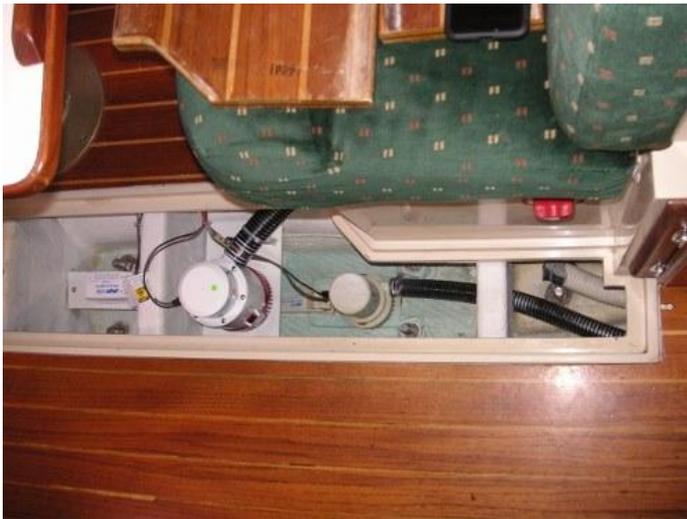
Photo (12) shows the new 2 electric pump bilge system with wires and hoses connected. Photo (13) is a closer view of the installed pumps. The 3700 1 1/2" bilge hose has a tie wrap attaching it to the shelf to pull it down to get a straight run to the pump connection.

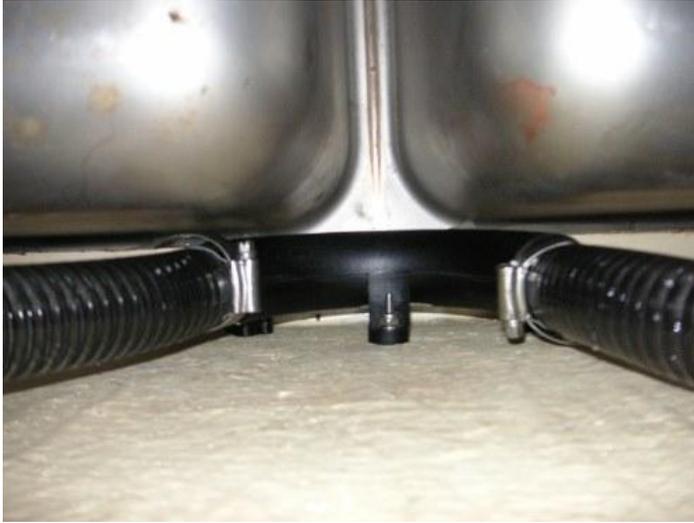
Photo (16) is a view from underneath the galley sink looking up to see the newly installed 1 1/8" vented loop and connecting to/from bilge hoses. The vented loop is up as high as it can go and still leave a small air gap between the top of the loop and the underside of the wood support for the galley countertop. I used my 90 degree drill adaptor to drill a hole for a #8 truss head SST screw to fasten the vented loop with a SST nyloc nut to the bulkhead. Photo (17) shows the screw head visible from the outside of the sink cabinet.

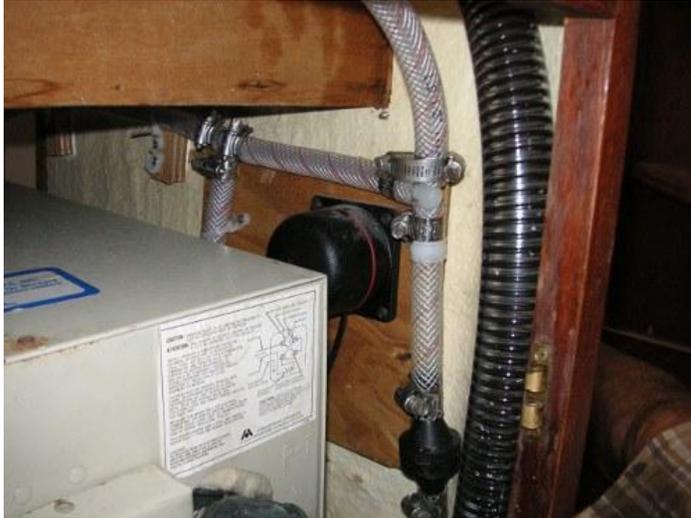
Photo (18) shows the 1 1/8" bilge hose running up the galley sink bulkhead from the Rule 1500 pump, over the sink drawer frame to the vented loop. Photo (19) shows the 1 1/8" bilge hose after the vented loop running down the galley sink bulkhead on the other side of the drawer frame to pass underneath the galley floor on its way to the are underneath the aft cabin.

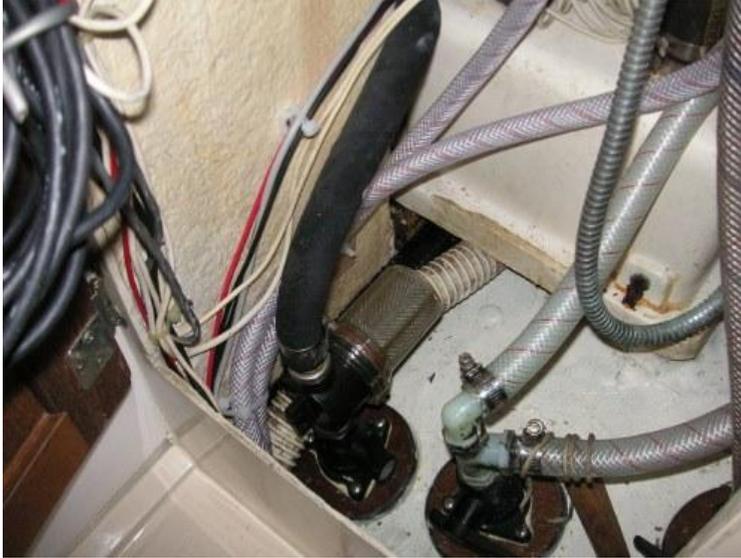
In photo (20) you can see the white manual bilge 1 1/2" pump hose. Tucked behind it is the Rule 3700 1 1/2" bilge pump hose. Previously the manual 1 1/2" and Rule 1500 bilge pump 1 1/8" hoses ran through this area making access to the raw water and head sea water sea cock handles awkward to open and close. This arrangement makes access very easy. In the lower left corner of the photo you can see the hot & cold fresh water supply hoses going to the head sink from the galley sink that I rerouted out of the engine compartment.

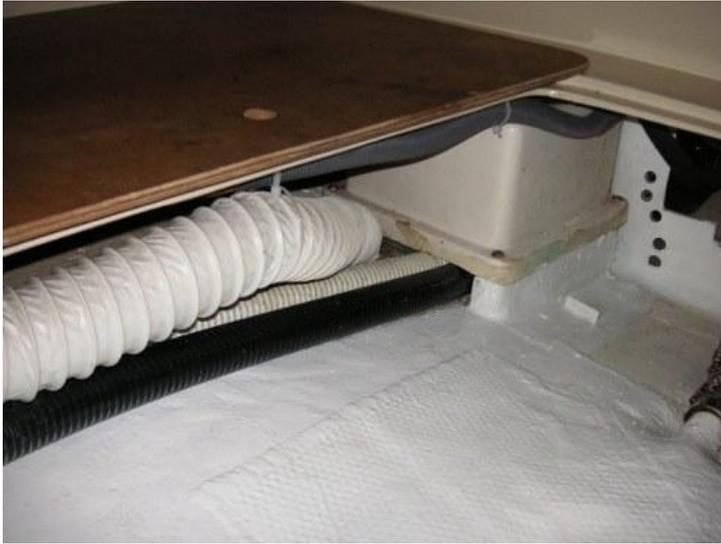
Photo (22) is a closer view of the 1 1/2" hoses passing under the Aqualift muffler.

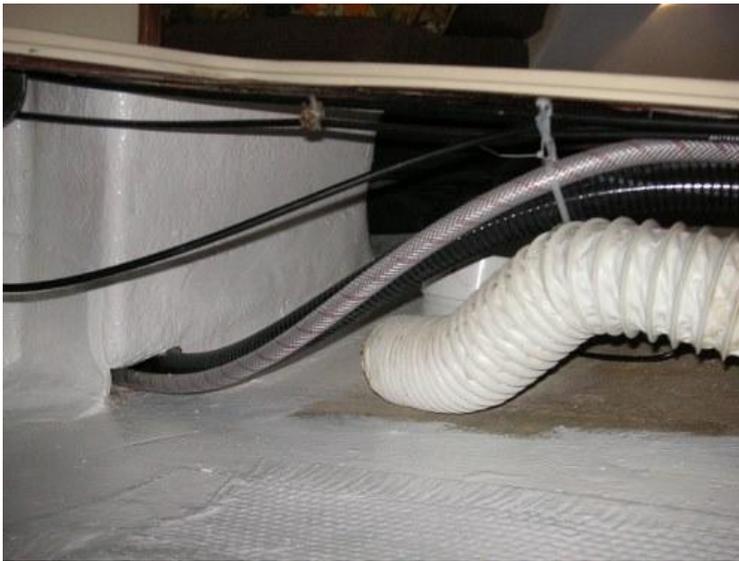
Photo (23) is a closer view of the water supply hose and the 1 1/8" bilge pump hose.

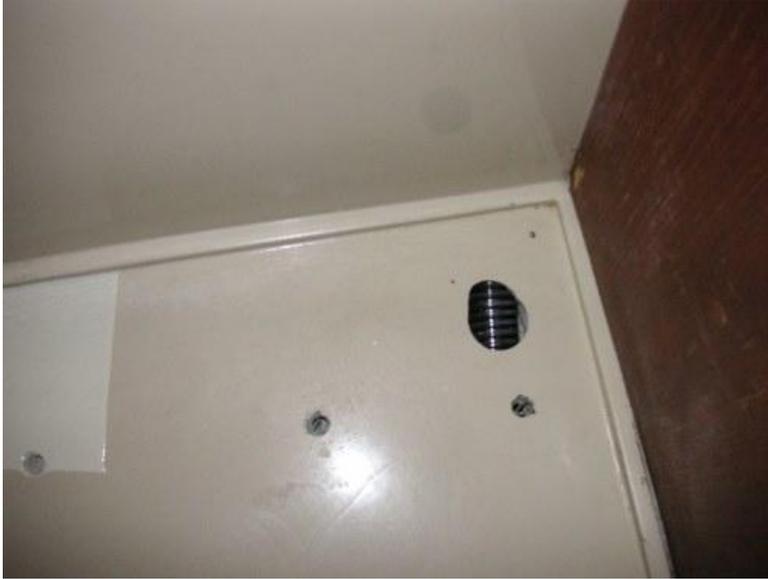
Photo (24) shows a hole I needed to drill into the subfloor. It is in the corner where the fiberglass bulkhead before the aft cabin mattress and the teak engine compartment bulkhead meet. The hole was needed because the area under the sub-floor needed some grinding to enable the 1 1/8" hose to slide through.

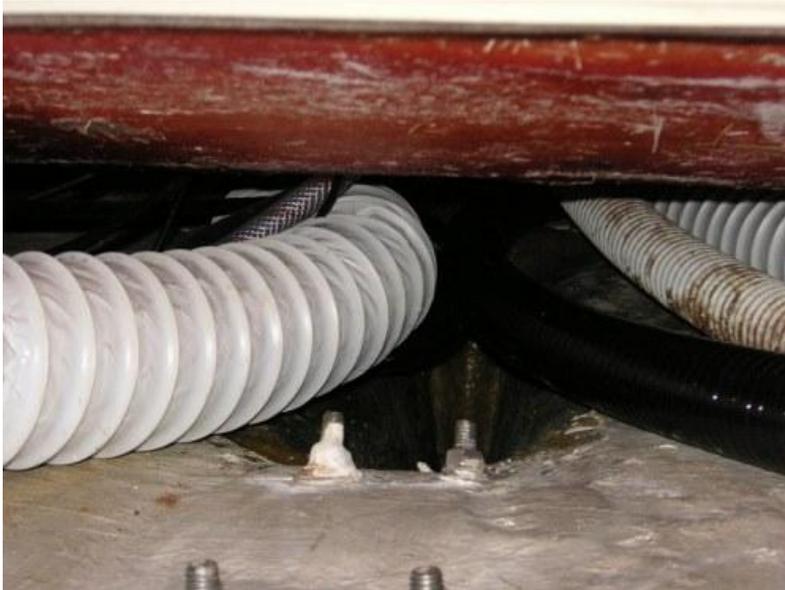
Photo (25) shows the bilge pump hoses, and the large air vent hoses passing from under the aft cabin to the aft lazarette under the aft water tank.

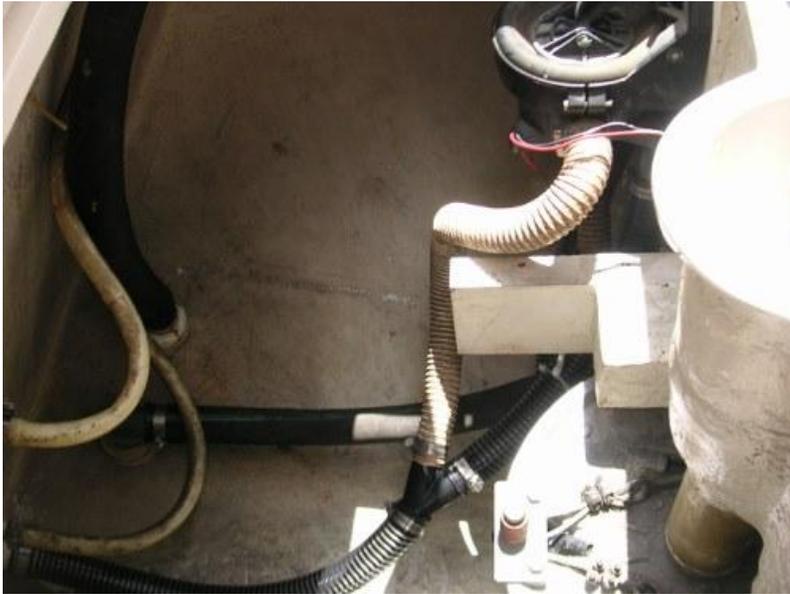
Photo (28) shows the Whale manual and new Rule 3700 electric bilge pump discharge hoses tied together and connecting to the 1 1/2" thru hull at the bottom of the transom they both now share.

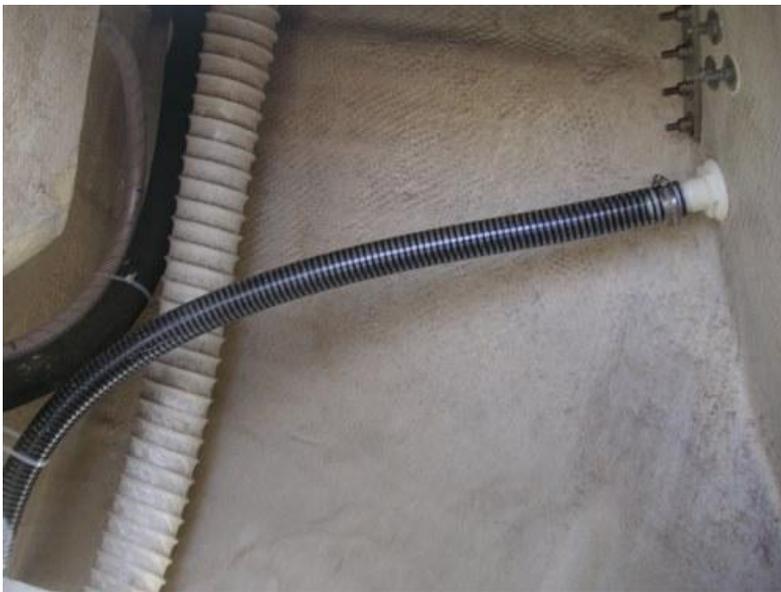
(29)

In photo (29), the 1 1/8" bilge hose from the Rule 1500 runs to starboard and connects high on the transom near the backstay chain plate. When I tested the system, water shot straight out of the thru hull approximately 6 inches beyond the transom.

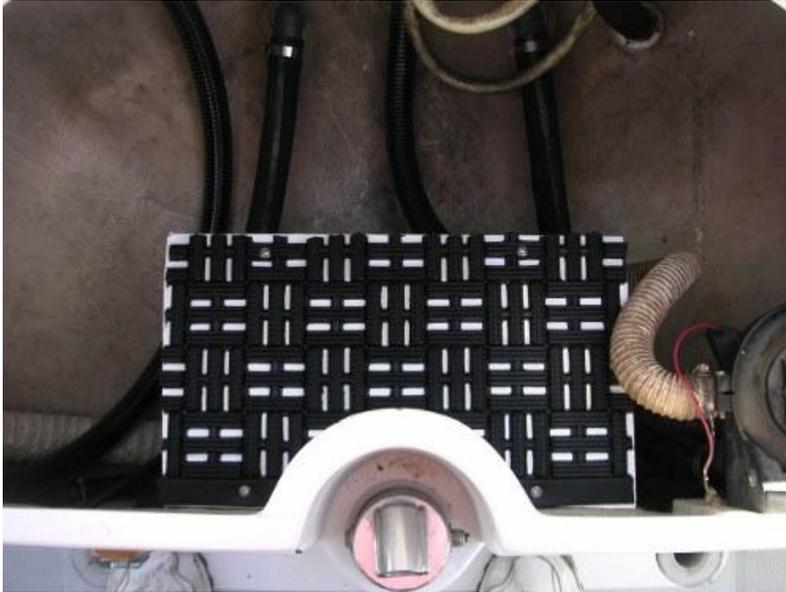
Photo (30) is of the wood cover in the aft lazarette protecting the radial from damage. I removed the propane locker and installed a non skid mat so this can be used as a step to get into the lazarette easier. I will be making a new propane locker to hold one 11# tank for the galley and one 5# tank for the BBQ. I will be installing it in the aft lazarette on the starboard side as my next project.

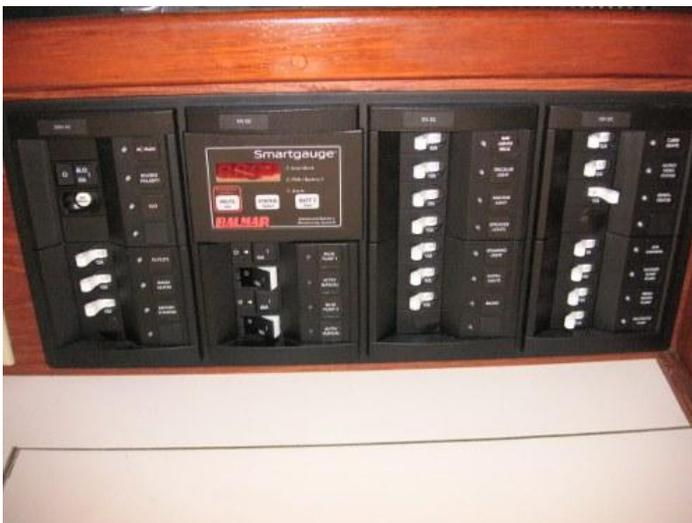
Photo (31) shows the Main Distribution Panel with both bilge pump breakers turned on. The bilge pump breakers are directly below the Smartgauge battery monitor. The Rule 1500 on/off/Auto breaker is first and the Rule 3700 on/off/Auto breaker is second. The Rule 1500 is labeled “Bilge Pump 1” and has a 10A breaker. The Rule 3700 is labeled “Bilge Pump 2” and has a 25A breaker.
