1987 MK 1 Catalina 34 Adding A 2nd Electric Bilge Pump

By **Jon Windt**; s/v Della Jean

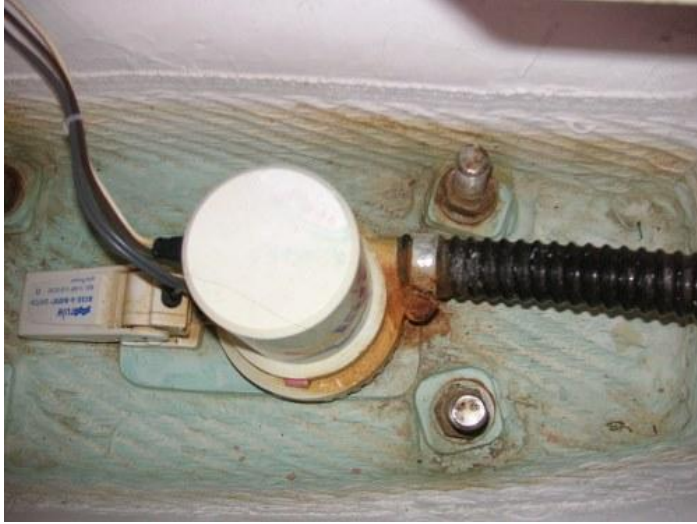
Photo (1) is the existing Rule 1500 pump and switch mounted on an ~ 5/16" raised surface glassed into the bottom of the bilge. Notice the severely rusted hose clamp. I was not able to loosen it so used my Dremel tool to cut the metal band to remove it. Photo (2) is the aft most bilge section. The 1 1/8" hose for the Rule 1500 and one of the in line check valves ran along the bottom of the bilge and through a ~2" hole in the port to starboard stringer to attach to the pump located in the center bilge section. Also in this bilge section is the end of 1 1/2" manual bilge pump hose. It had a screen tie wrapped over the end to keep debris from being drawn into the hose and eventually the pump. The screen was torn and the hose clamp for the in-line check valve was rusted.

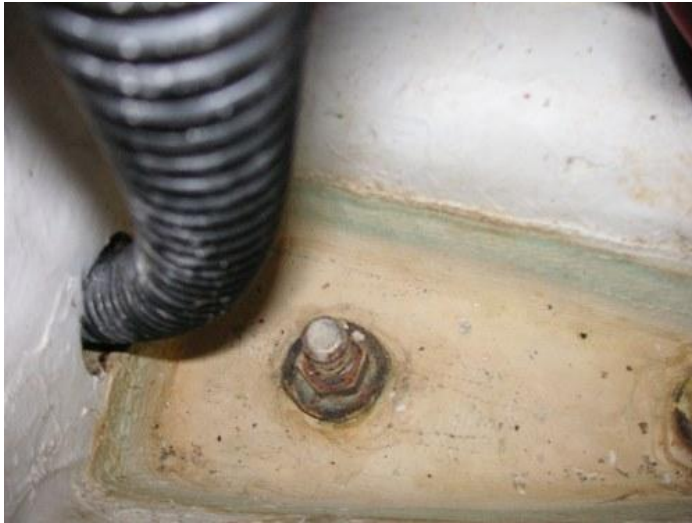
Photo (3) is the 1st keel bolt in the aft bilge section with the bilge hoses moved out of the way. Photo (4) is the 2nd keel bolt in the aft bilge section also with the bilge hoses moved out of the way. Both showed quite a bit of corrosion from the standing water that **used** to sit in this section. One of my first upgrades was to install a SST propeller shaft and change the packing gland material to a Gortex product. Now this section remains dry. Later in this write up are photos after I cleaned all the keel bolts With Davis brand FSR.

As I mentioned earlier in the description, the keel bolts were very corroded in the aft section of the bilge due to the standing water that used to always be there. I used a product called FSR from Davis to clean them up. Photos (14) and (15) show the results. Not like new, but a lot better.

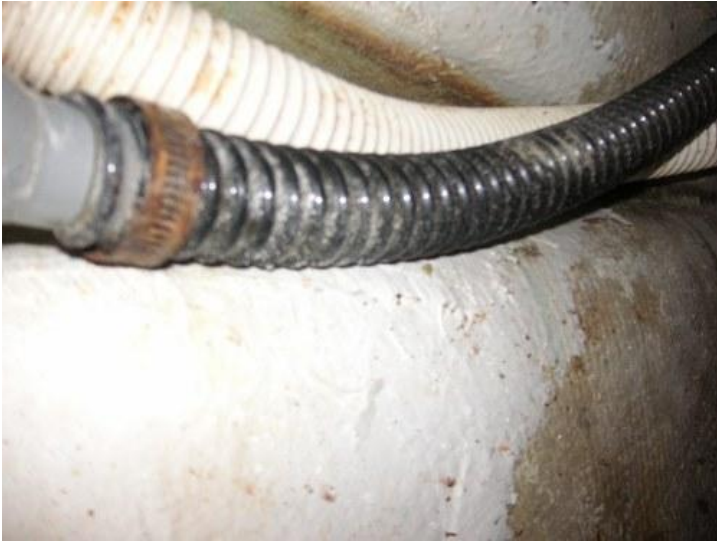
Photo (5) is the same bilge section but farther aft under the subfloor showing another rusted hose clamp on the 1 1/8" bilge hose. I point these out because this is the primary bilge pump system that could fail, even with a good pump and switch. I suggest you look at your bilge hoses and clamps, even if not planning to change anything.

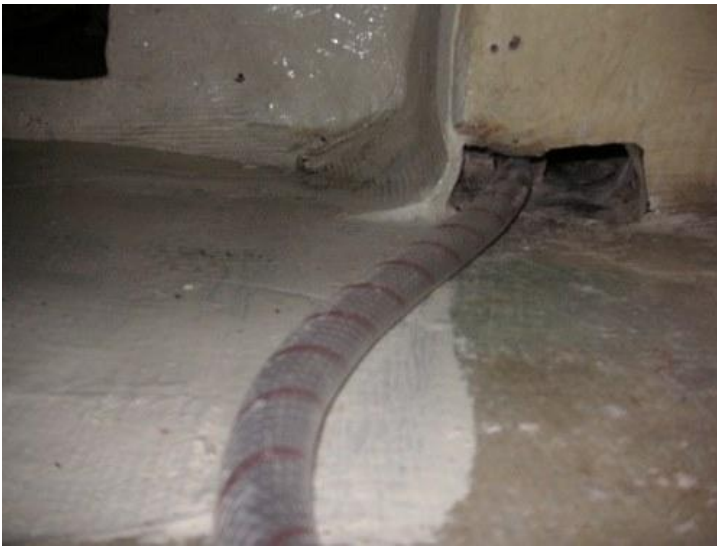
Photo (6) is under the aft cabin on the starboard side. The hose shown is the 1/2" fresh water supply line from the aft water tank going to the galley sink area where it connects into the main fresh water line with the starboard water tank prior to the fresh water pump. Previously I had run the starter, alternator out, and main negative cables through this opening. I found a way to route those cables more directly to the engine compartment. See photo (7). This routing change is both better electrically, and it gets the hot and cold fresh water hoses to the head sink out of the engine compartment which then frees up this opening up to run the 1 1/8" bilge hose for the Rule 1500.

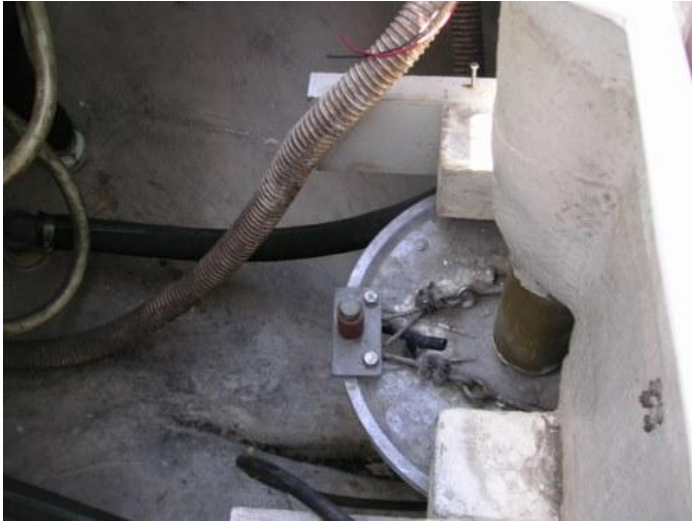
Photo (9) shows the manual bilge pump hose in the aft lazarette with the propane locker and shelf protecting the radial removed. The manual bilge hose discharge thru hull is very low on the transoms centerline just barely out of the photo. The two light colored hoses are the vent lines from the propane locker moved out of the way to get in this area to work.

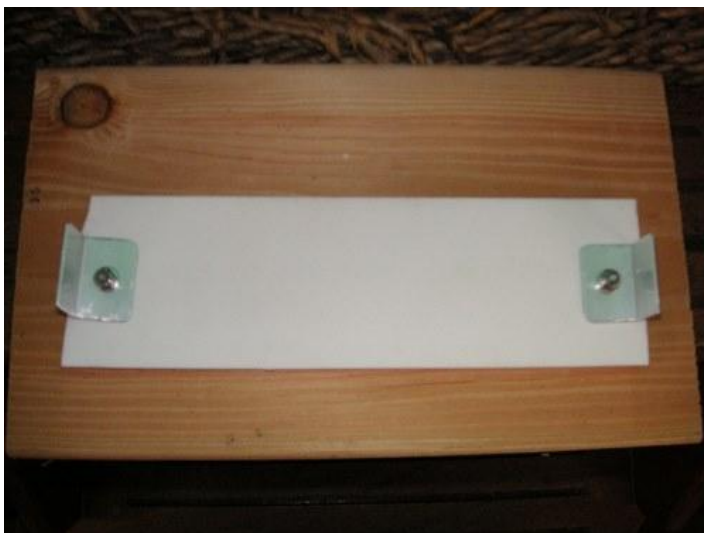
Photo (10) shows an example of the aluminum angle mounting method ready to be bonded into the bilge. To bond the aluminum angles to the bilge, I used West Systems 610 to epoxy. This is the float switch shelf with the aluminum angle fastened with SST #8 pan head machine screws, washers, and nyloc lock nuts at each end. The shelf is upside down to show the angles.

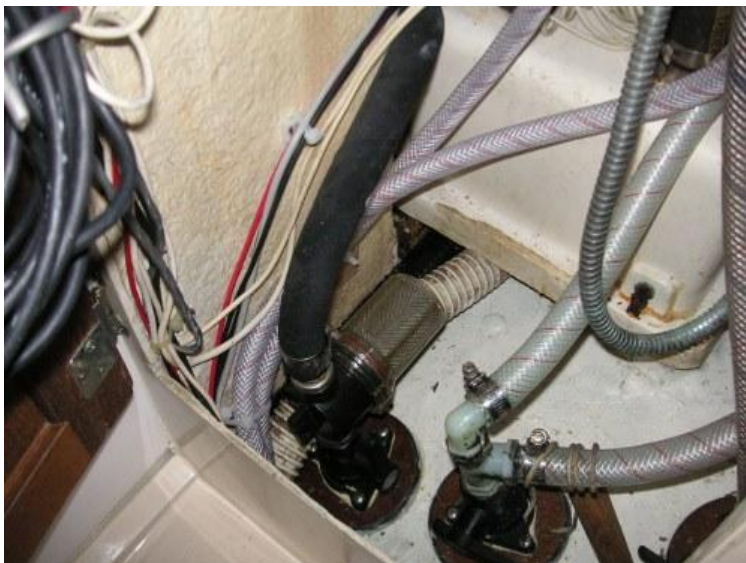
In photo (20) you can see the white manual bilge 1.5” pump hose. Tucked behind it is the Rule 3700 1.5” bilge pump hose. Previously the manual 1.5” and Rule 1500 bilge pump 1.12” hoses ran through this area making access to the raw water and head sea water sea cock handles awkward to open and close. This arrangement makes access very easy. In the lower left corner of the photo you can see the hot & cold fresh water supply hoses going to the head sink from the galley sink that I rerouted out of the engine compartment.

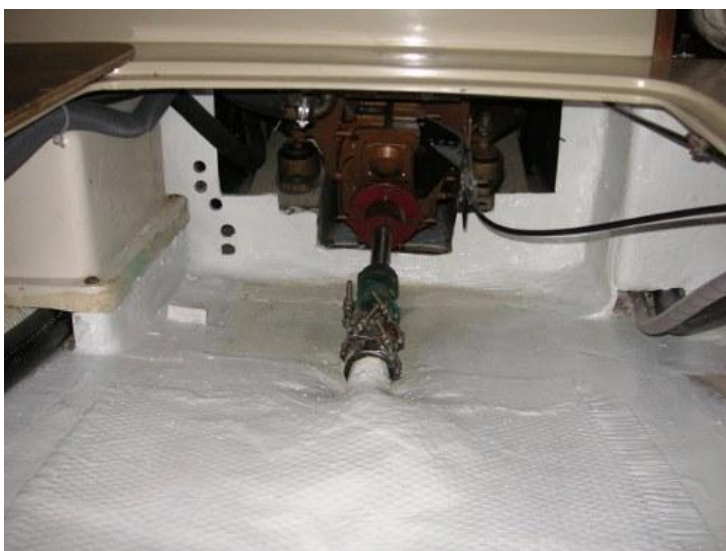
Photo (21) is taken underneath the aft cabin with the mattress and wood cover removed. The air vent lines are moved out of the way for clarity. The left side of the photo you can see the 1.5" bilge hoses running underneath the Aqualift muffler. It is a snug fit, but they both fit without putting pressure on the muffler. On the right side of the photo you see the 1/2" fresh water supply hose from the aft tank and the 1.12" bilge pump hose from the galley sink area.

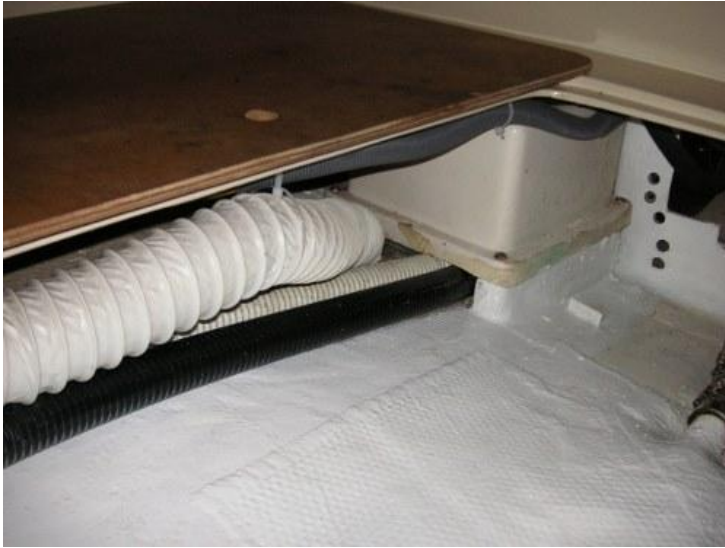
Photo (22) is a closer view of the 1.5" hoses passing under the Aqualift muffler.

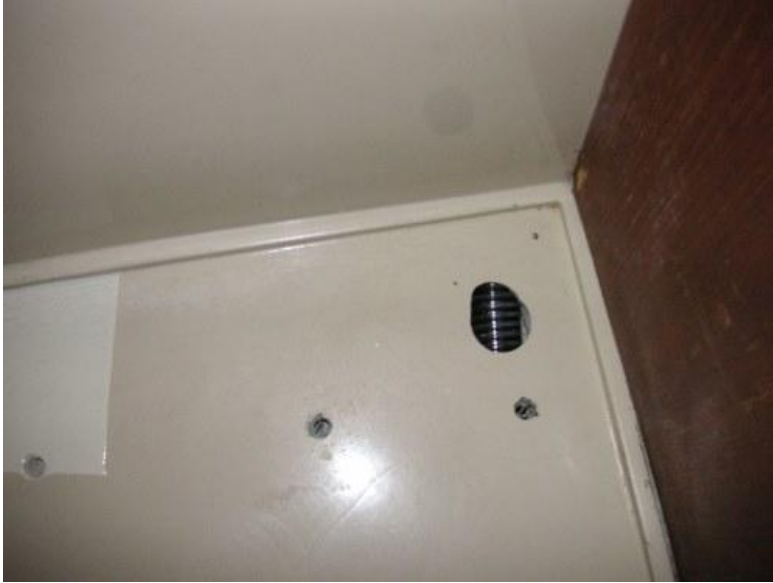
Photo (24) shows a hole I needed to drill into the subfloor. It is in the corner where the fiberglass bulkhead before the aft cabin mattress and the teak engine compartment bulkhead meet. The hole was needed because the area under the sub-floor needed some grinding to enable the 1.12" hose to slide through.

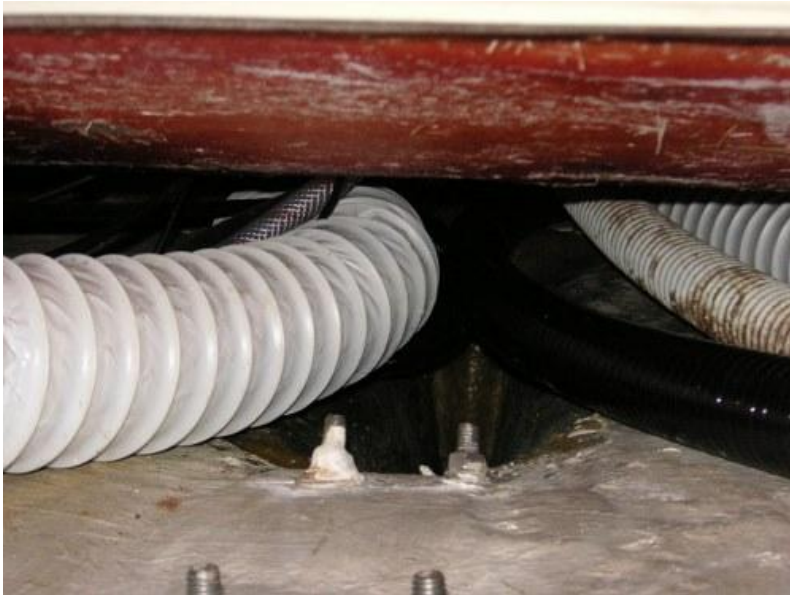
Photo (25) shows the bilge pump hoses, and the large air vent hoses passing from under the aft cabin to the aft lazarette under the aft water tank.

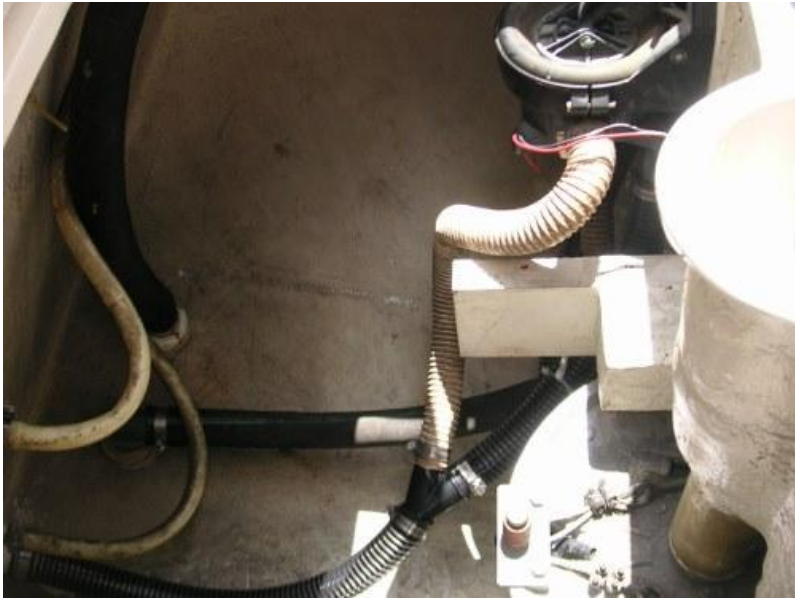
Photo (28) shows the Whale manual and new Rule 3700 electric bilge pump discharge hoses tied together and connecting to the 1.5" thru hull at the bottom of the transom they both now share.

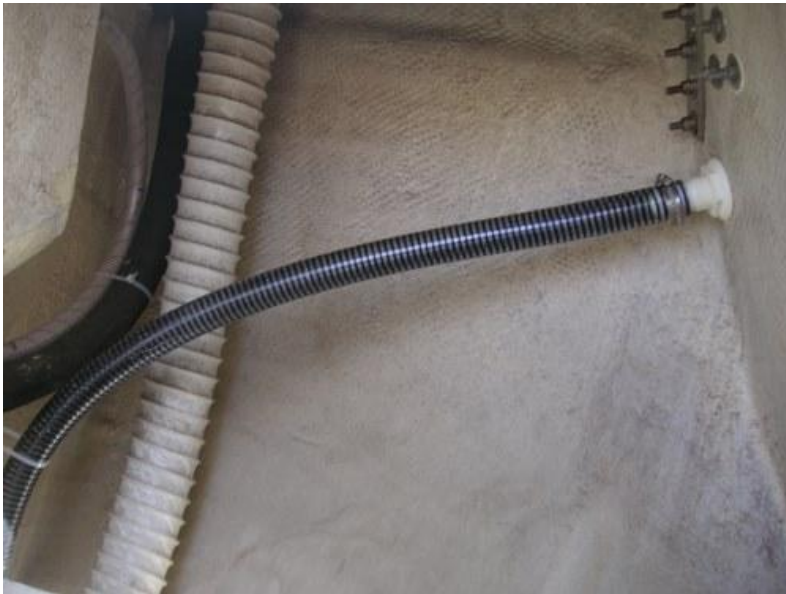
(29)

In photo (29), the 1.12" bilge hose from the Rule 1500 runs to starboard and connects high on the transom near the backstay chain plate. When I tested the system, water shot straight out of the thru hull approximately 6 inches beyond the transom.

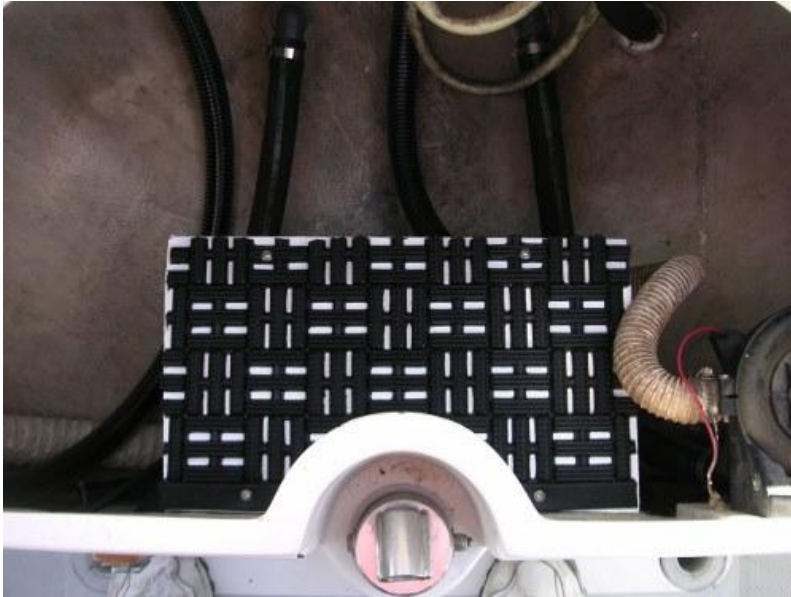
Photo (30) is of the wood cover in the aft lazarette protecting the radial from damage. I removed the propane locker and installed a non skid mat so this can be used as a step to get into the lazarette easier. I will be making a new propane locker with two 11# tanks and installing in the lazarette on the starboard side as my next project.

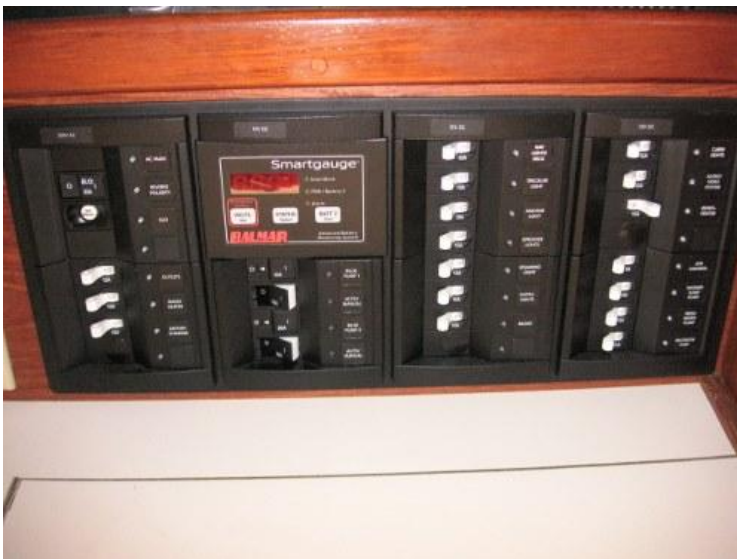
Photo (31) shows the Main Distribution Panel with both bilge pump breakers turned on. The bilge pump breakers are directly below the Smartgauge battery monitor. The Rule 1500 on/off/Auto breaker is first and the Rule 3700 on/off/Auto breaker is second. The Rule 1500 is labeled “Bilge Pump 1” and has a 10A breaker. The Rule 3700 is labeled “Bilge Pump 2” and has a 25A breaker.
