1987 MK 1 Catalina 34 Adding A 2nd Electric Bilge Pump

By **Jon Windt**; s/v Della Jean

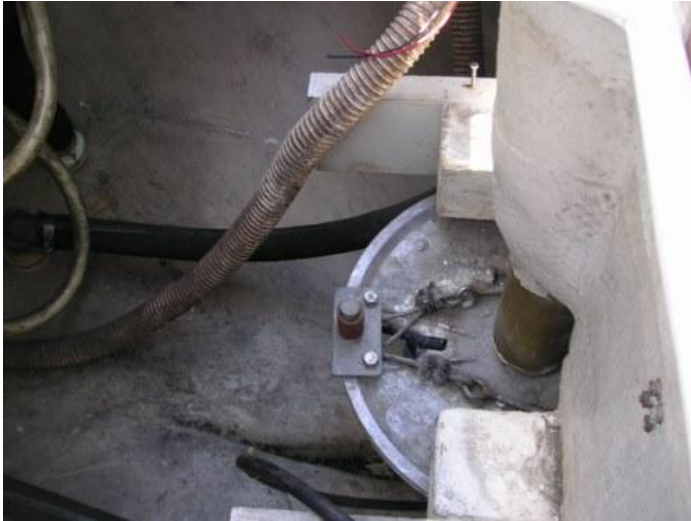
Photo (9) shows the manual bilge pump hose in the aft lazarette with the propane locker and shelf protecting the radial removed. The manual bilge hose discharge thru hull is very low on the transoms centerline just barely out of the photo. The two light colored hoses are the vent lines from the propane locker moved out of the way to get in this area to work.

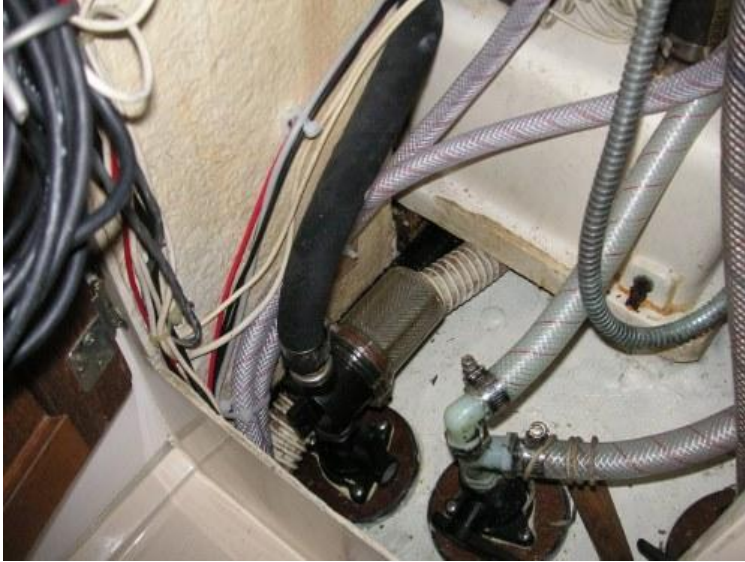
In photo (20) you can see the white manual bilge 1 1/2" pump hose. Tucked behind it is the Rule 3700 1 1/2" bilge pump hose. Previously the manual 1 1/2" and Rule 1500 bilge pump 1 1/8" hoses ran through this area making access to the raw water and head sea water sea cock handles awkward to open and close. This arrangement makes access very easy. In the lower left corner of the photo you can see the hot & cold fresh water supply hoses going to the head sink from the galley sink that I rerouted out of the engine compartment.

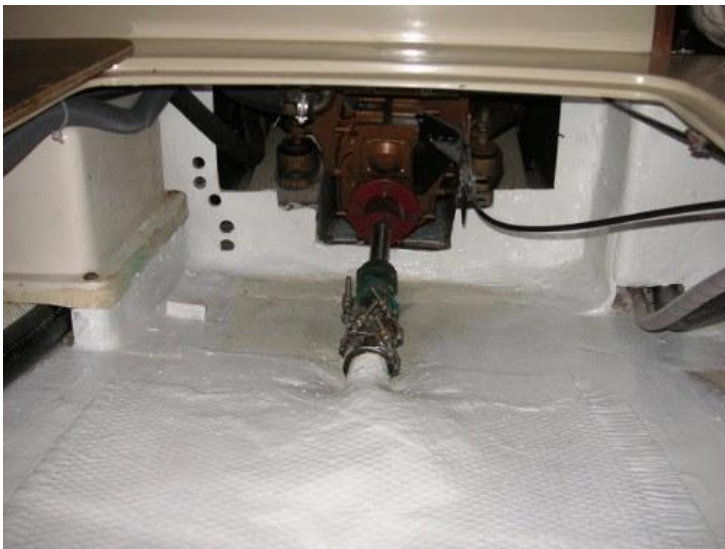
Photo (21) is taken underneath the aft cabin with the mattress and wood cover removed. The air vent lines are moved out of the way for clarity. The left side of the photo you can see the 1 1/2" bilge hoses running underneath the Aqualift muffler. It is a snug fit, but they both fit without putting pressure on the muffler. On the right side of the photo you see the 1/2" fresh water supply hose from the aft tank and the 1 1/8" bilge pump hose from the galley sink area.

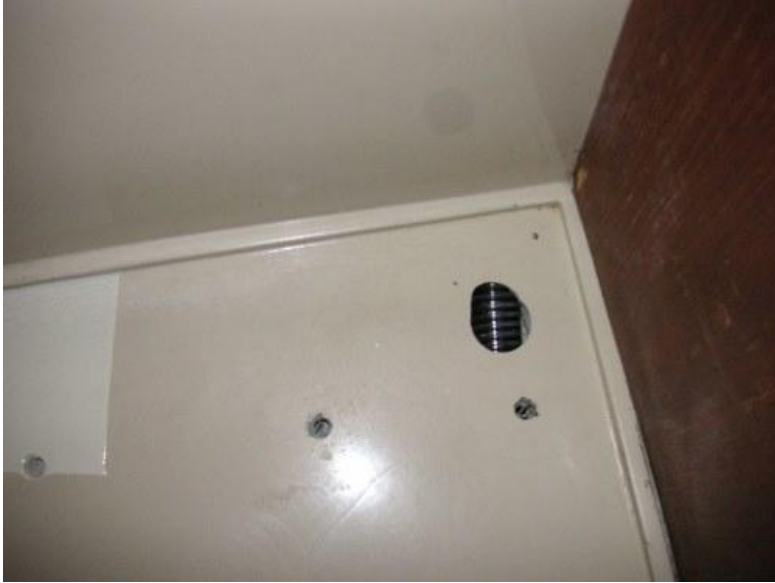
Photo (24) shows a hole I needed to drill into the subfloor. It is in the corner where the fiberglass bulkhead before the aft cabin mattress and the teak engine compartment bulkhead meet. The hole was needed because the area under the sub-floor needed some grinding to enable the 1 1/8" hose to slide through.

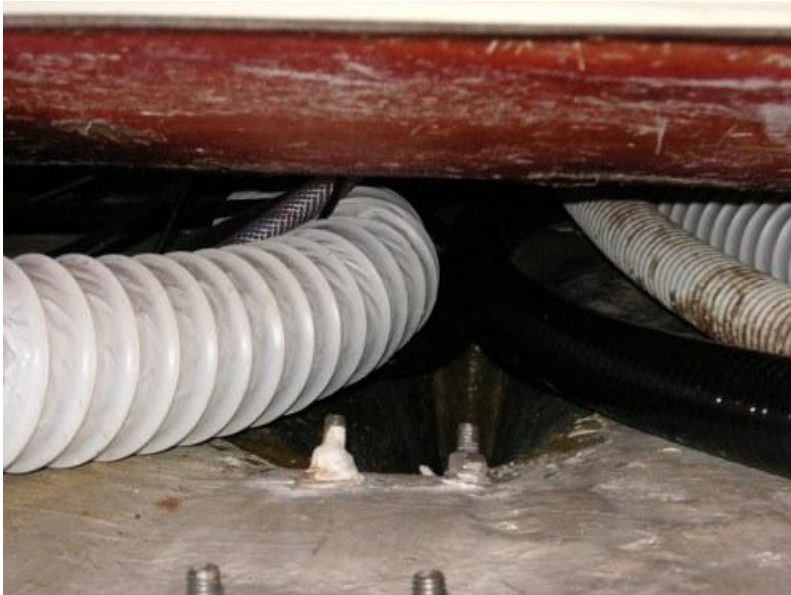
Photo (25) shows the bilge pump hoses, and the large air vent hoses passing from under the aft cabin to the aft lazarette under the aft water tank.

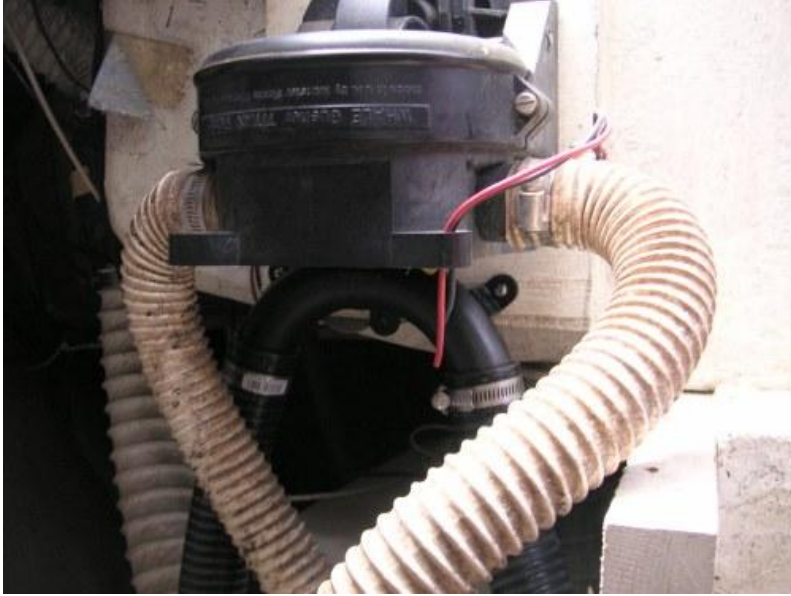
(26)

After the hoses leave the aft cabin and enter the aft lazarette they run port and starboard. In photo (26), the 1 1/2" bilge hoses run port and connect to the manual Whale pump and the new 1 1/2" vented loop I added just behind the Whale pump. 4.

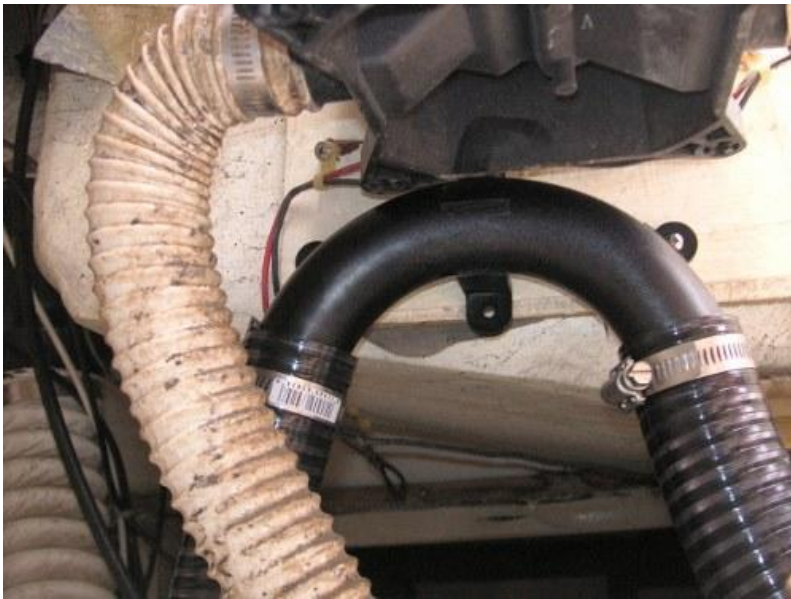
Photo (27) is a closer view of the installed 1 1/2" vented loop.

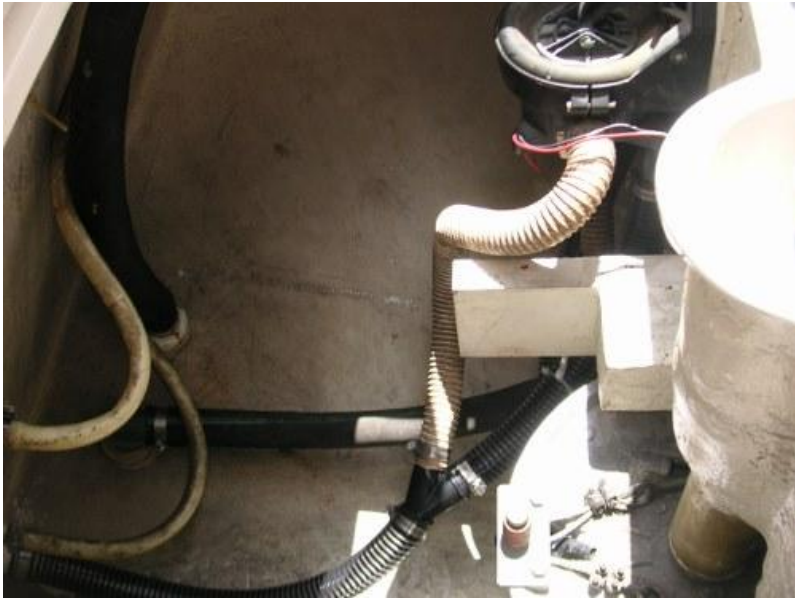
Photo (28) shows the Whale manual and new Rule 3700 electric bilge pump discharge hoses tied together and connecting to the 1 1/2" thru hull at the bottom of the transom they both now share.

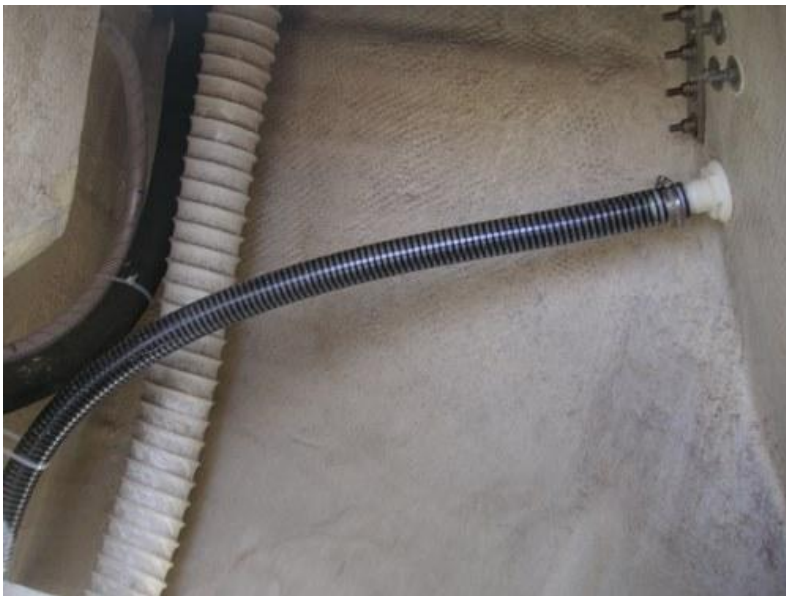
(29)

In photo (29), the 1 1/8" bilge hose from the Rule 1500 runs to starboard and connects high on the transom near the backstay chain plate. When I tested the system, water shot straight out of the thru hull approximately 6 inches beyond the transom.

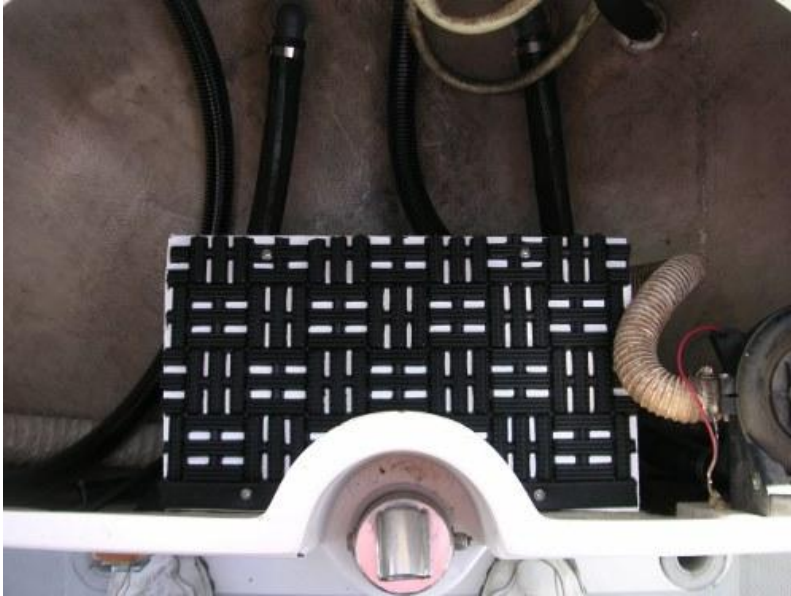
Photo (30) is of the wood cover in the aft lazarette protecting the radial from damage. I removed the propane locker and installed a non skid mat so this can be used as a step to get into the lazarette easier. I will be making a new propane locker to hold one 11# tank for the galley and one 5# tank for the BBQ. I will be installing it in the aft lazarette on the starboard side as my next project.

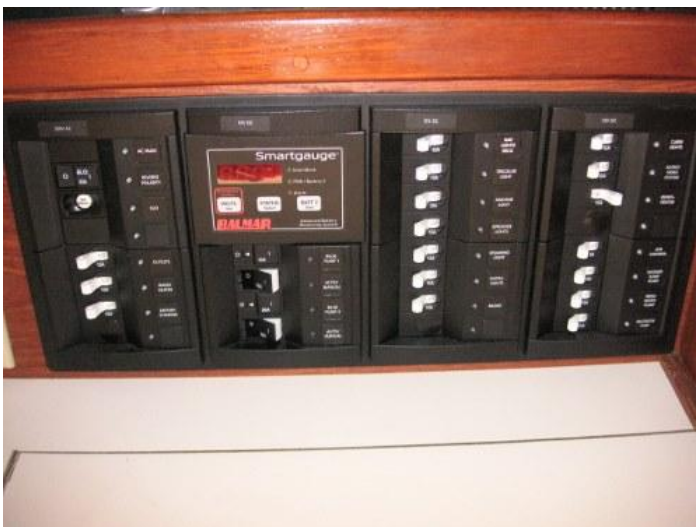
Photo (31) shows the Main Distribution Panel with both bilge pump breakers turned on. The bilge pump breakers are directly below the Smartgauge battery monitor. The Rule 1500 on/off/Auto breaker is first and the Rule 3700 on/off/Auto breaker is second. The Rule 1500 is labeled “Bilge Pump 1” and has a 10A breaker. The Rule 3700 is labeled “Bilge Pump 2” and has a 25A breaker.
