1987 MK 1 Catalina 34 Manuals and Paper Charts Storage

By Jon Windt; s/v Della Jean

Storage

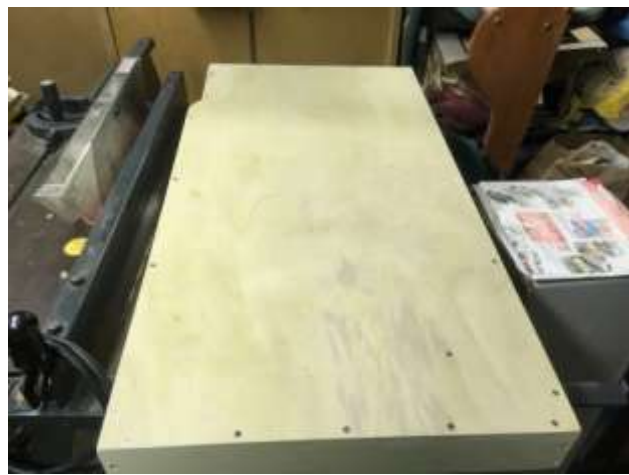
Photos (3), (4), and (5) show the different views of the unpainted storage bin.

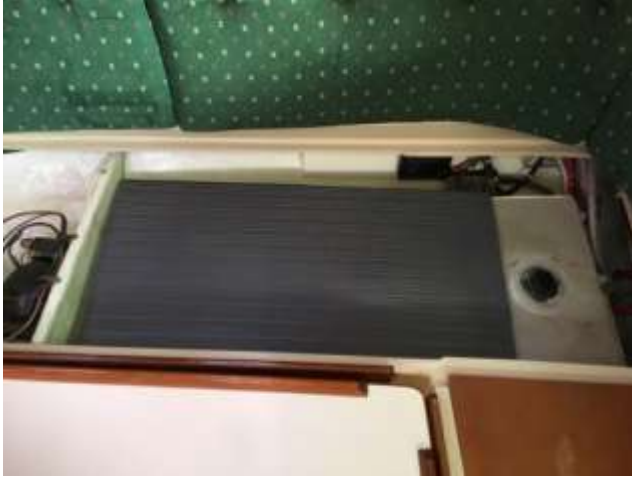
Mounting the storage shelf was straight forward. To avoid chafe wearing a hole in the top of the water tank over time, I put a gray foam pad between the tank and the storage bin. See Photo (6)

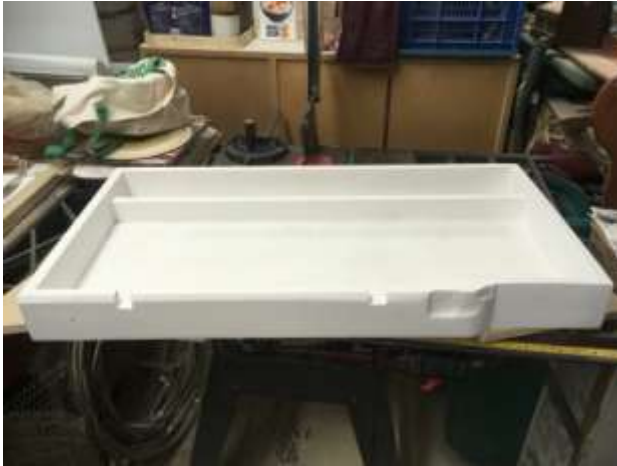
(8)

With the test fit complete and adjustments made, I applied a coat of Kilz brand white primer. See Photo (8).

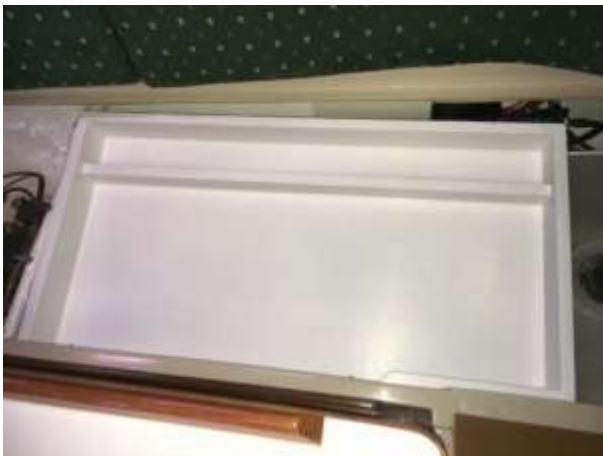
Photo (9) shows the final assembly painted with interior/exterior semi gloss enamel paint and installed on top of the water tank with the foam pad in between the tank and the storage bin. The storage bin is fastened to the boat using two #10-24 x 1 ½ long Truss head SST screws, washers and Nyloc nuts through the sette's vertical bulkhead just below the Teak trim.

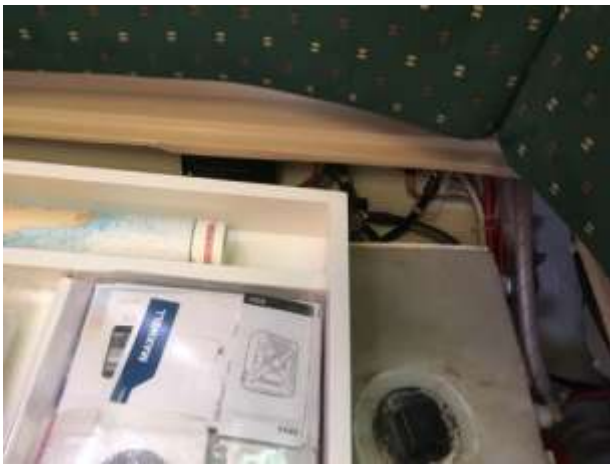
(11)

A couple of years ago I did a major project upgrading the electrical system on my boat. One of the upgrades was adding a Digital Echo Charger on a breadboard in the area under the settee and outboard of the water tank. When I do routine system checks, I check that this light is on so it's important that it continues to be visible without moving or removing anything. In photo (12) you can just see the green status light of the Digital Echo Charger is visible with the storage bin installed.

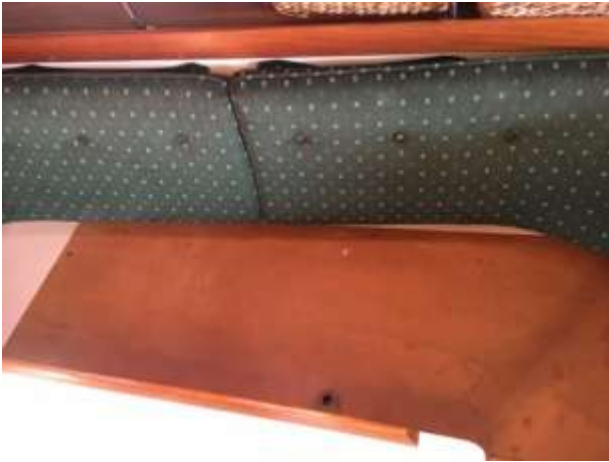
The last photo of this project is photo (12) showing the original lid reinstalled before putting the cushions back in place.
